South Elevation 1207 Cruce Street

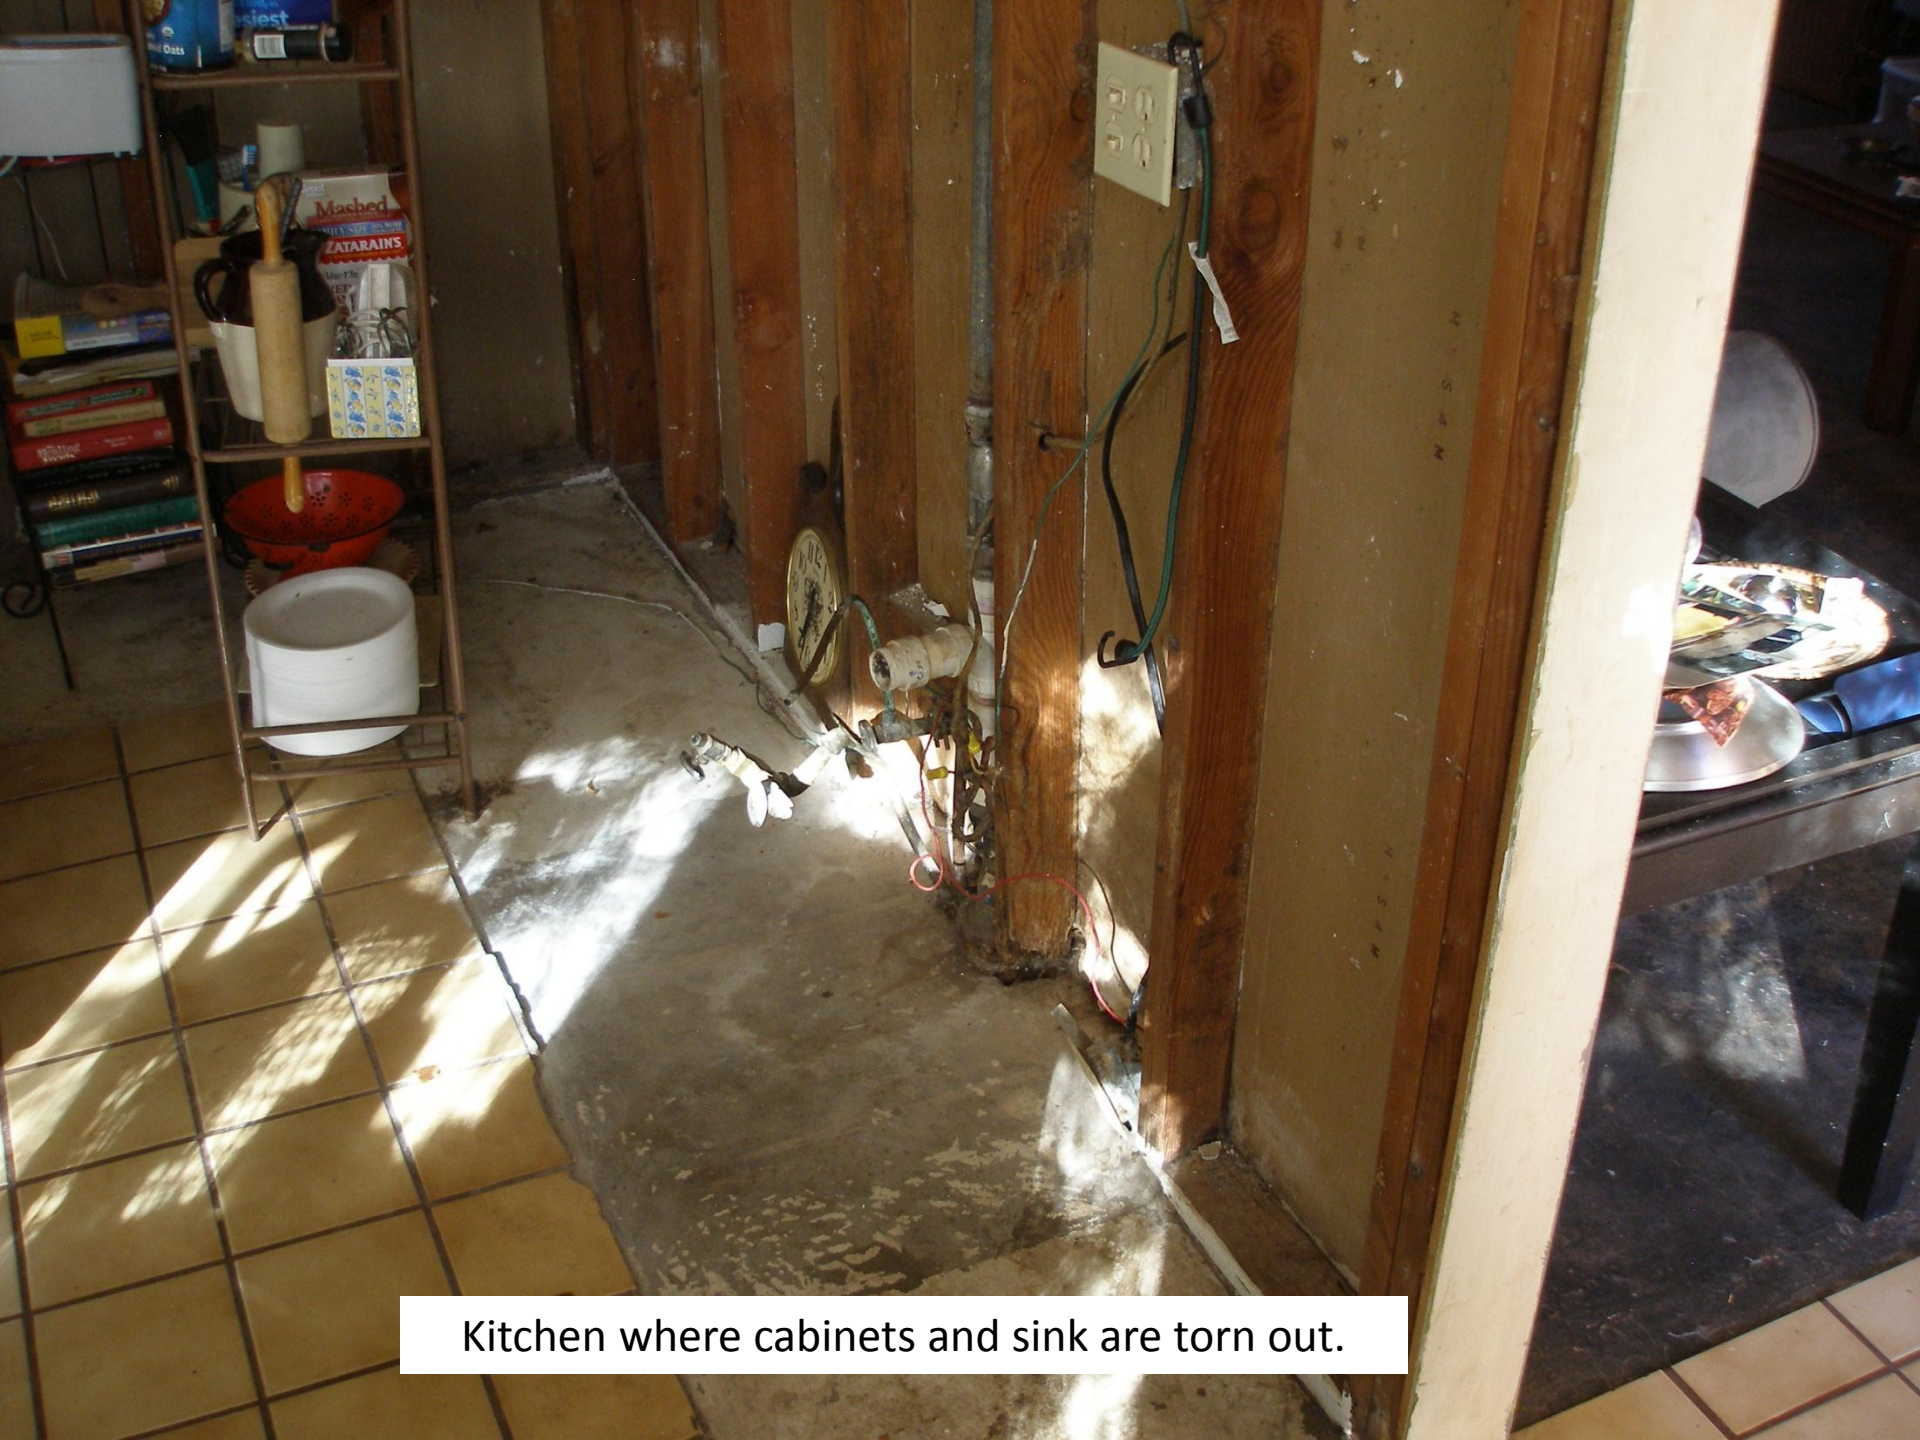
Kitchen where cabinets and sink are torn out.

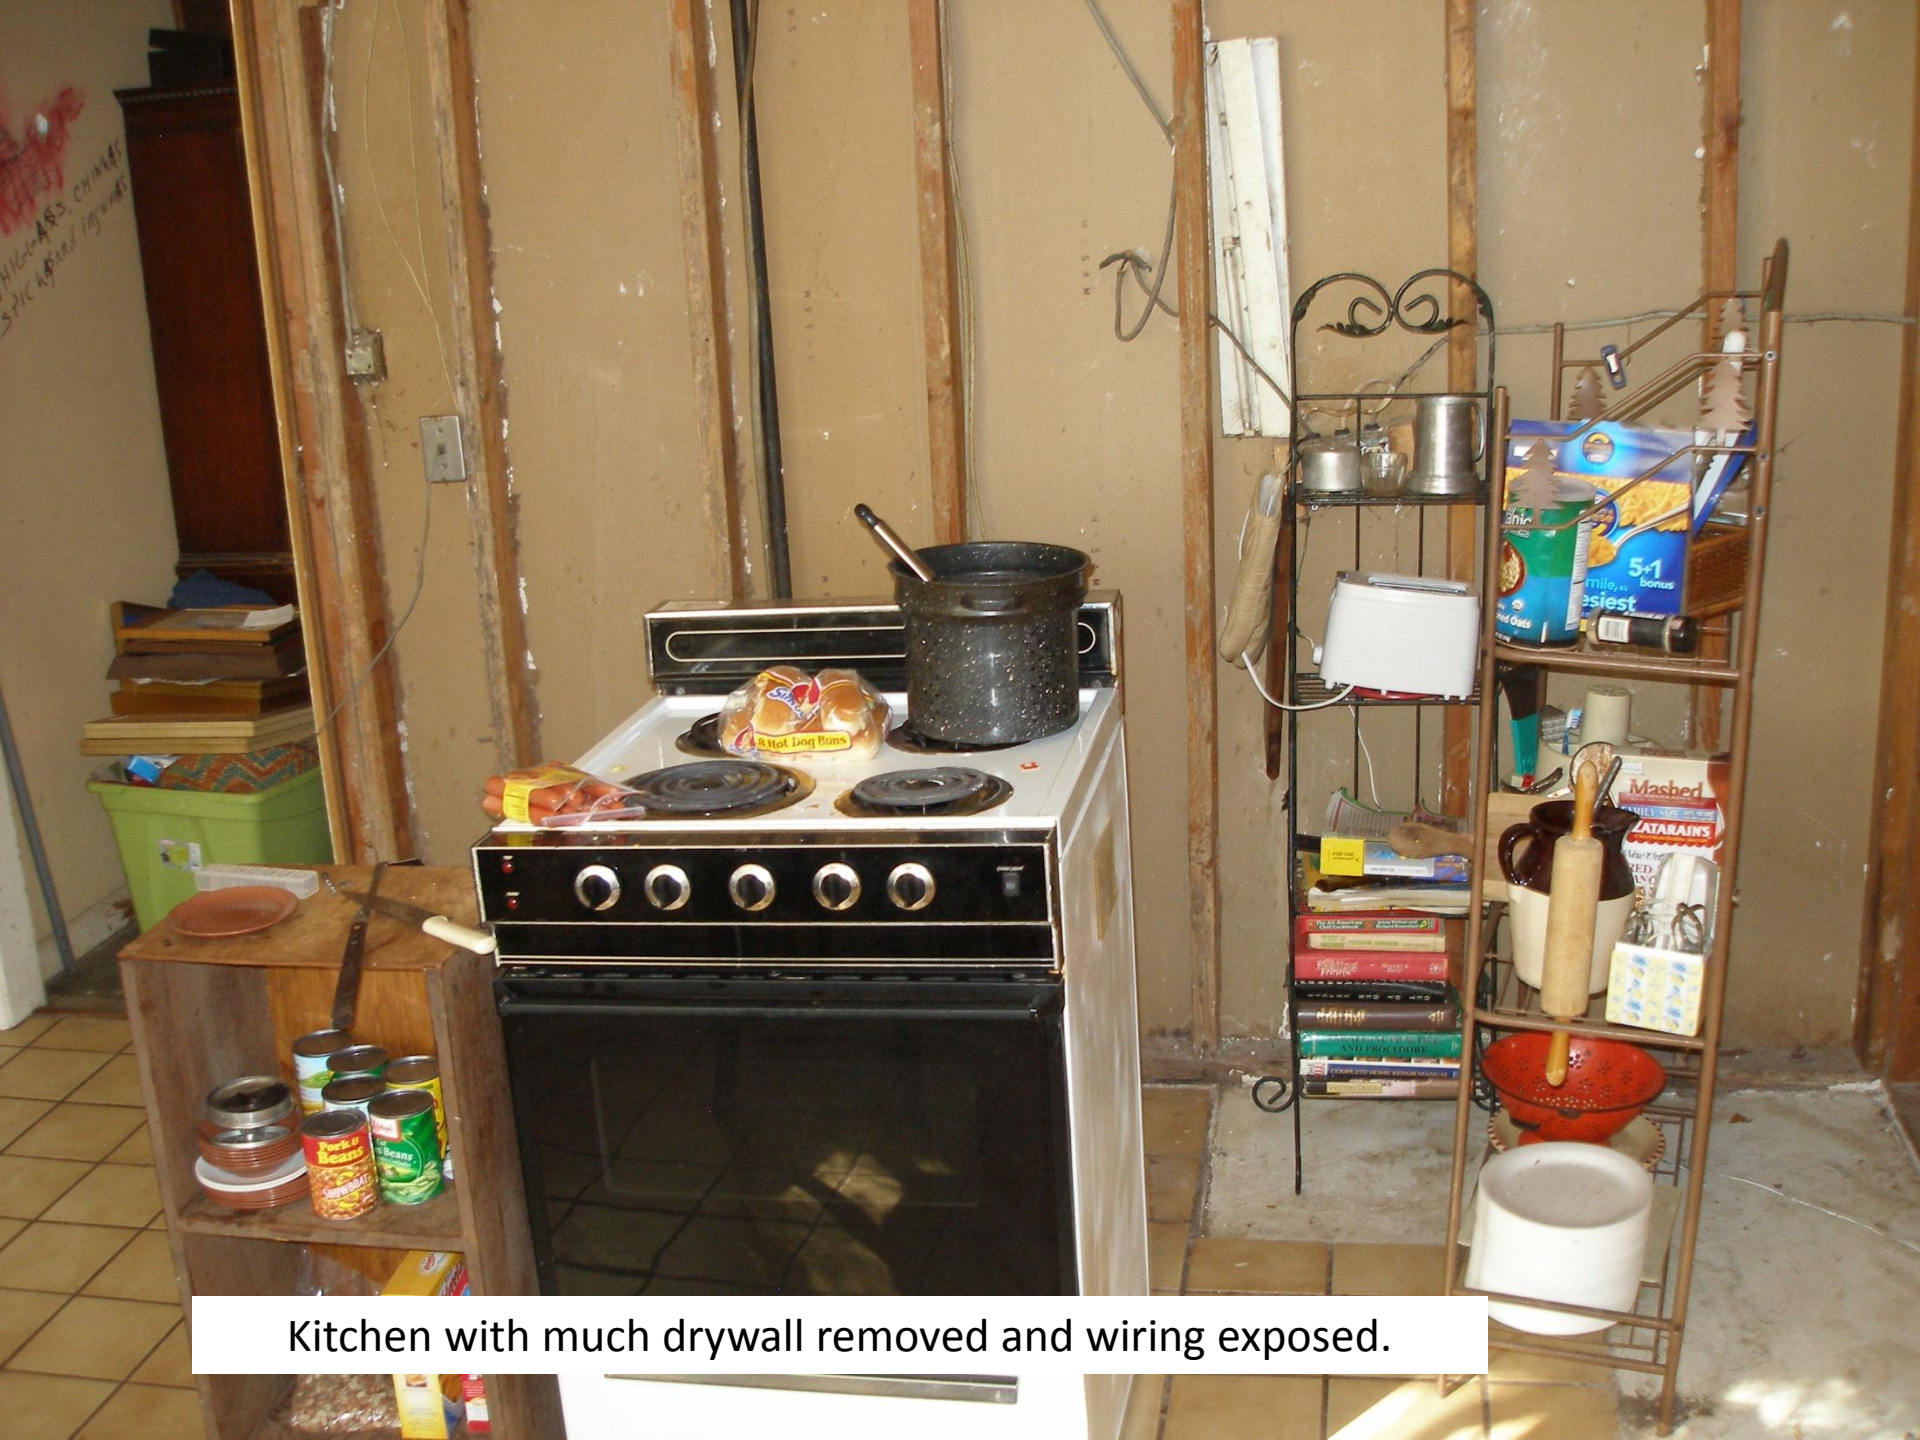
Kitchen with much drywall removed and wiring exposed.

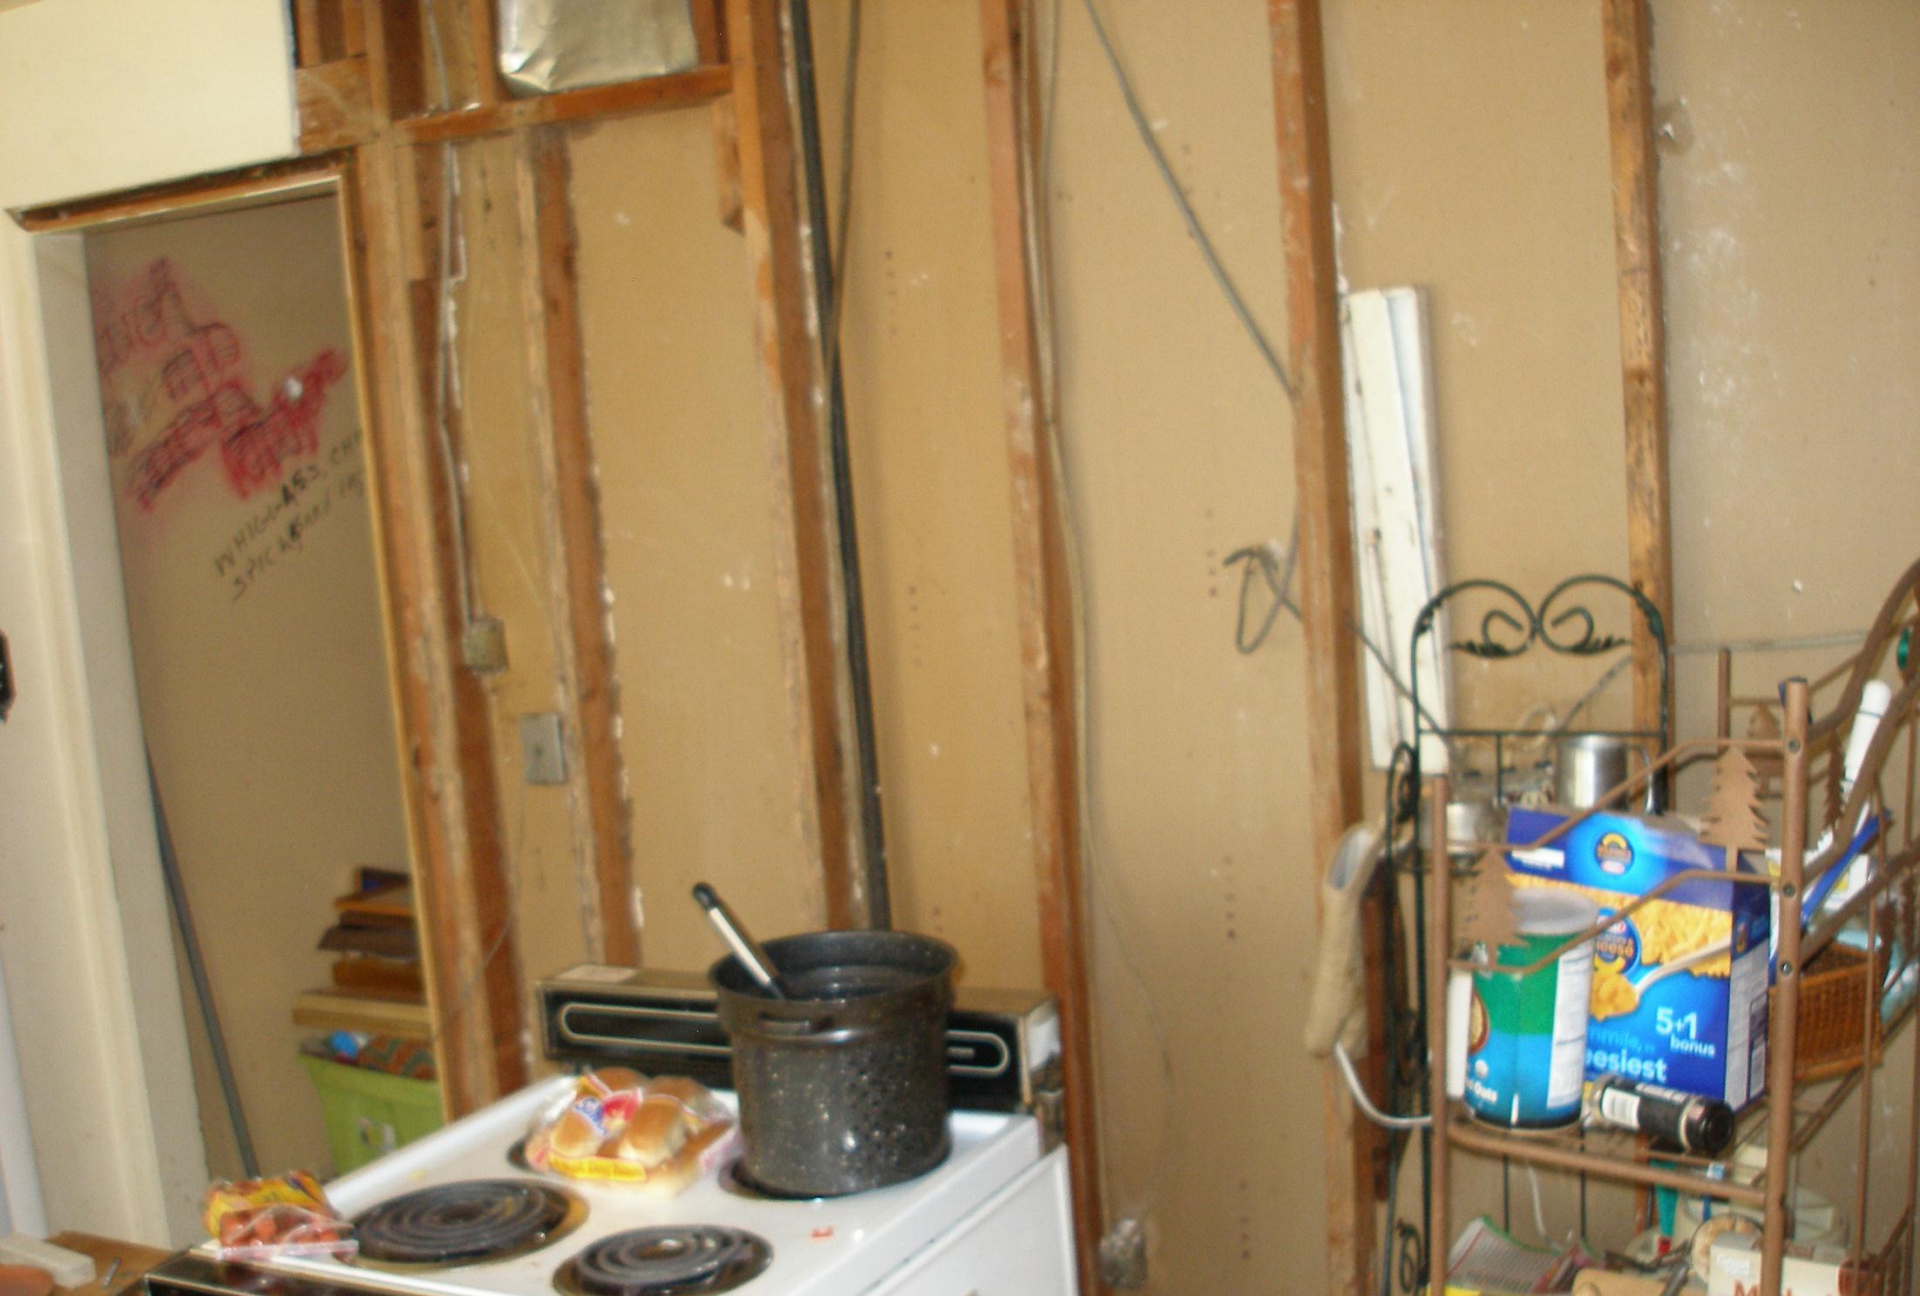
Although not evident in the picture, there is clear evidence of termite damage to exposed studs.

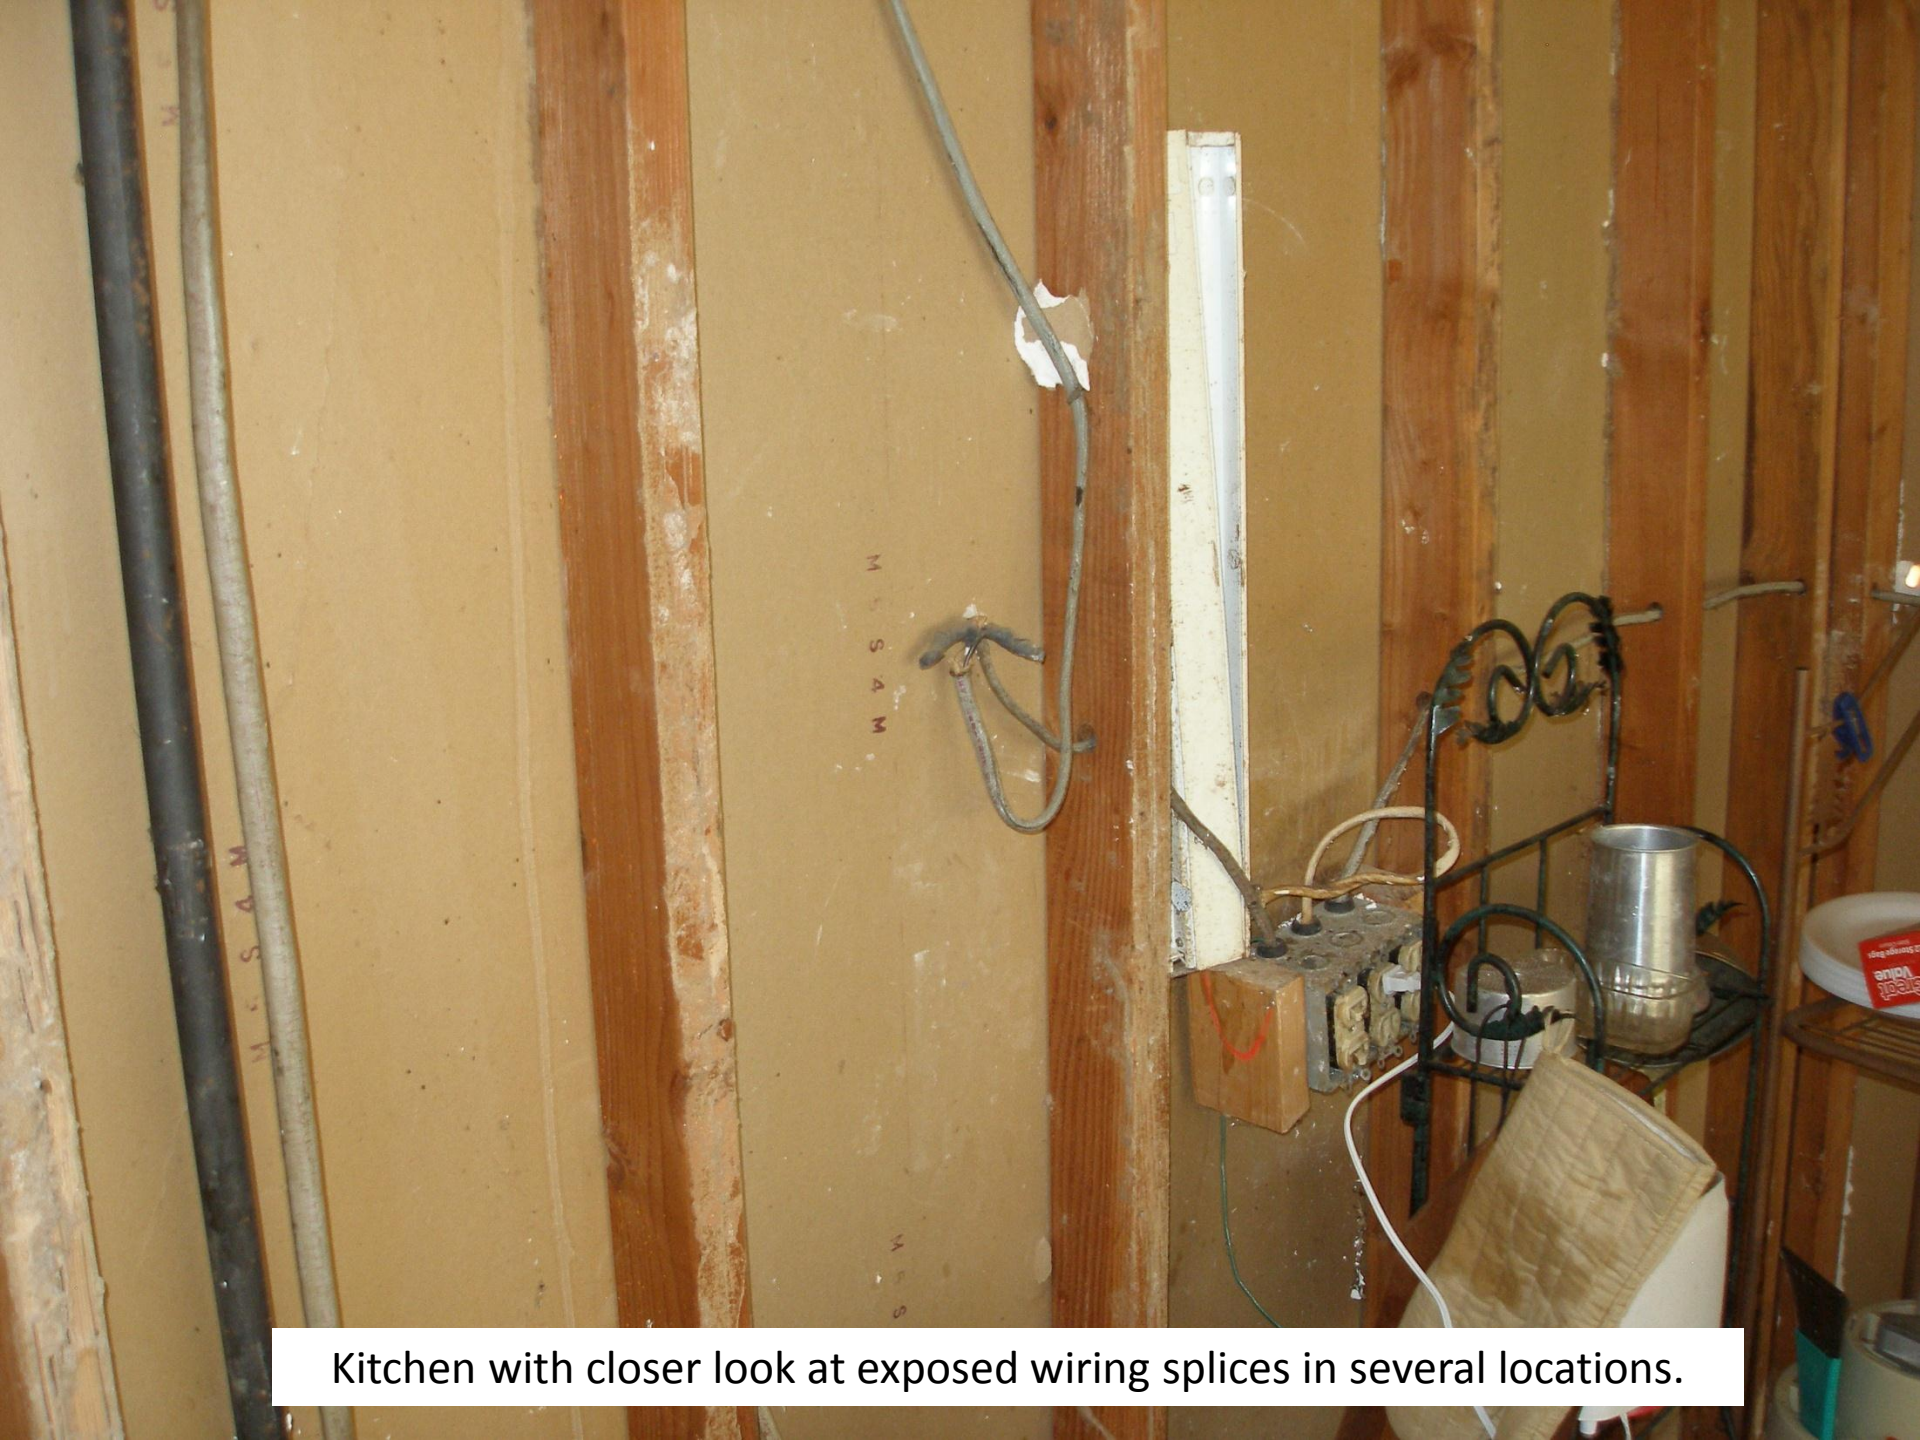
Kitchen with closer look at exposed wiring splices in several locations.

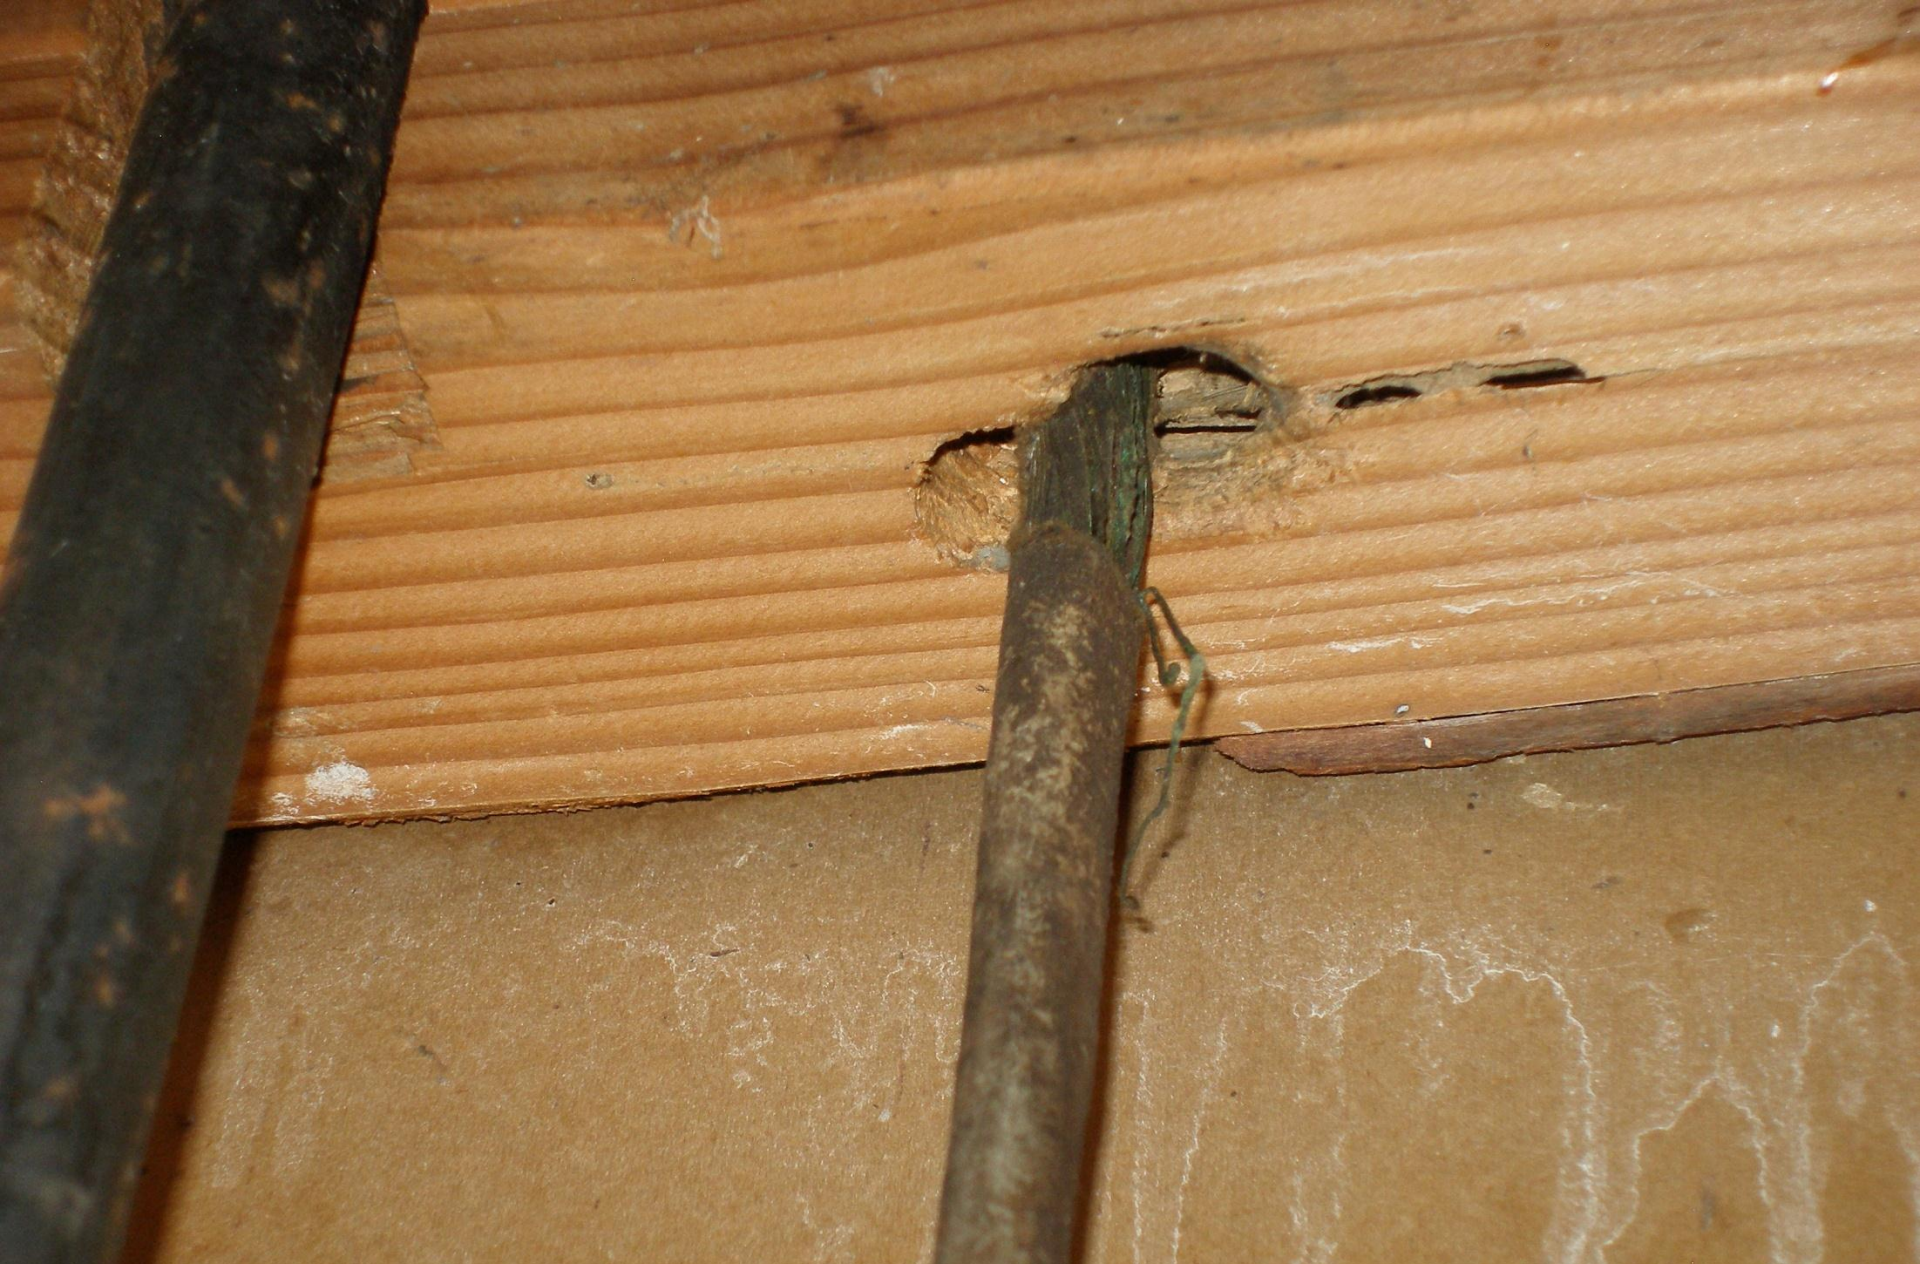
Damaged conductor sheathing leaves exposed wiring on this range circuit near the top of the wall.

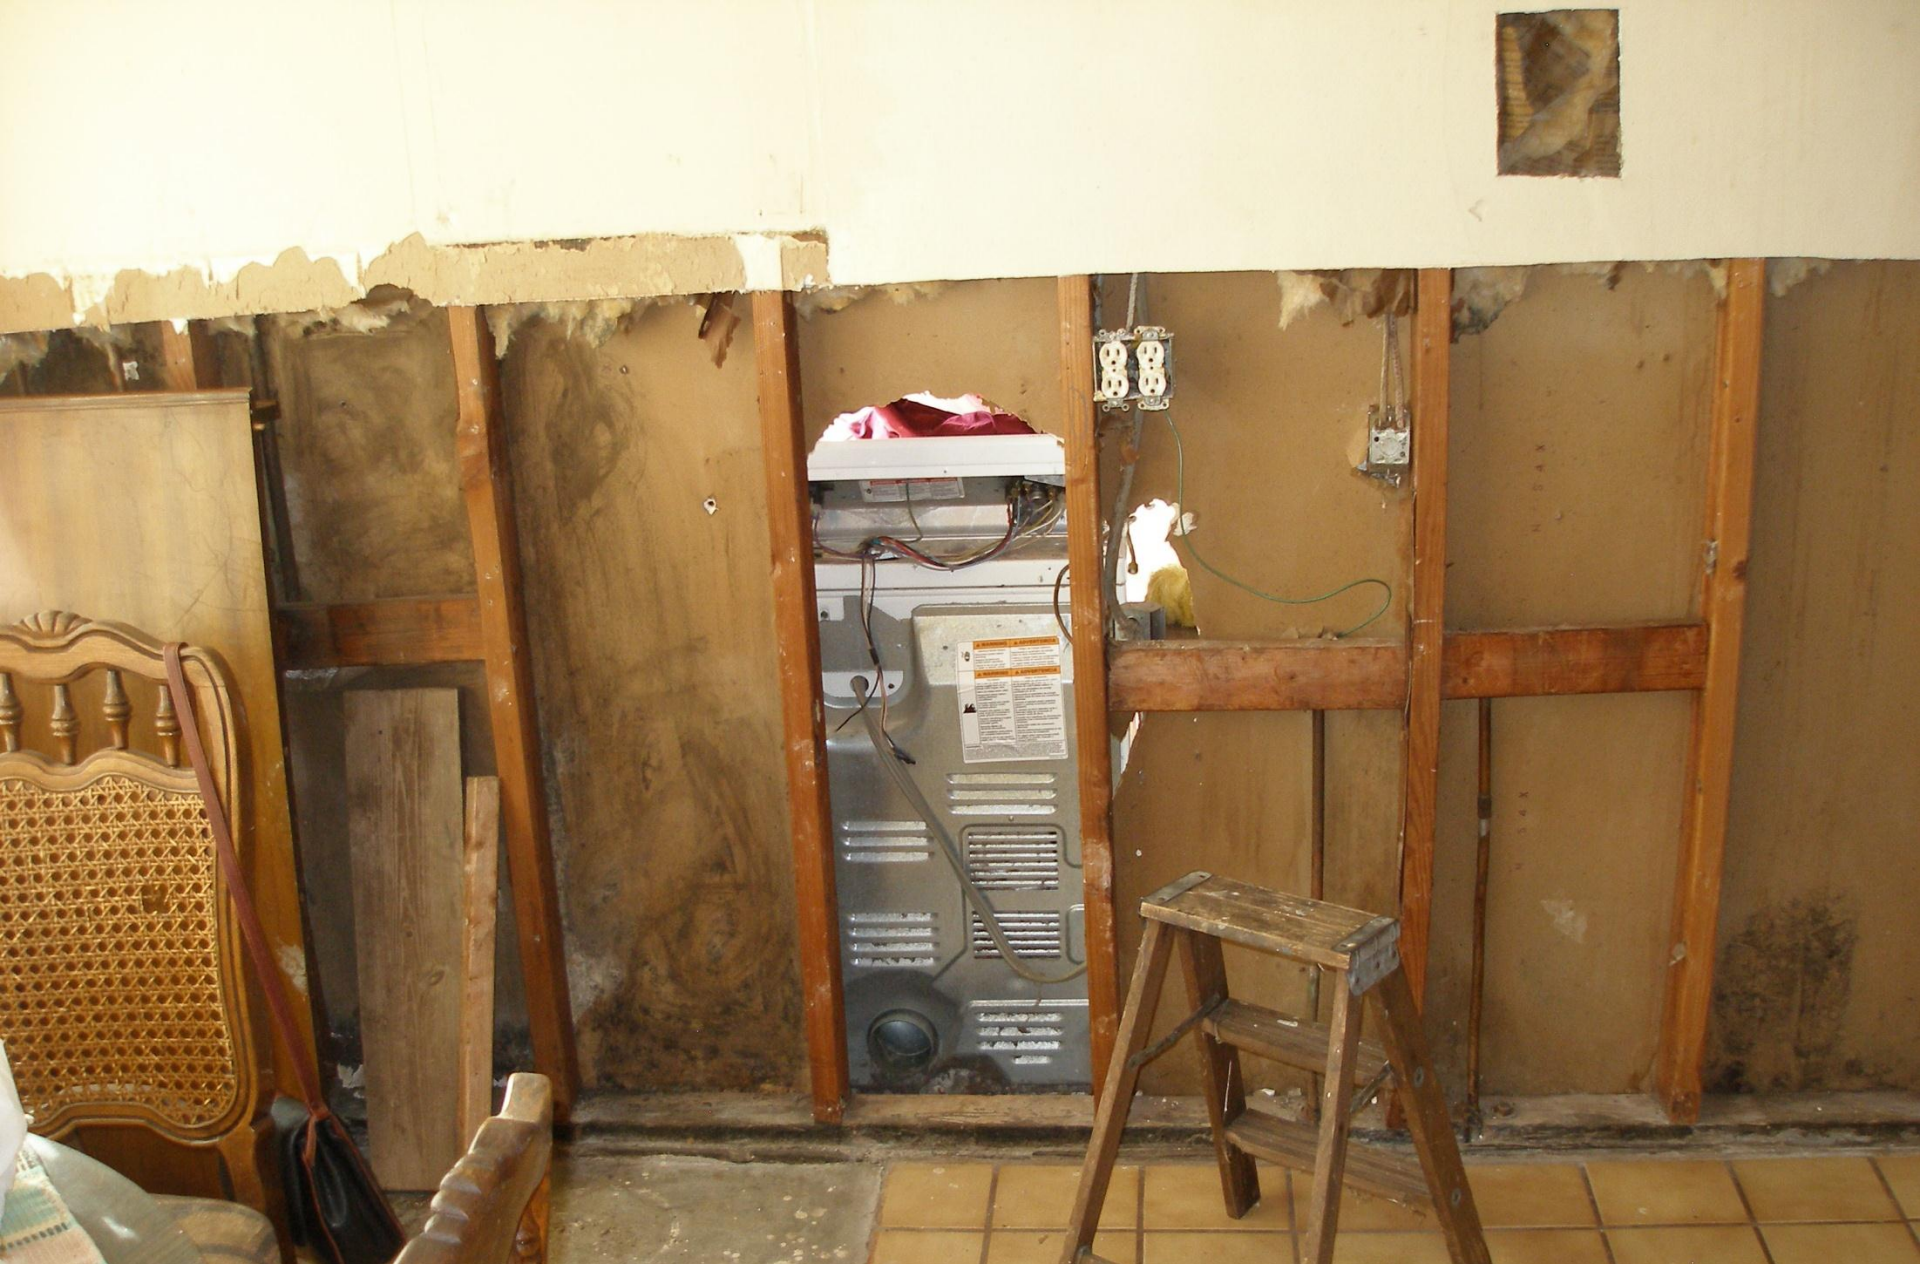
Looking from the kitchen into the garage where drywall is missing. This voids the required separation from the garage to the house.

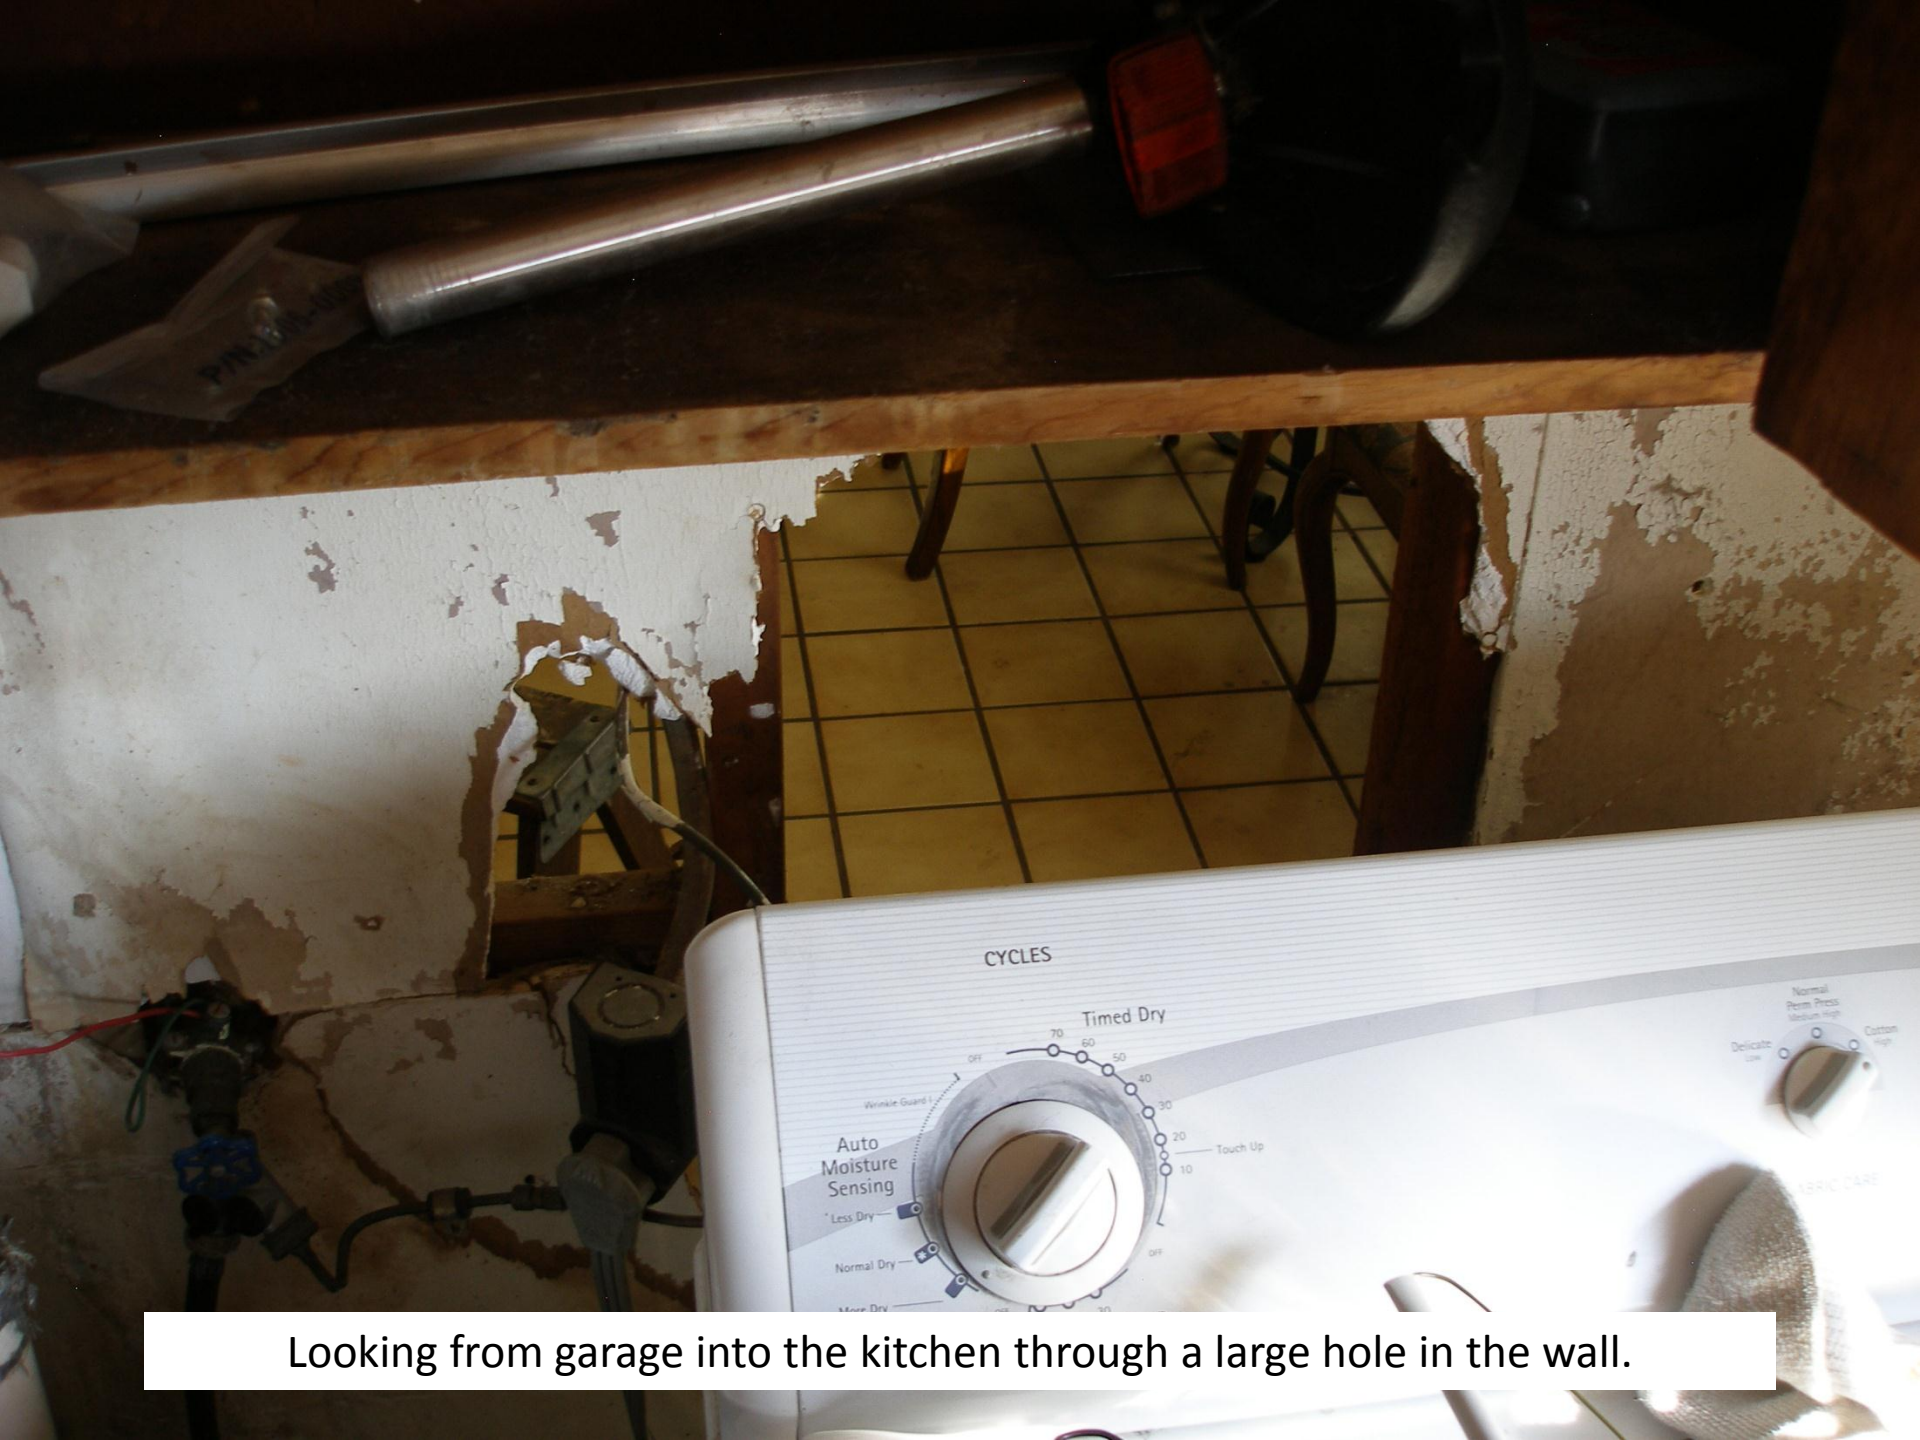
Looking from garage into the kitchen through a large hole in the wall.

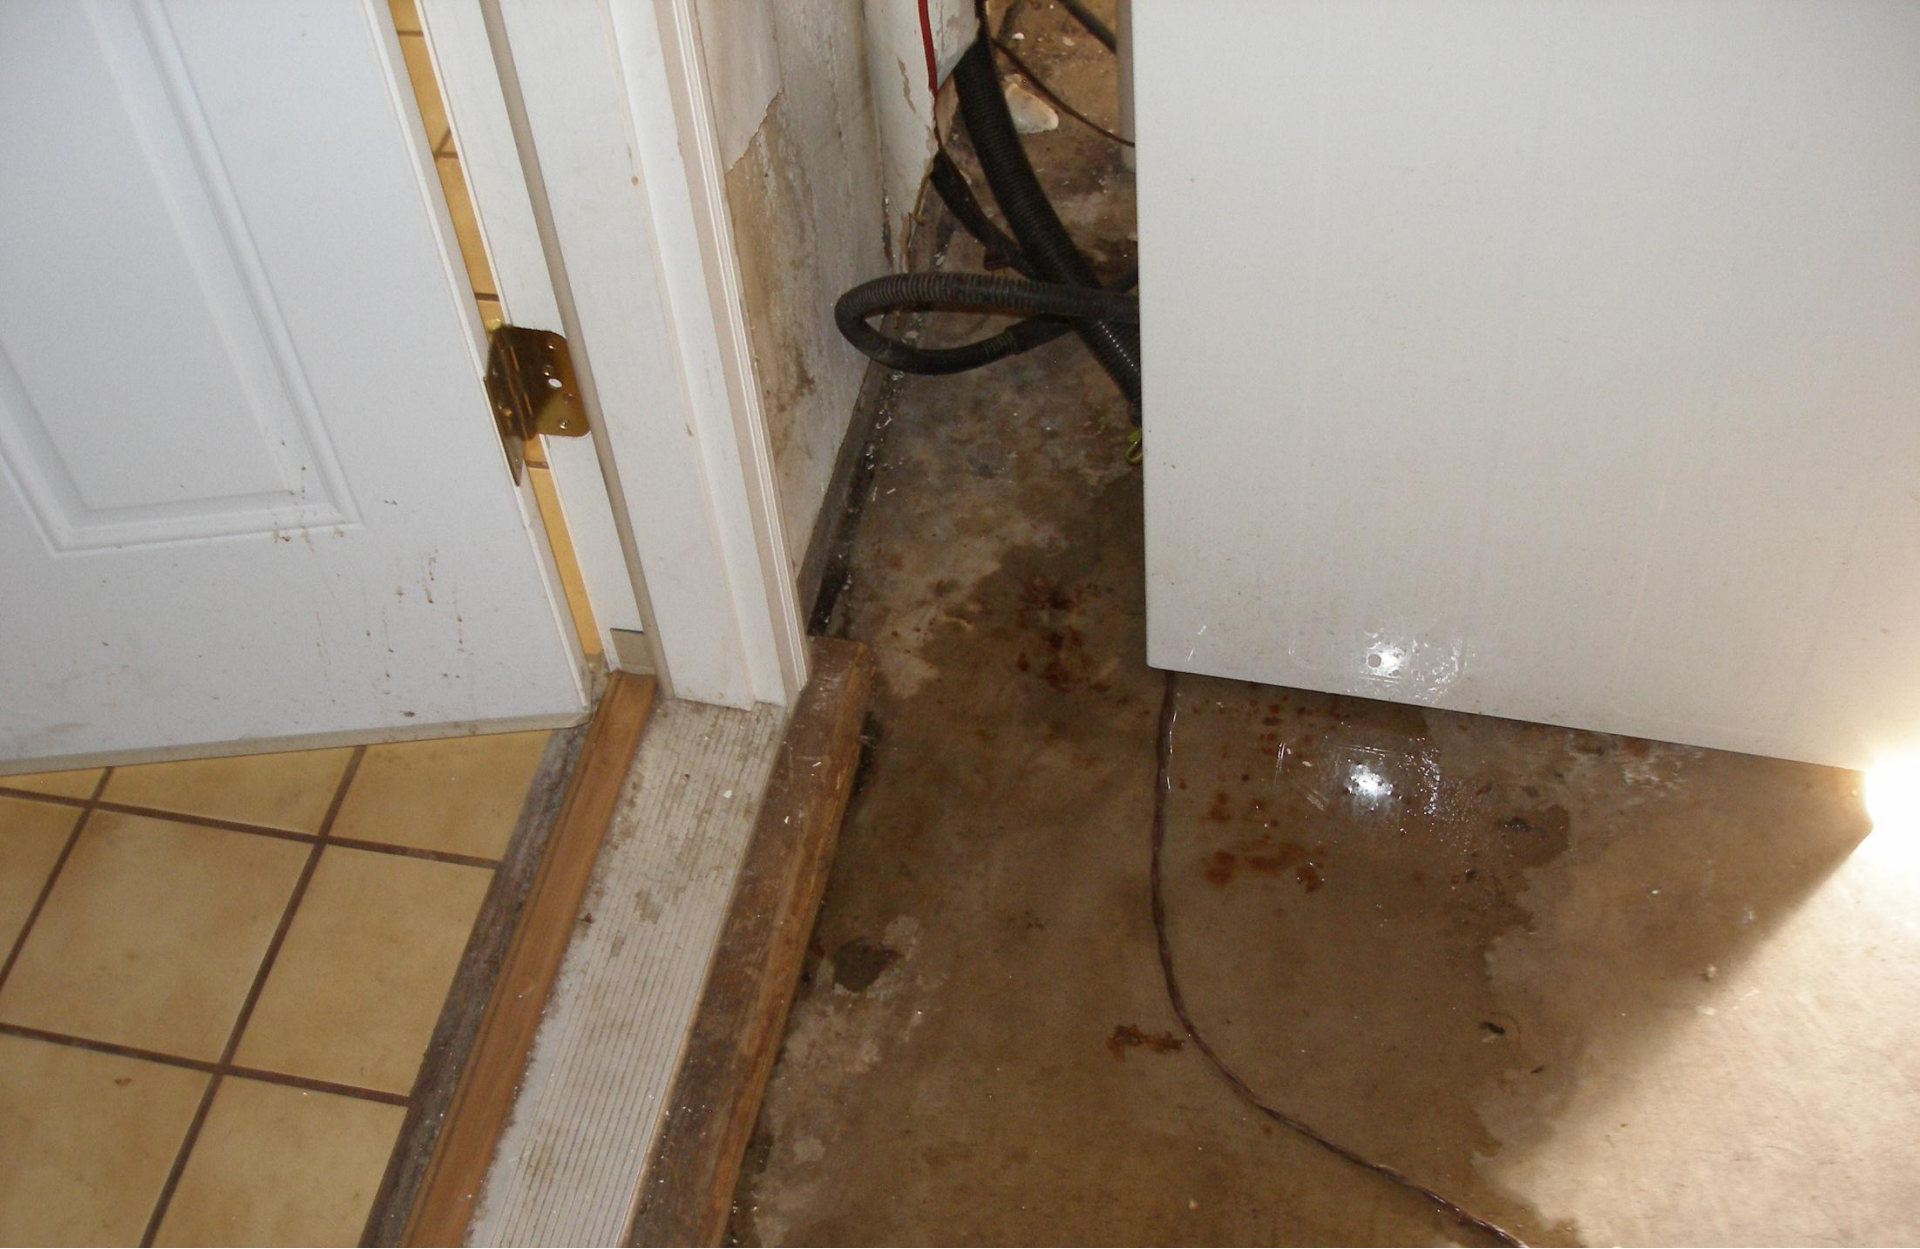
Washing machine likely has a leak, causing the water to pool around it. The extension cord used for the refrigerator is sitting in the pool of water (the cord was not plugged in).

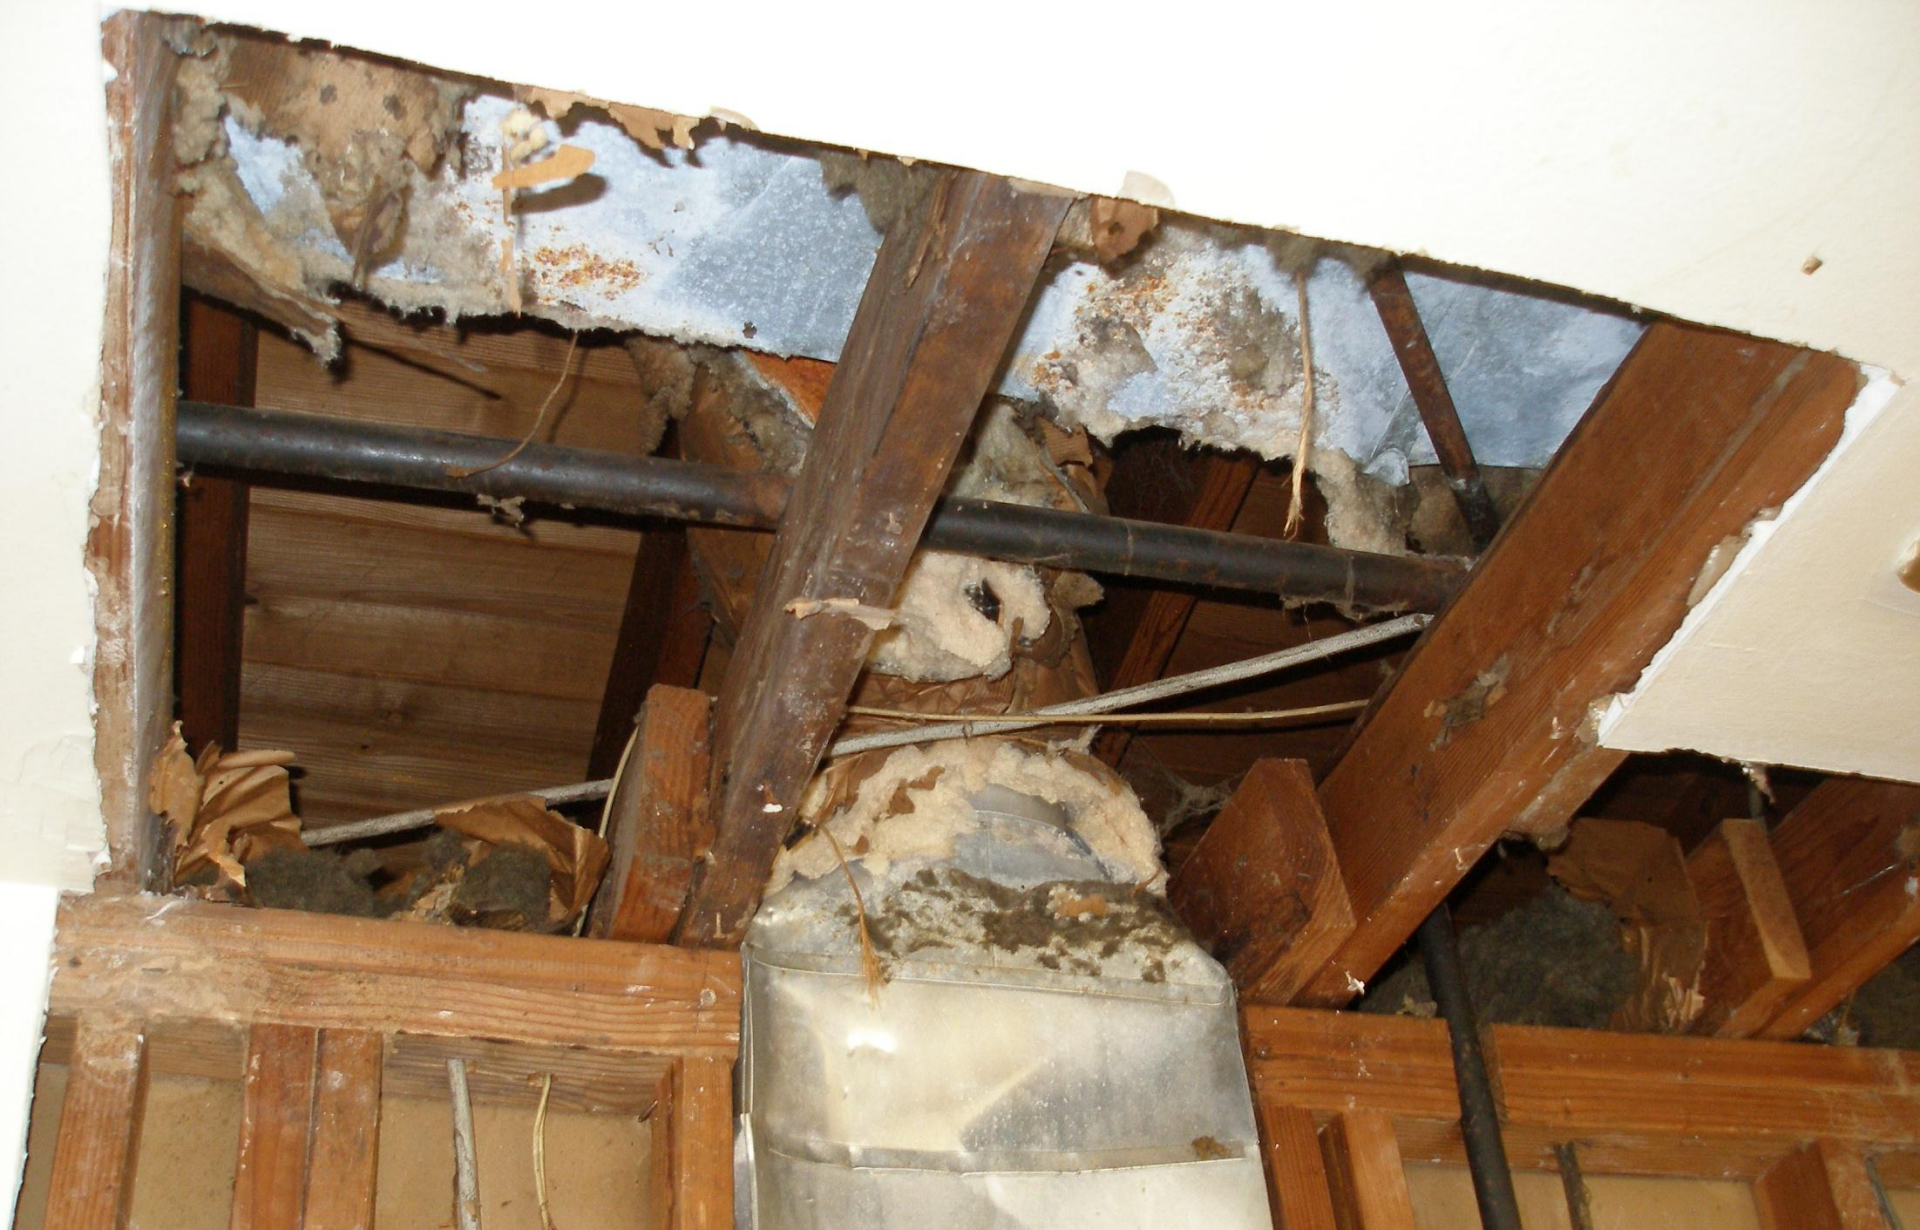
Kitchen ceiling above proper stove location. Lack of a ceiling challenges the ability to condition the air. Also difficult to maintain cleanliness and heightens the ability for fire or smoke to spread throughout the house.
