South Elevation 1207 Cruce Street

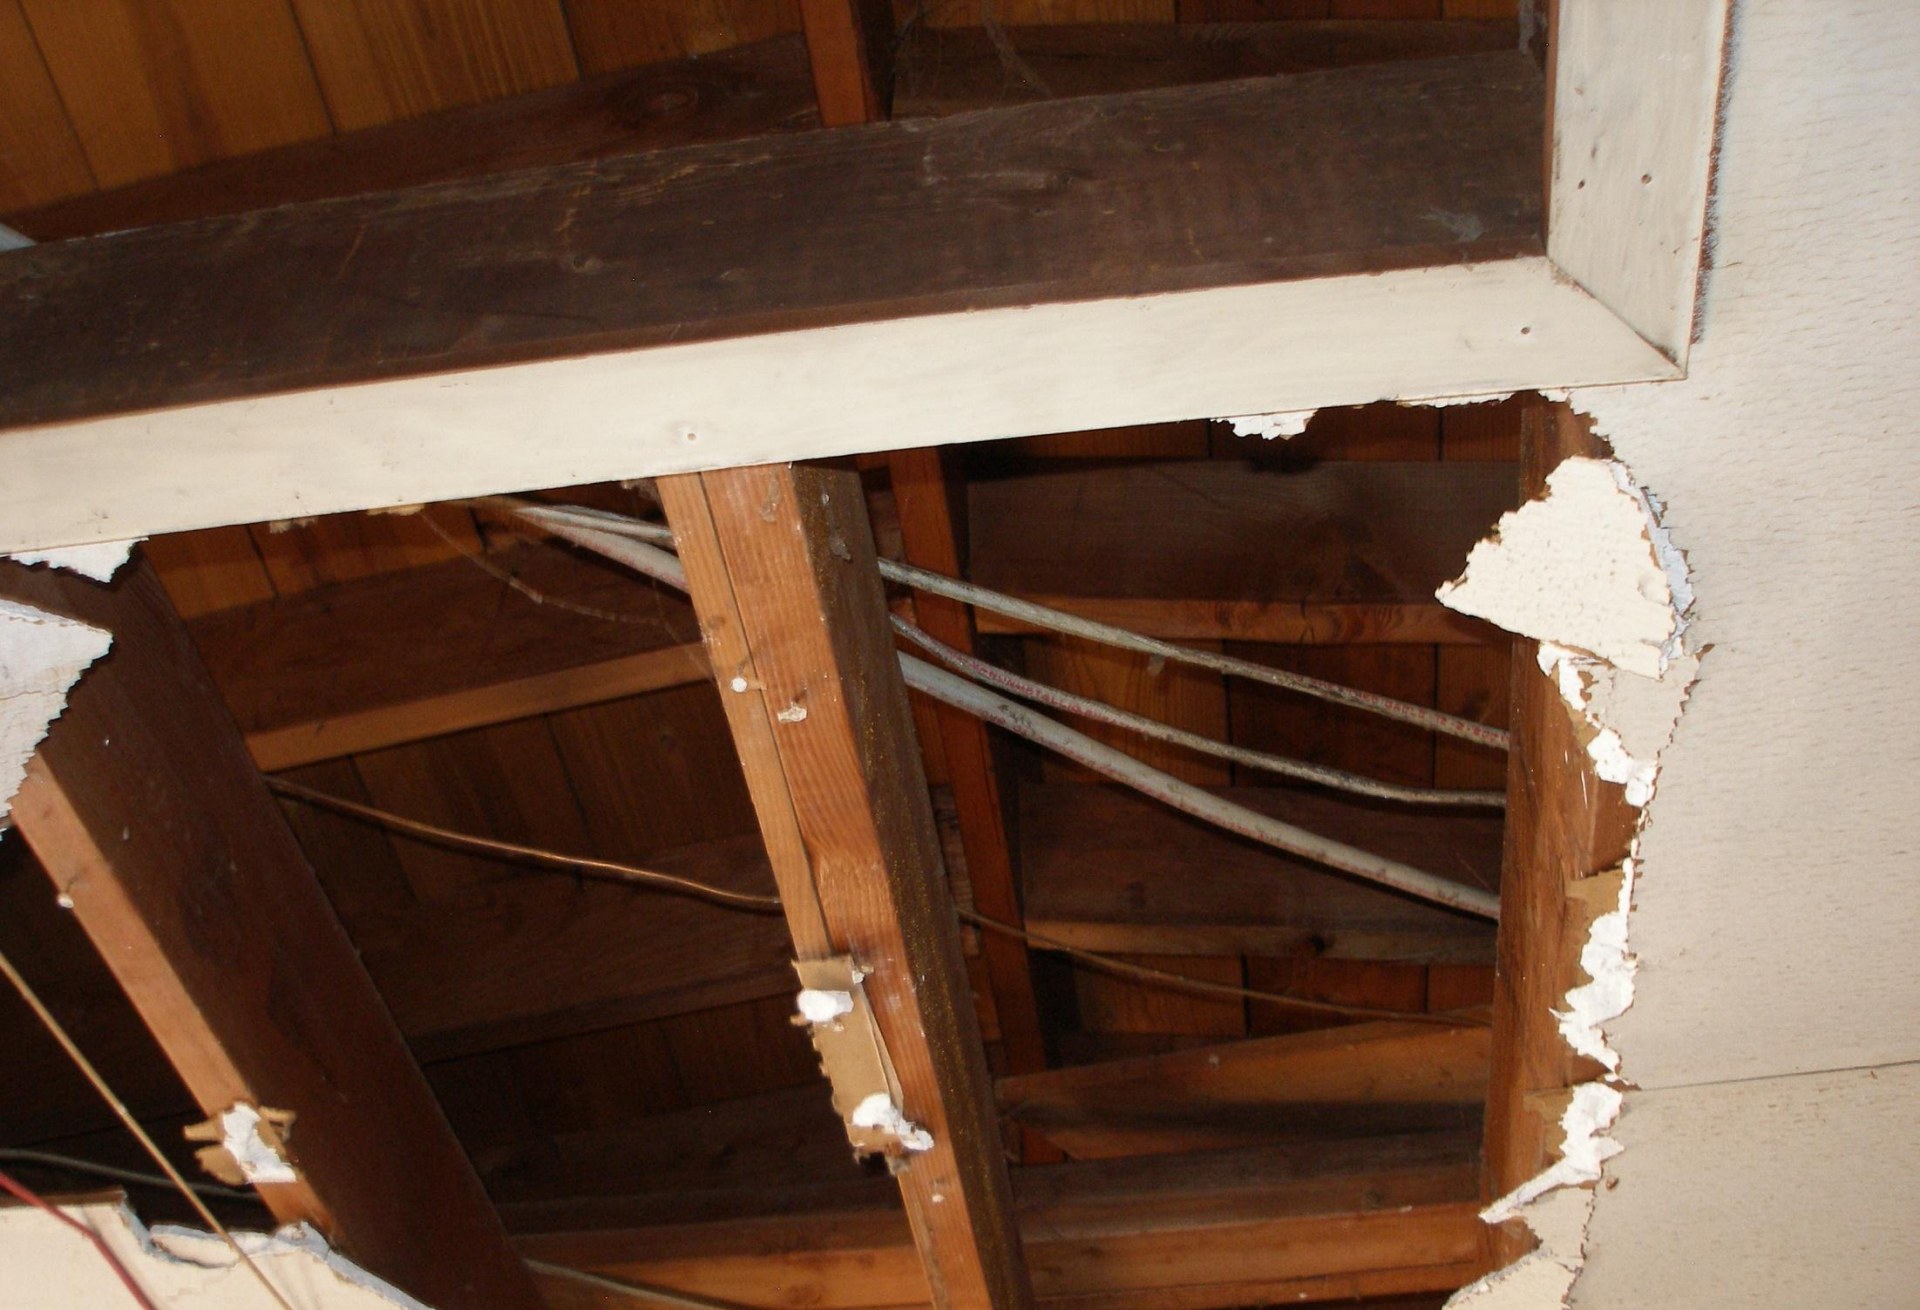
Missing ceiling in garage. The garage/house fire resistant separation is no longer intact.

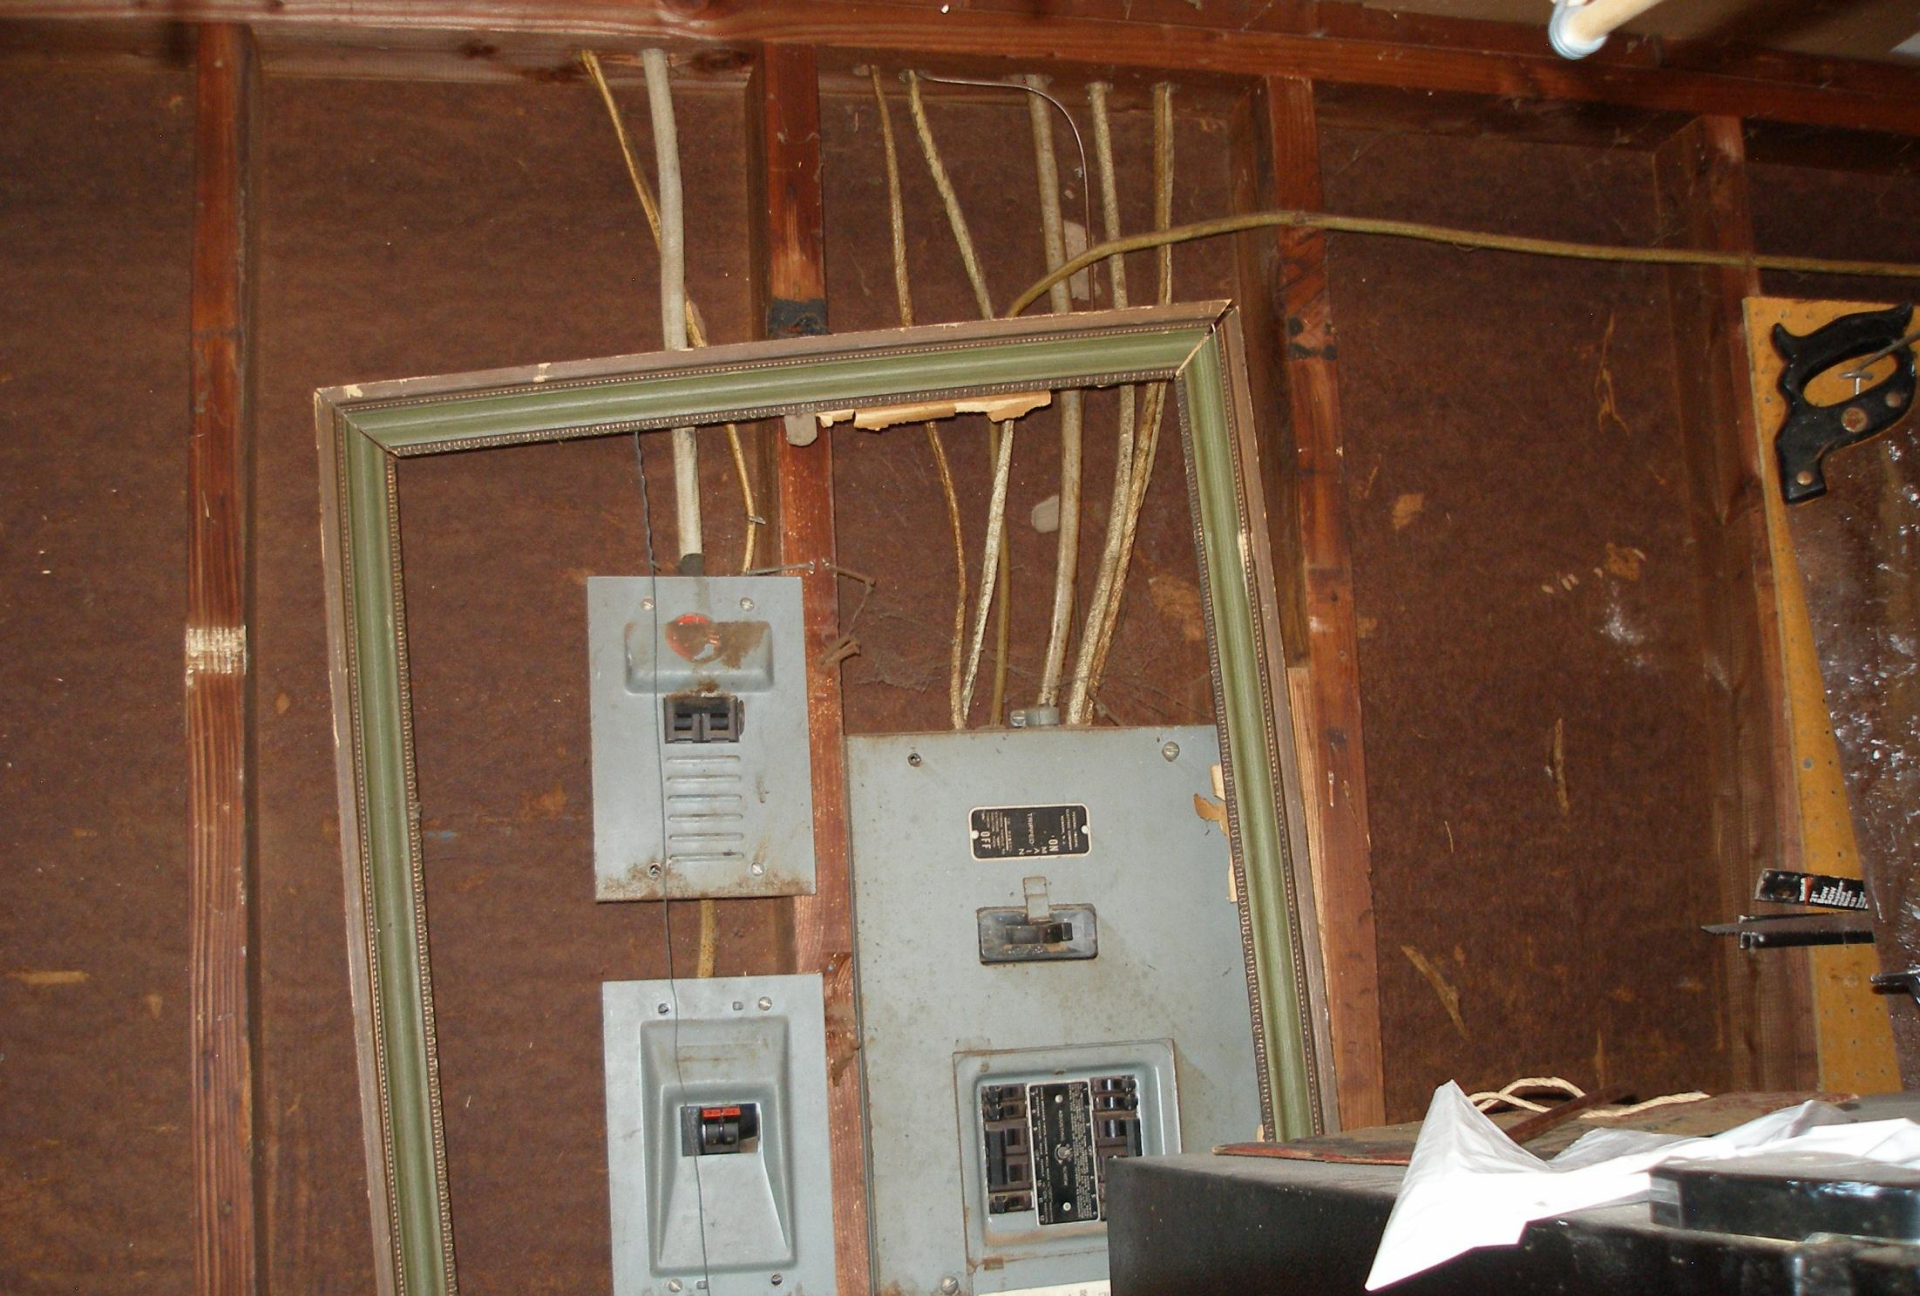
Electrical panels in garage. Drywall protecting panel wiring has been removed in the garage and in the kitchen.

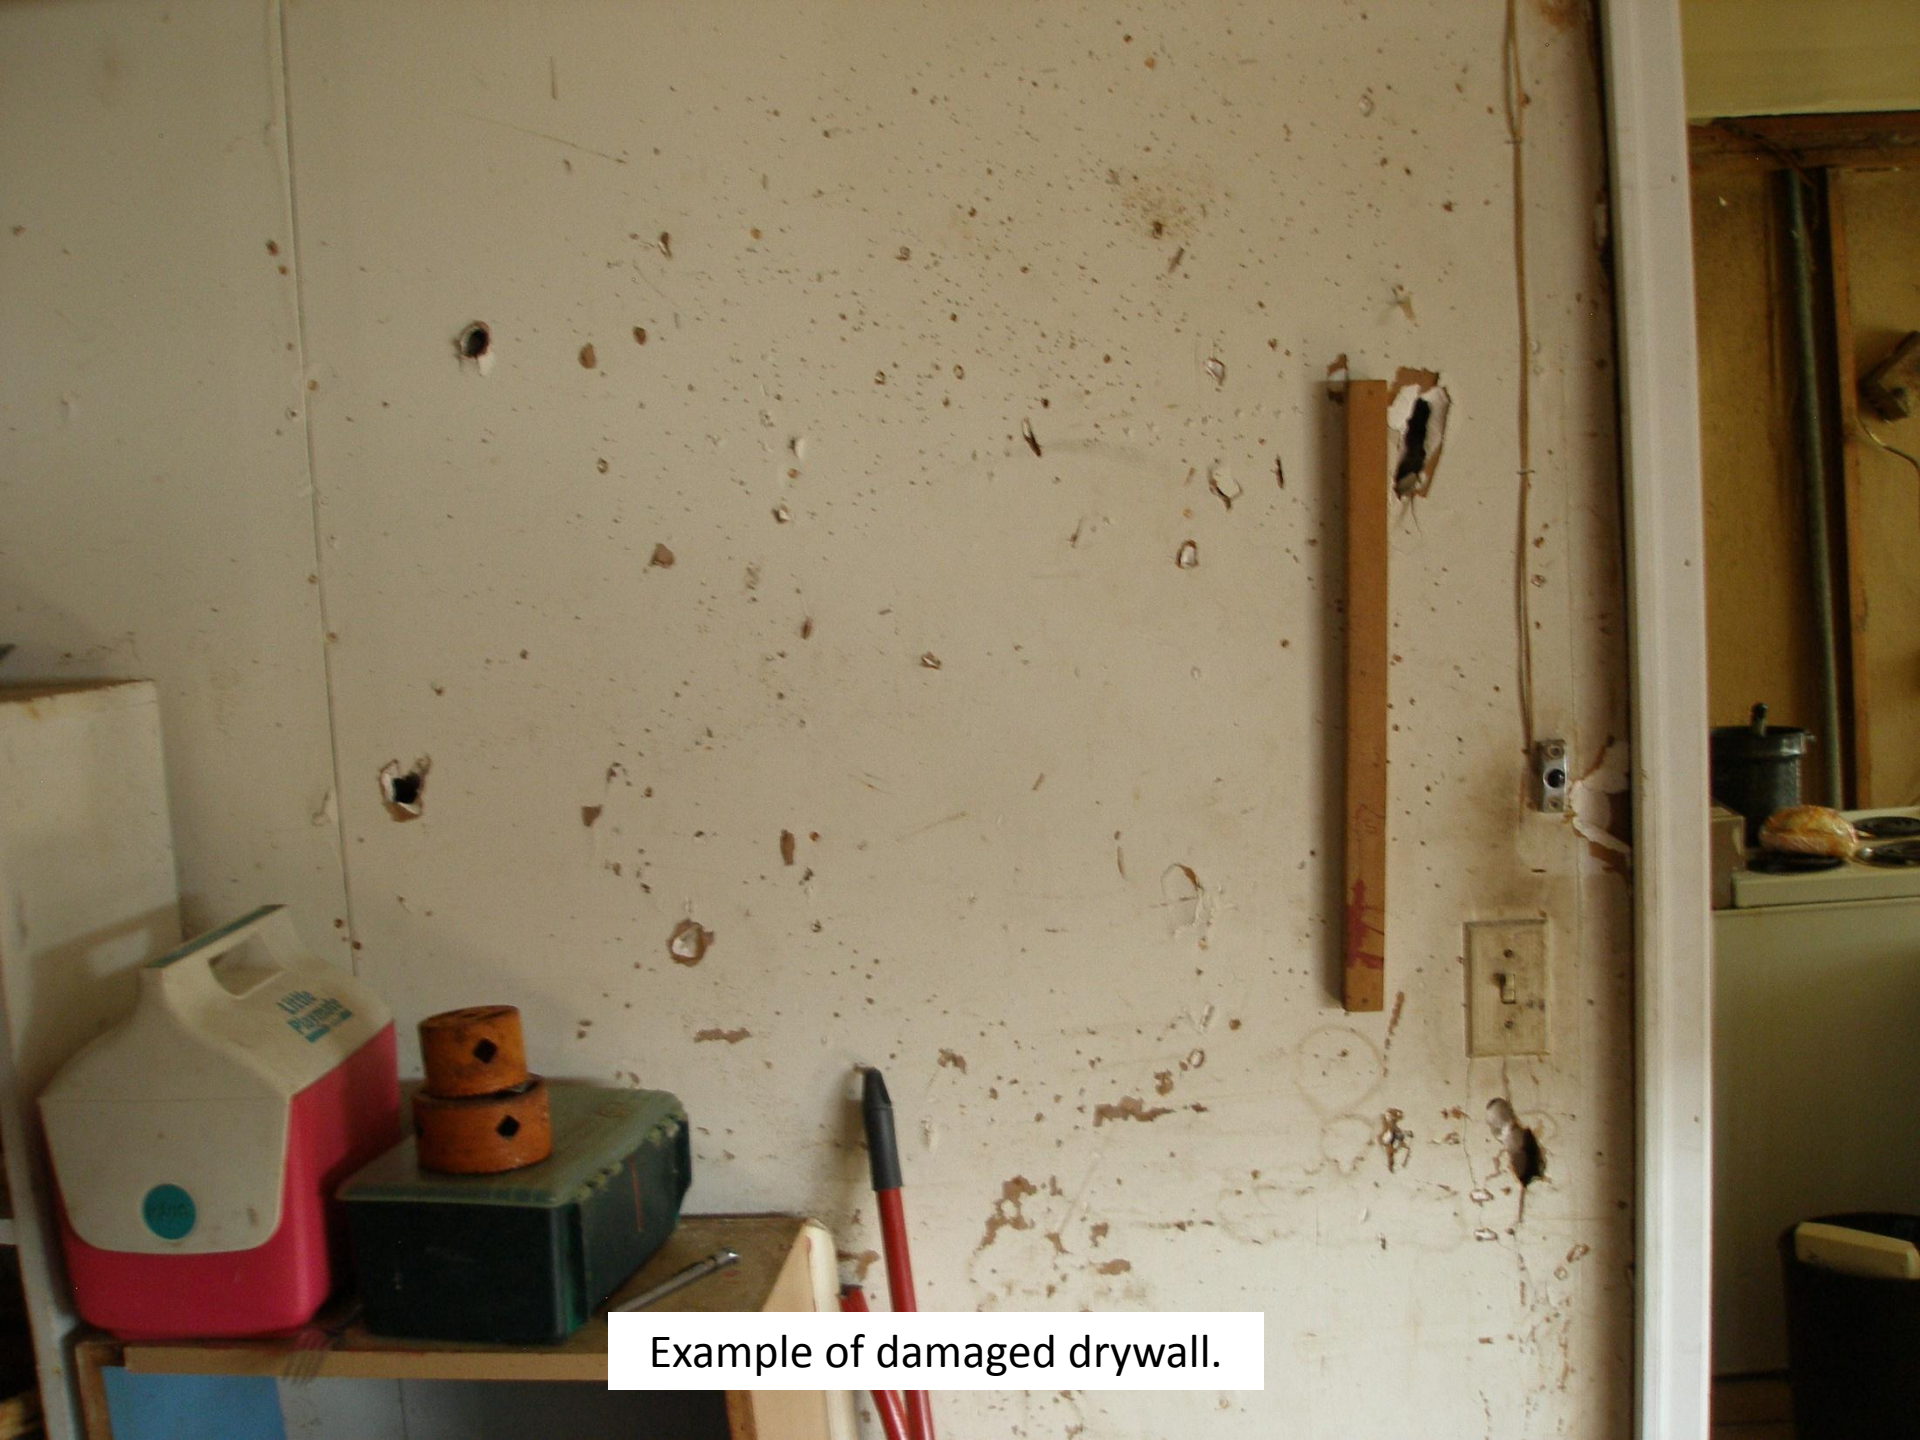
Example of damaged drywall.

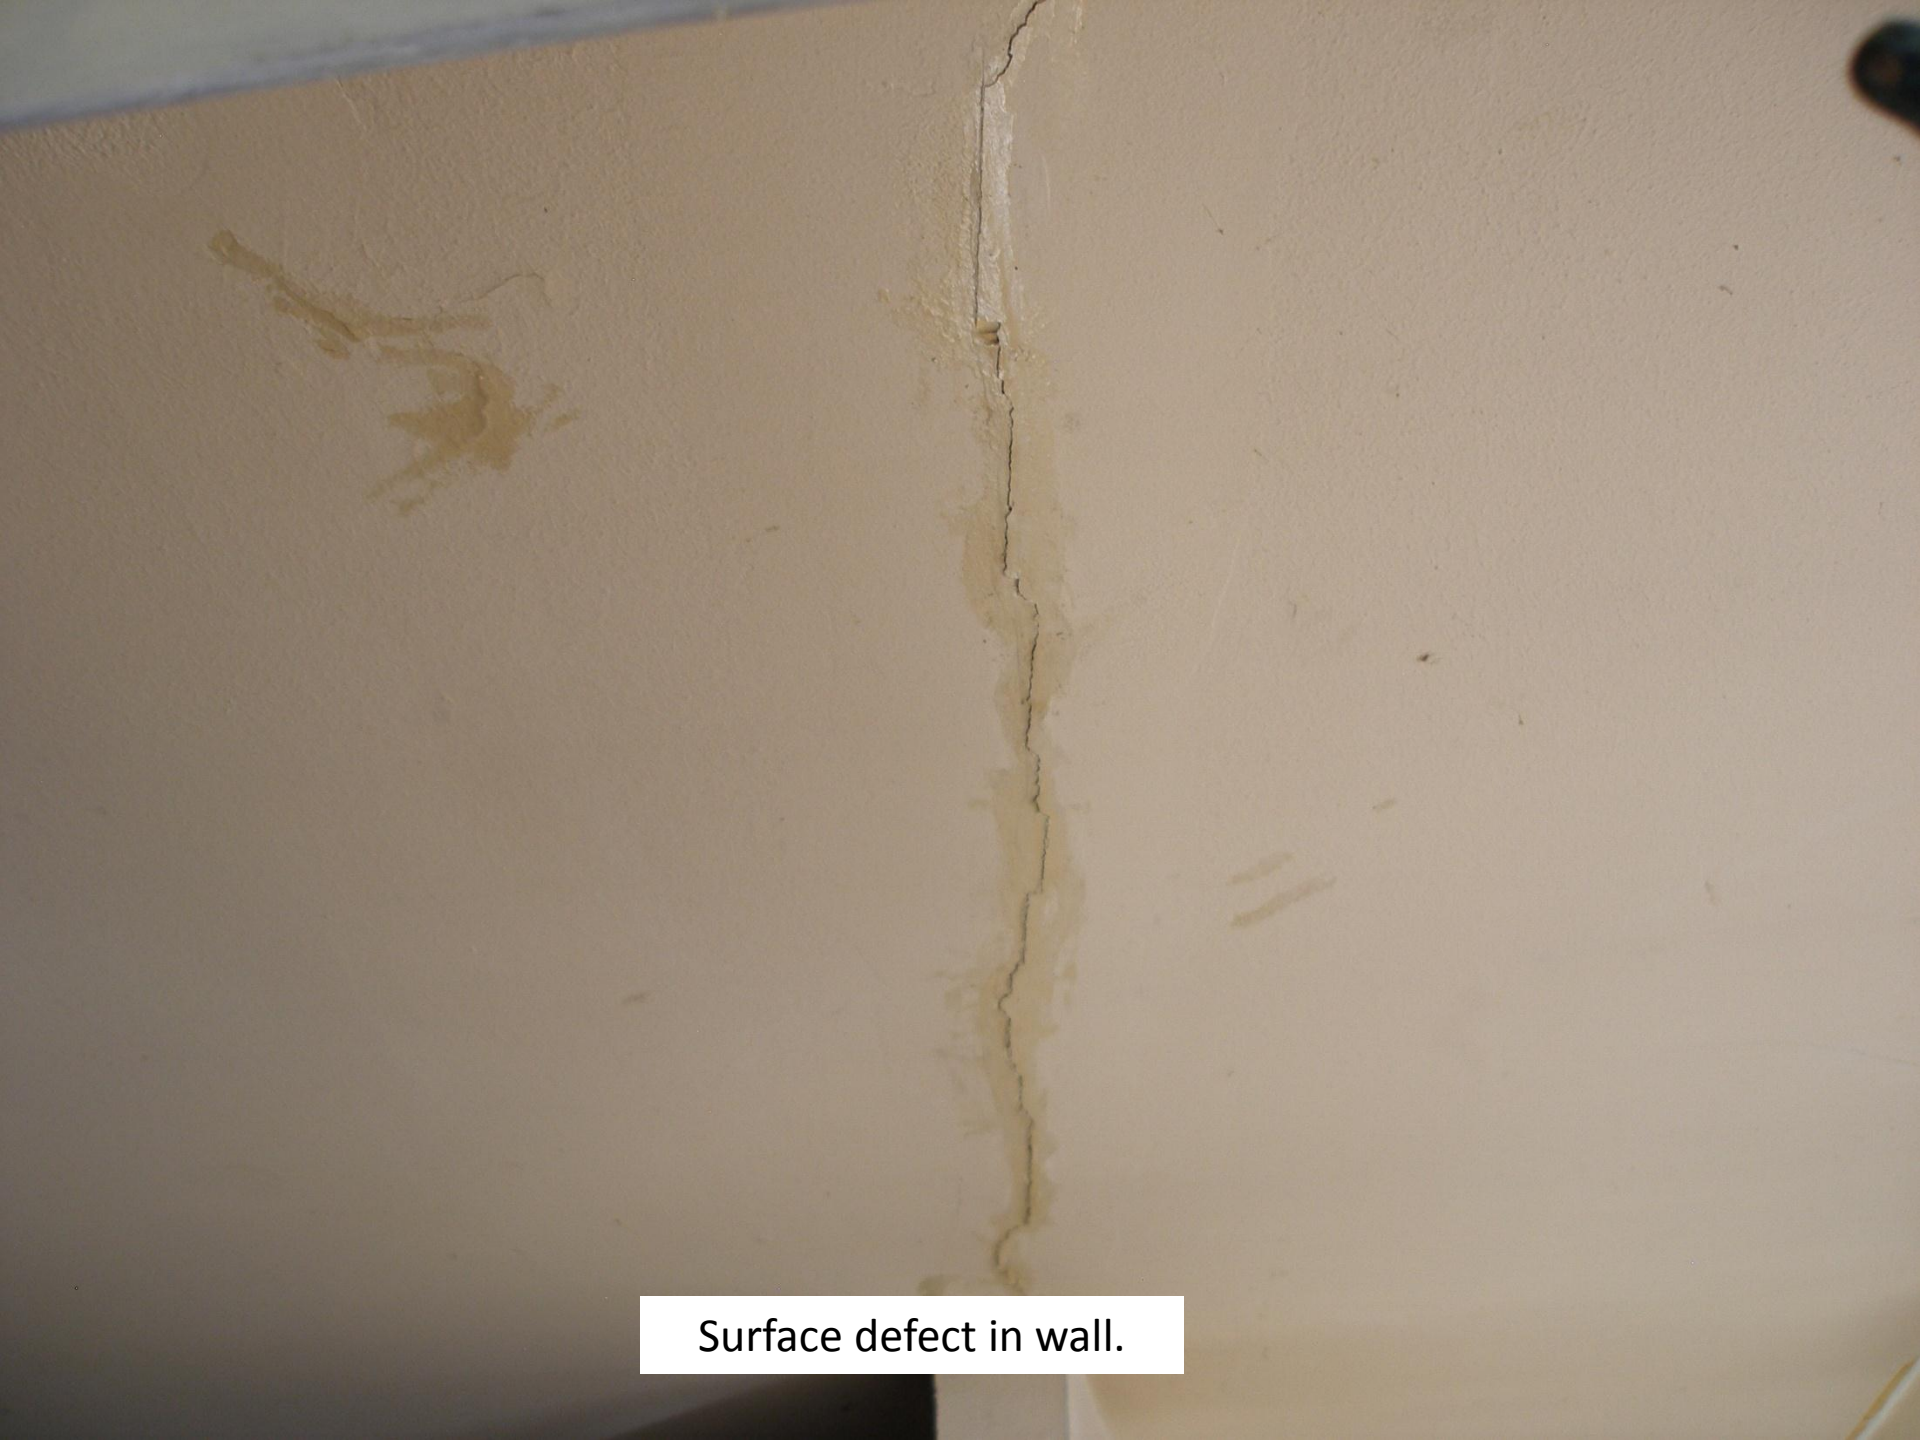
Surface defect in wall.

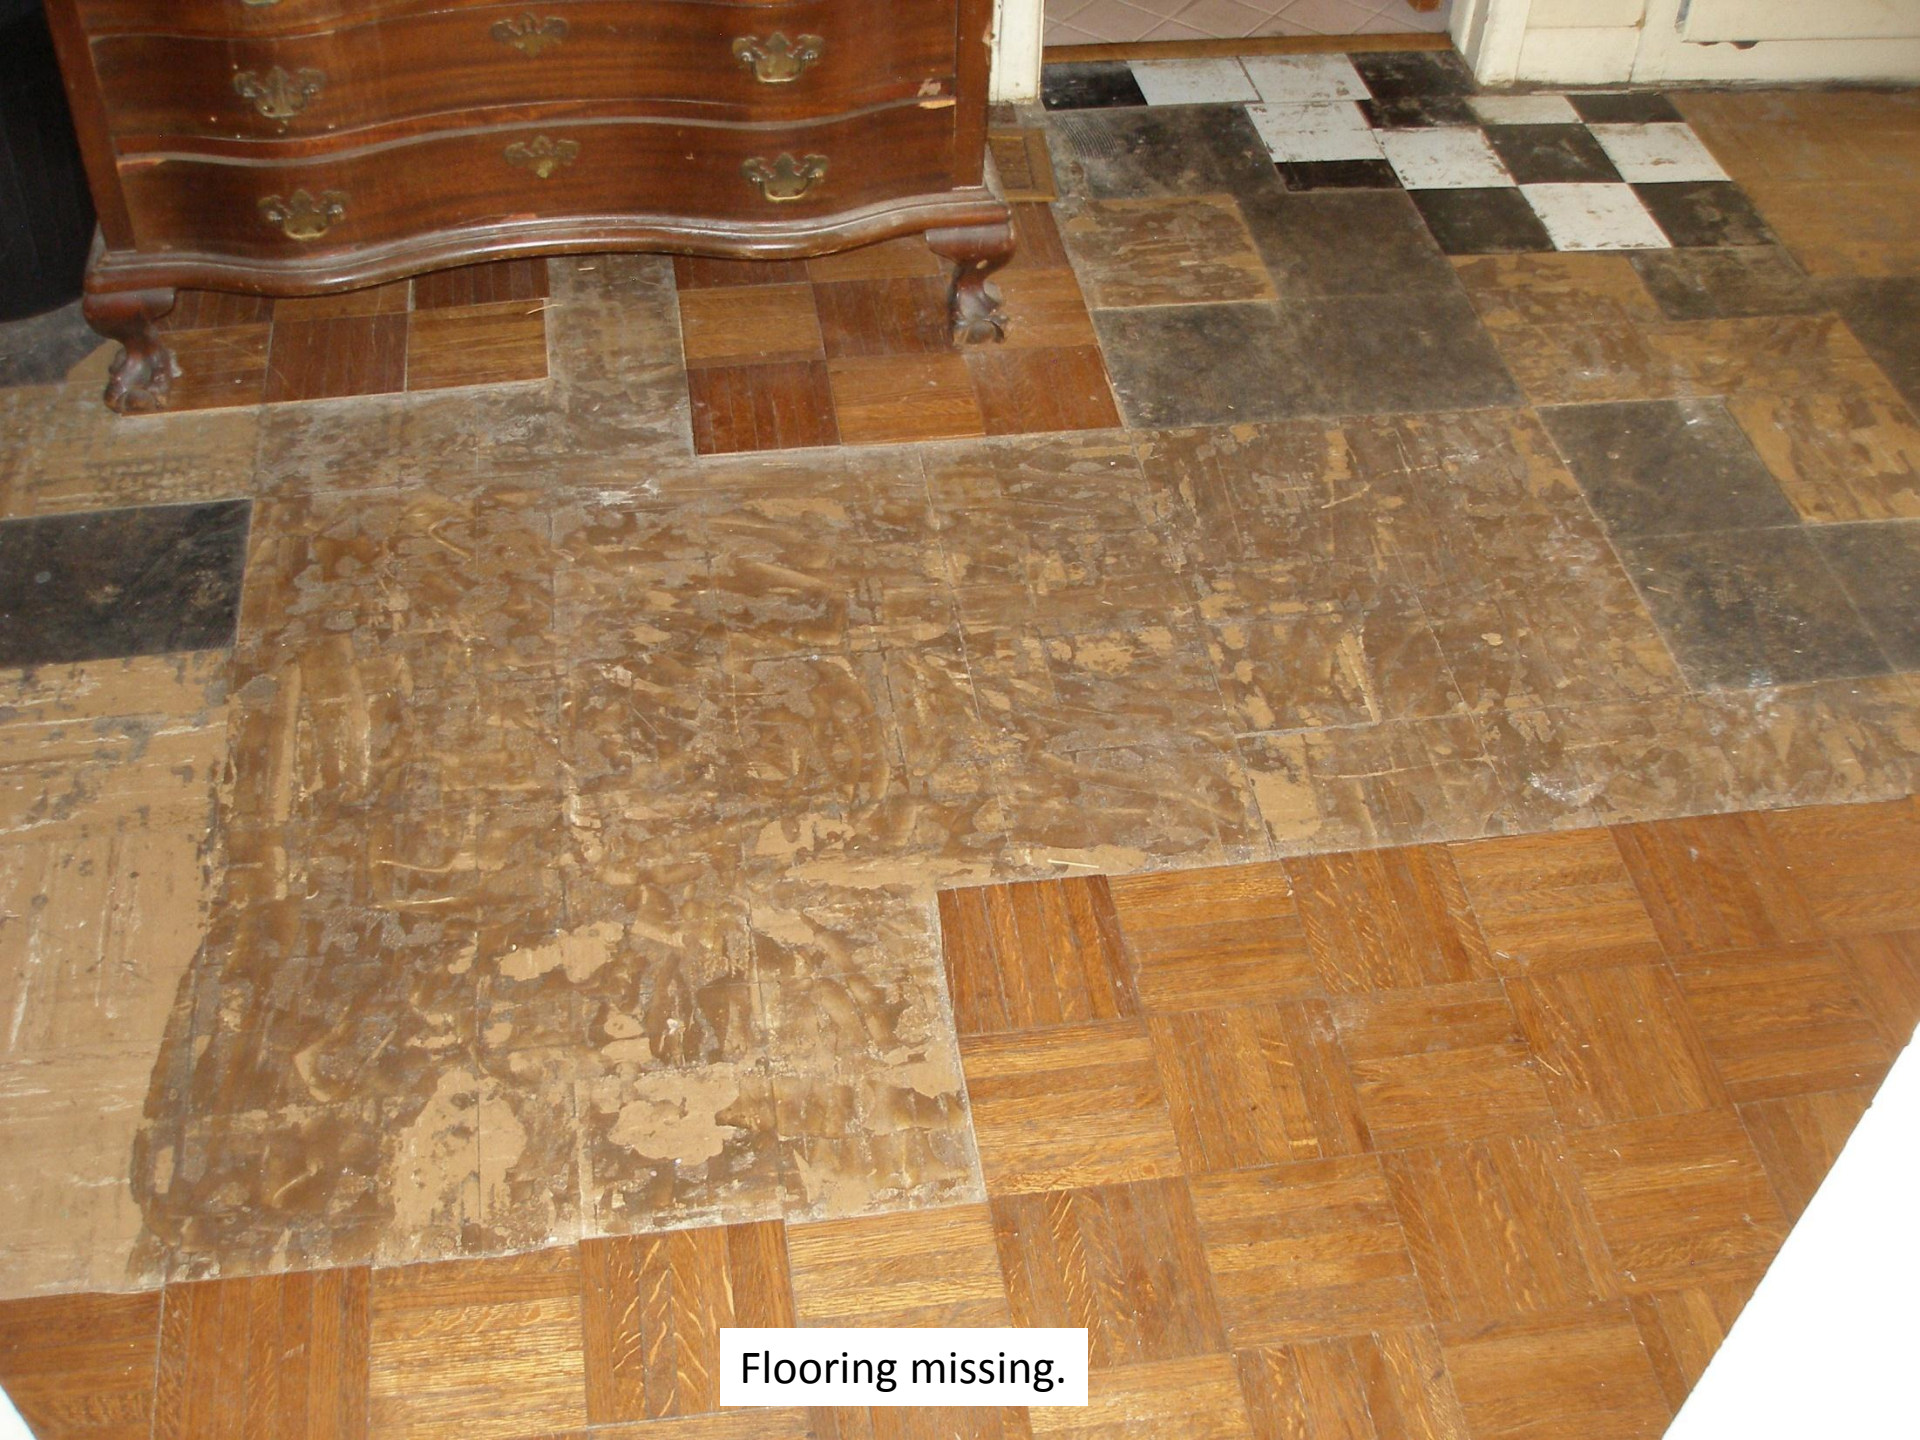
Flooring missing.

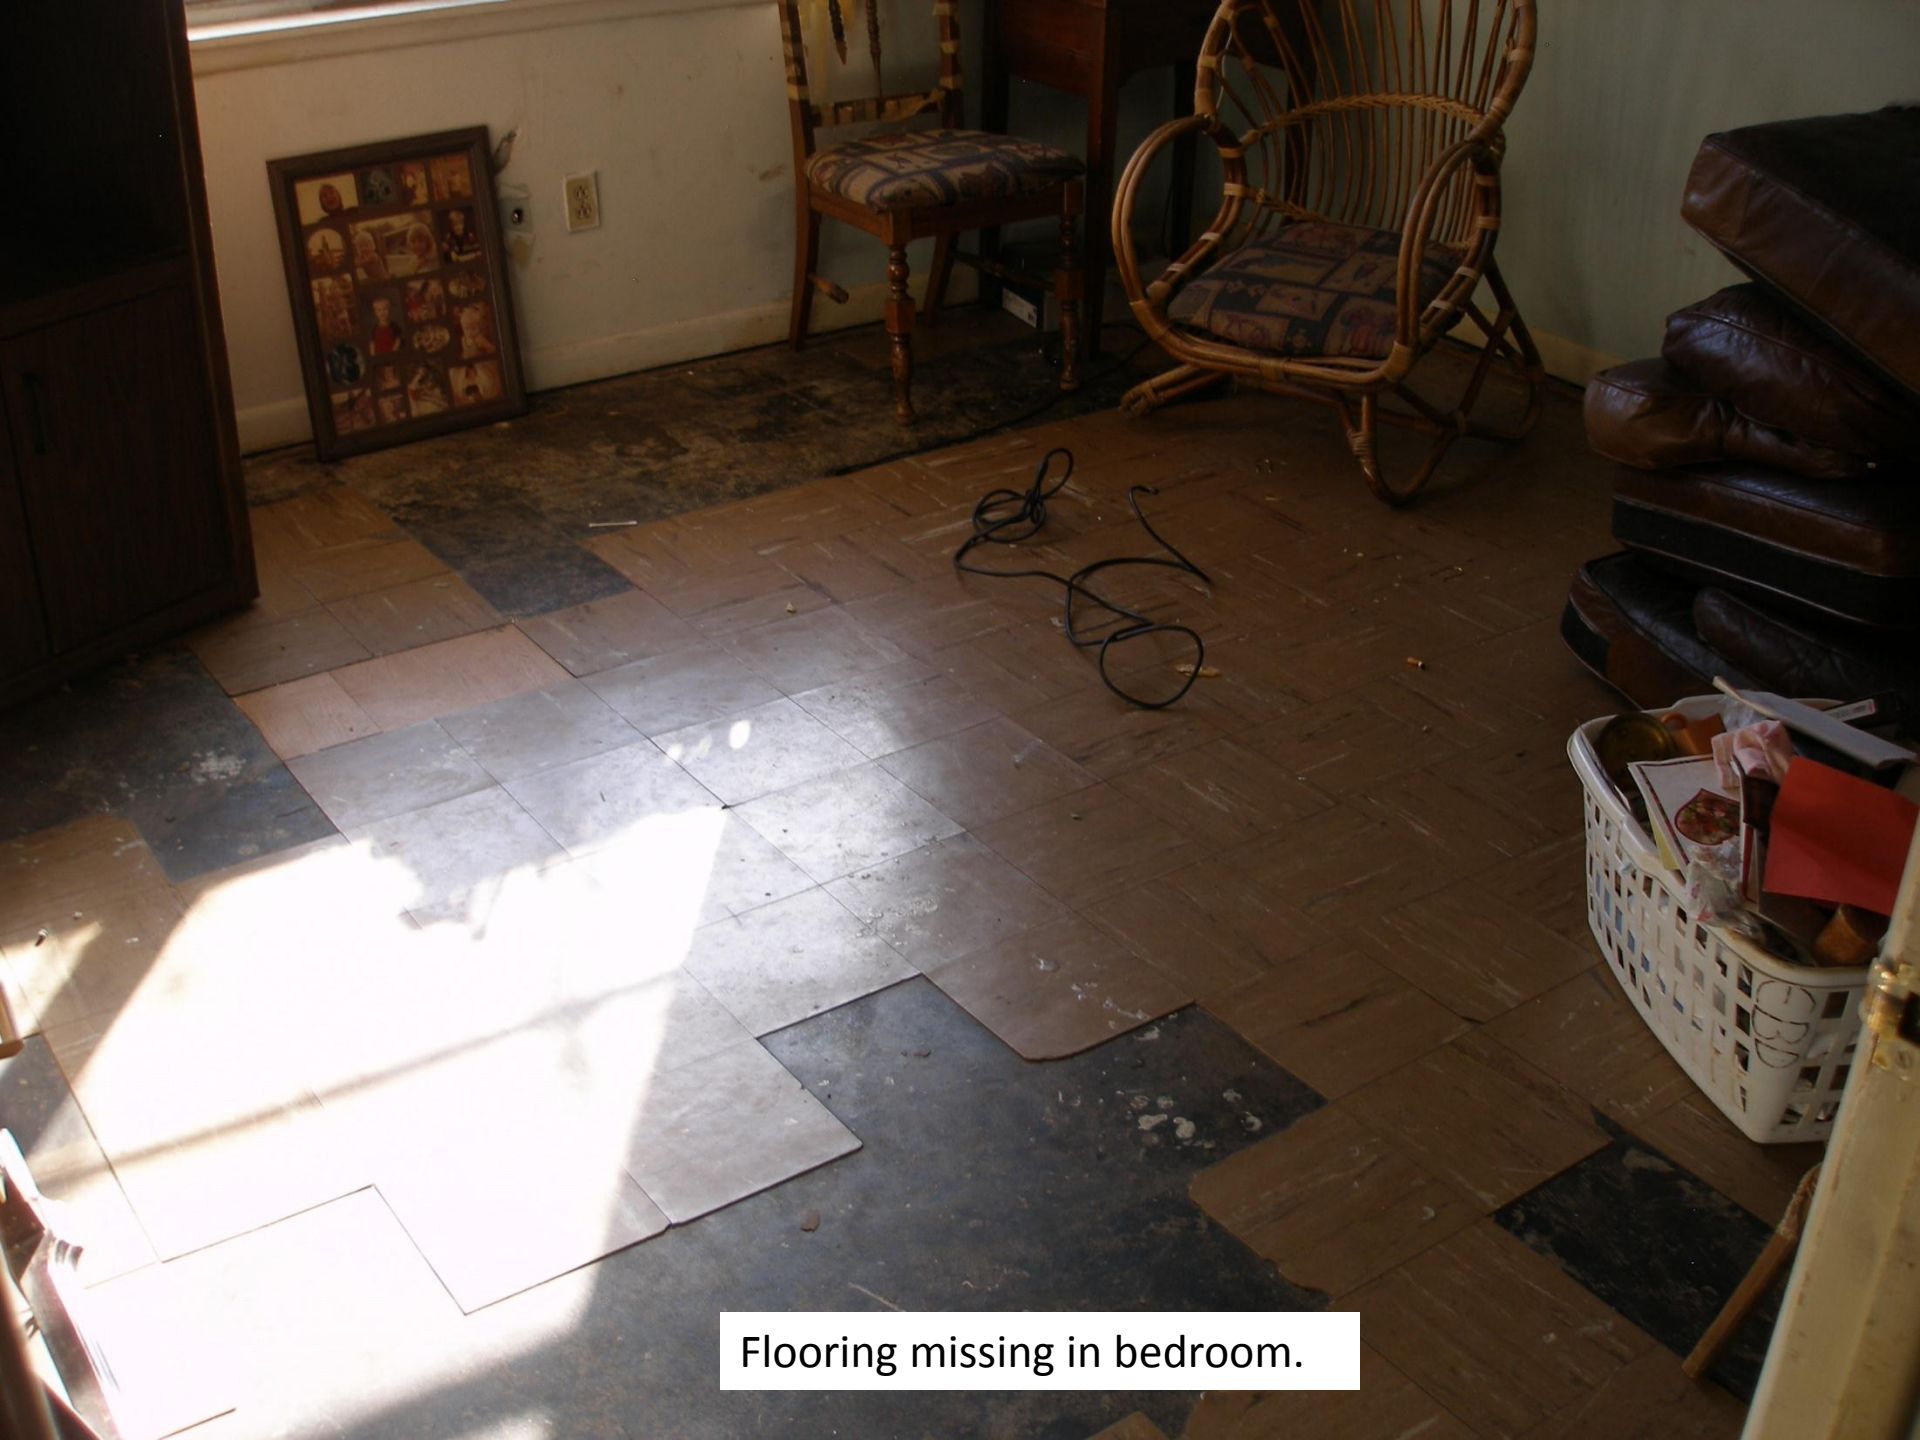
Flooring missing in bedroom.

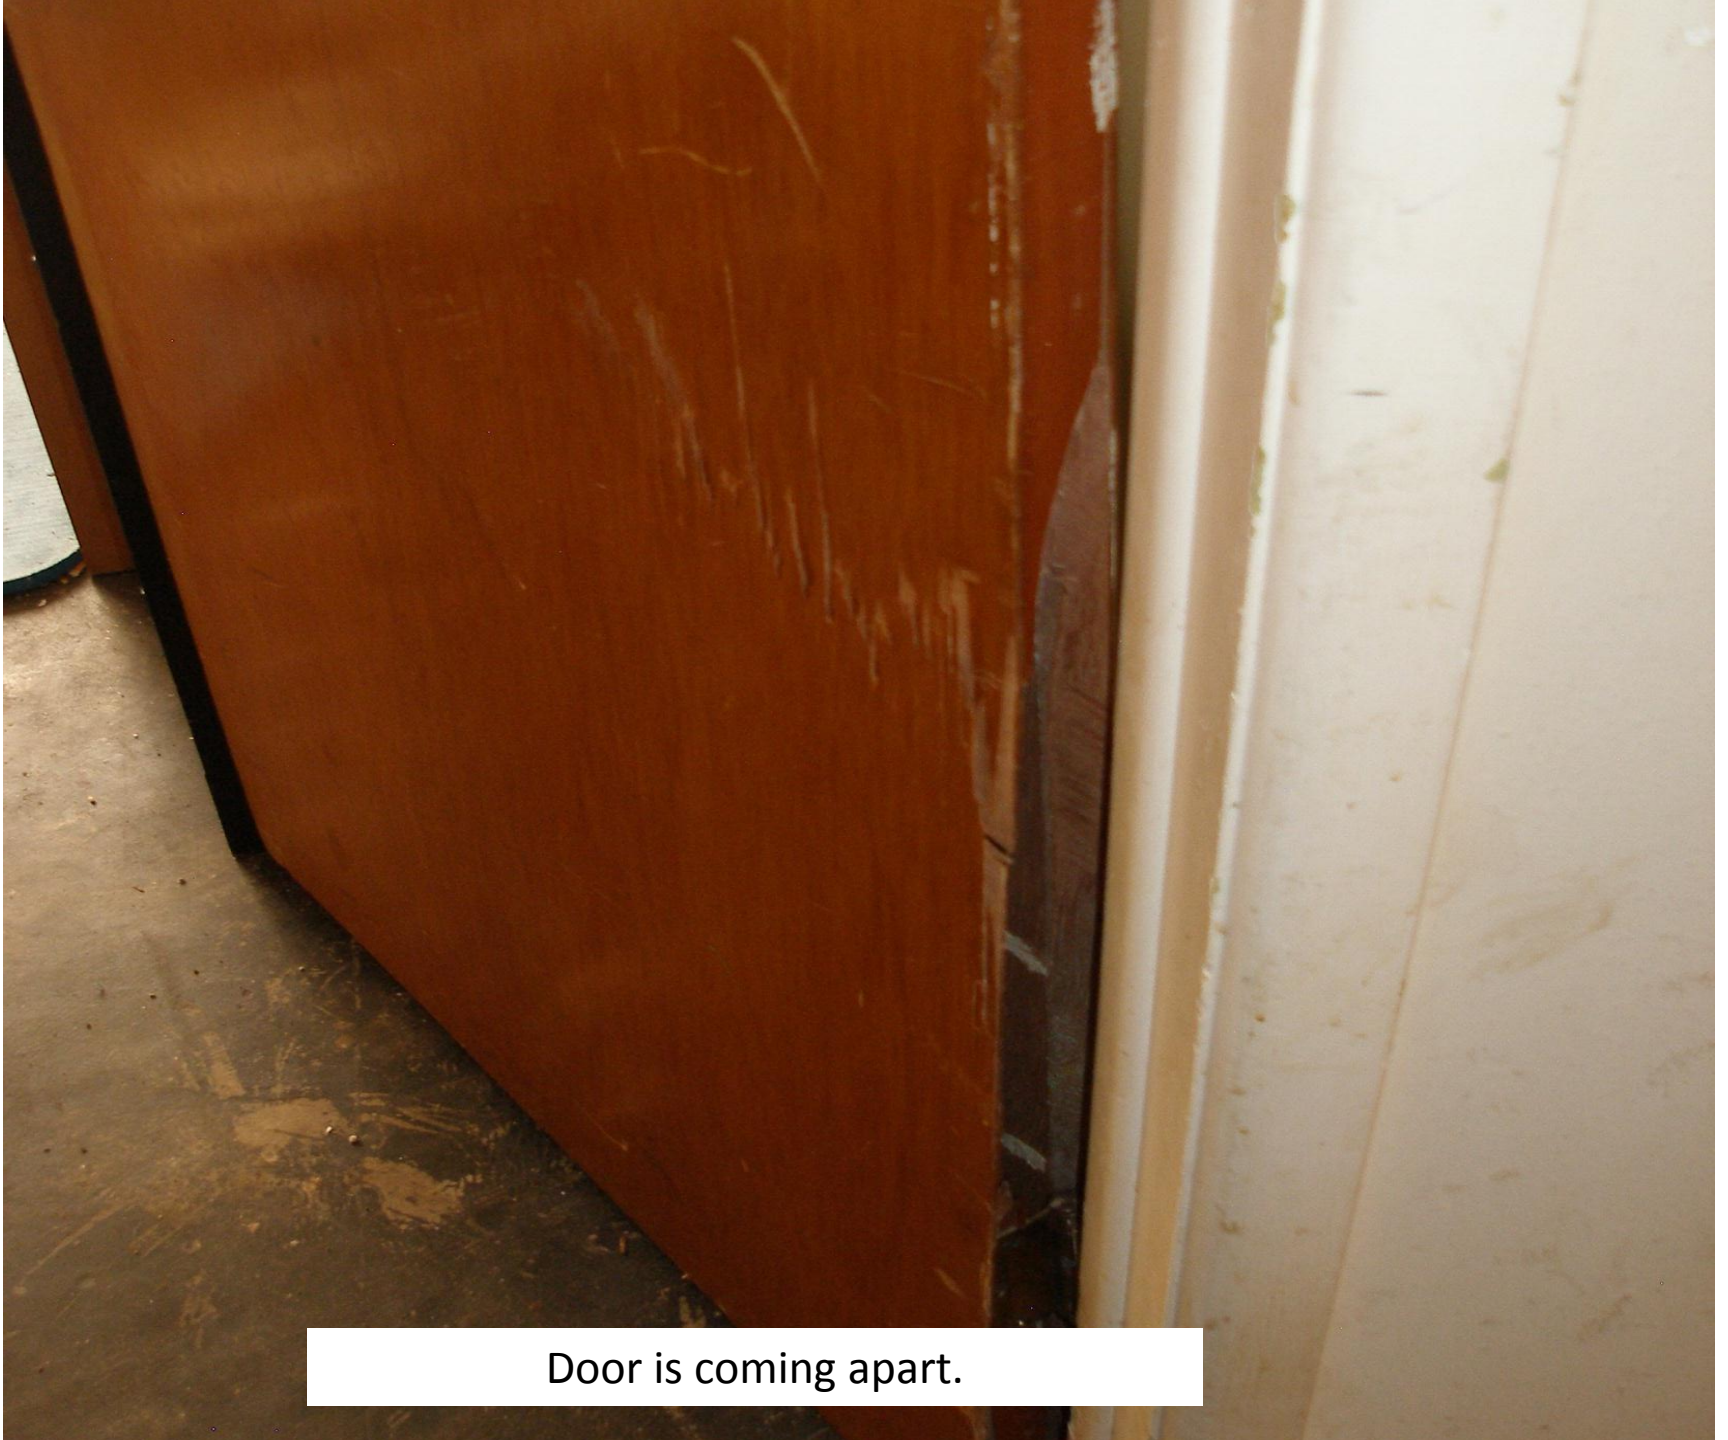
Door is coming apart.

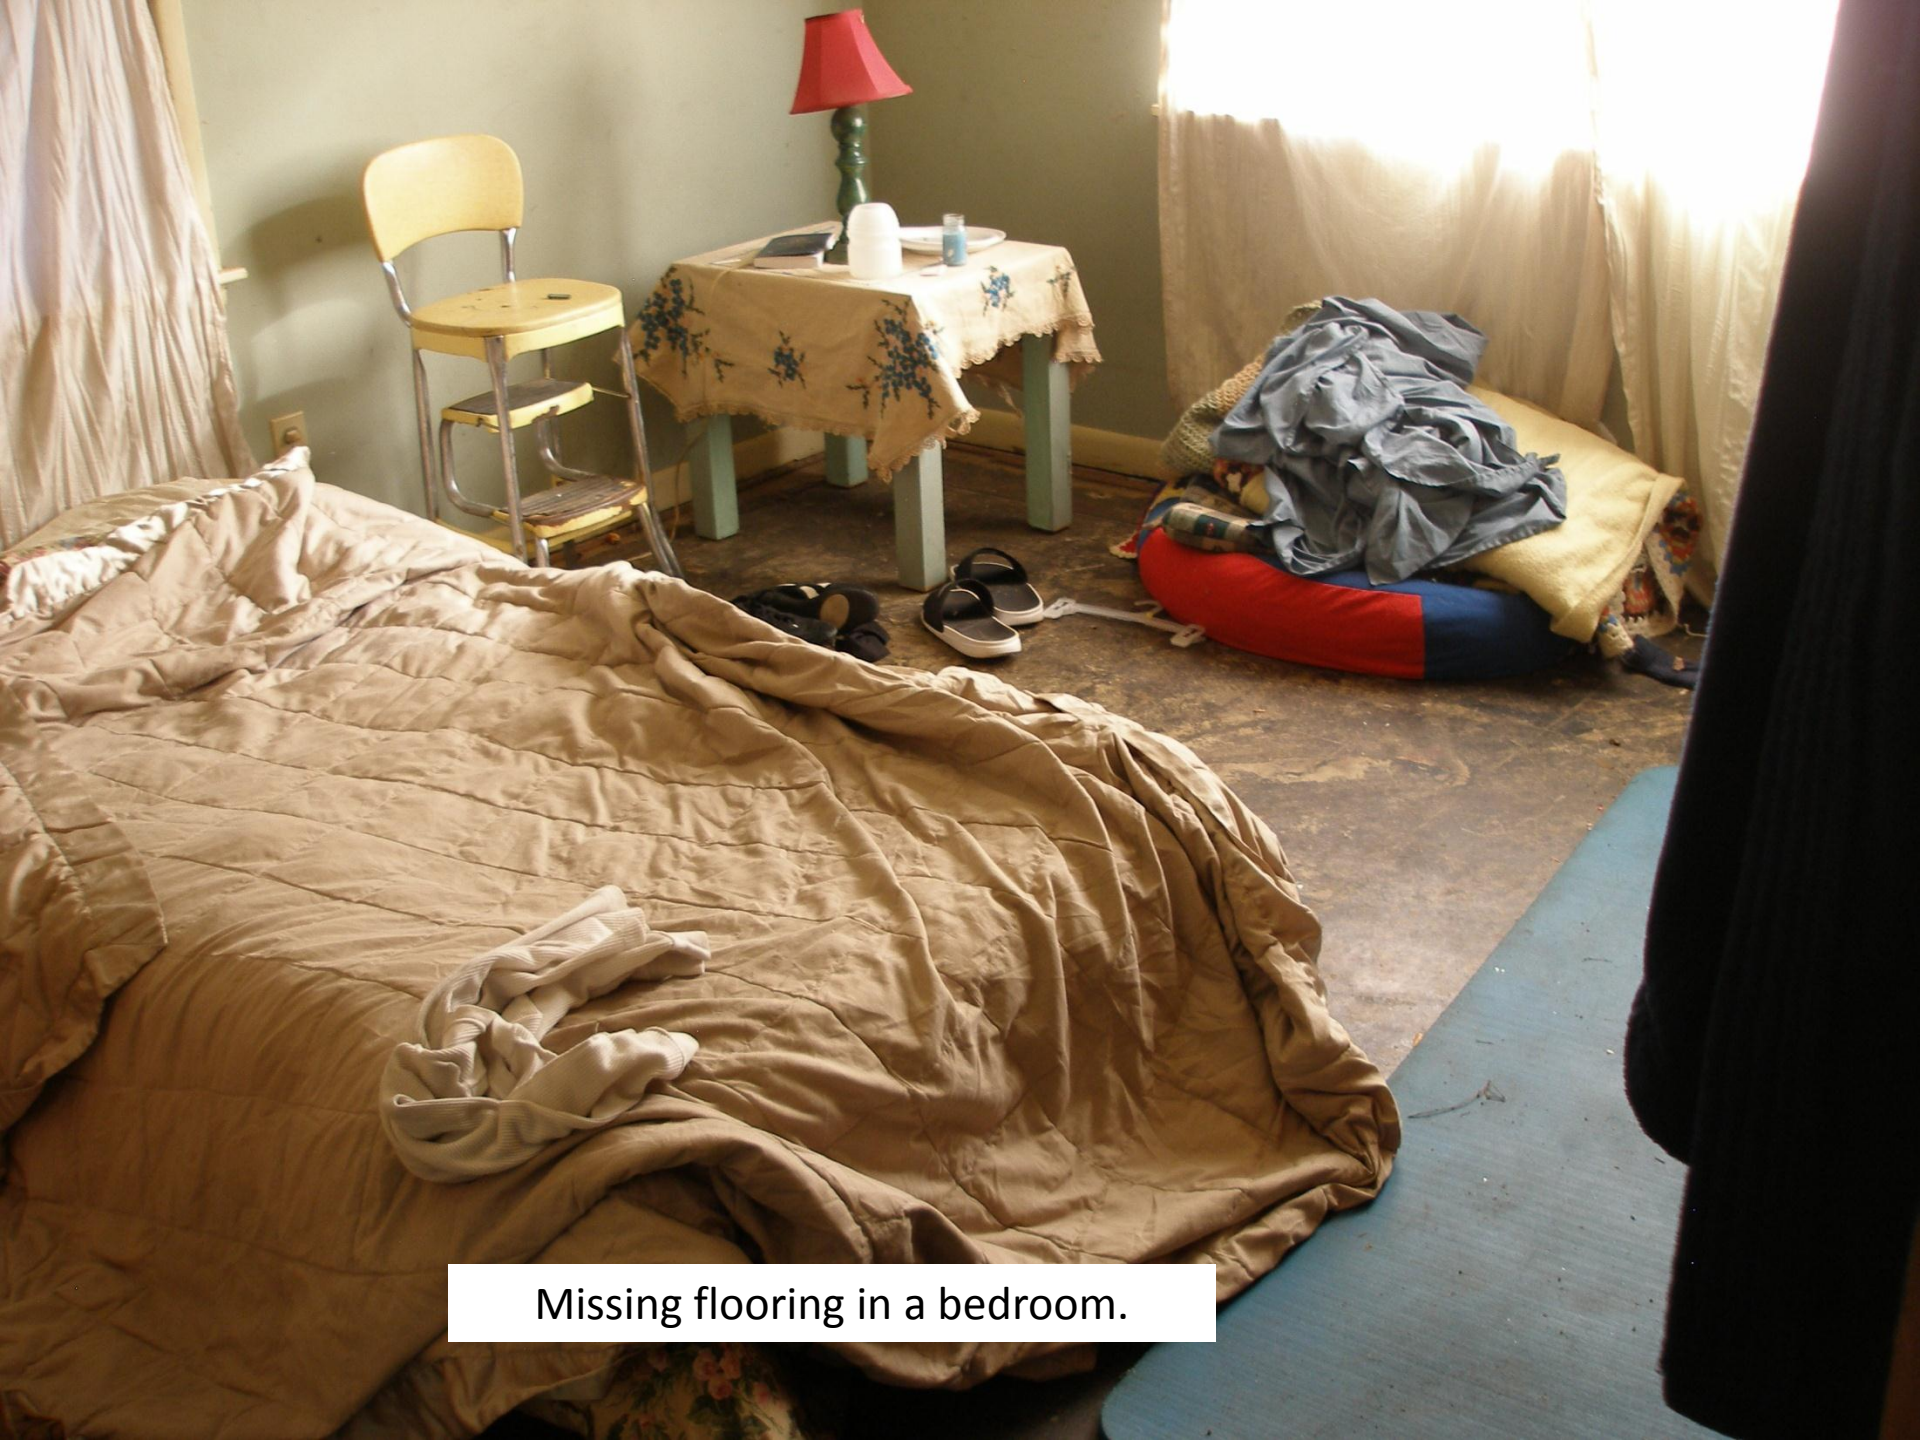
Missing flooring in a bedroom.
