South Elevation 1207 Cruce Street

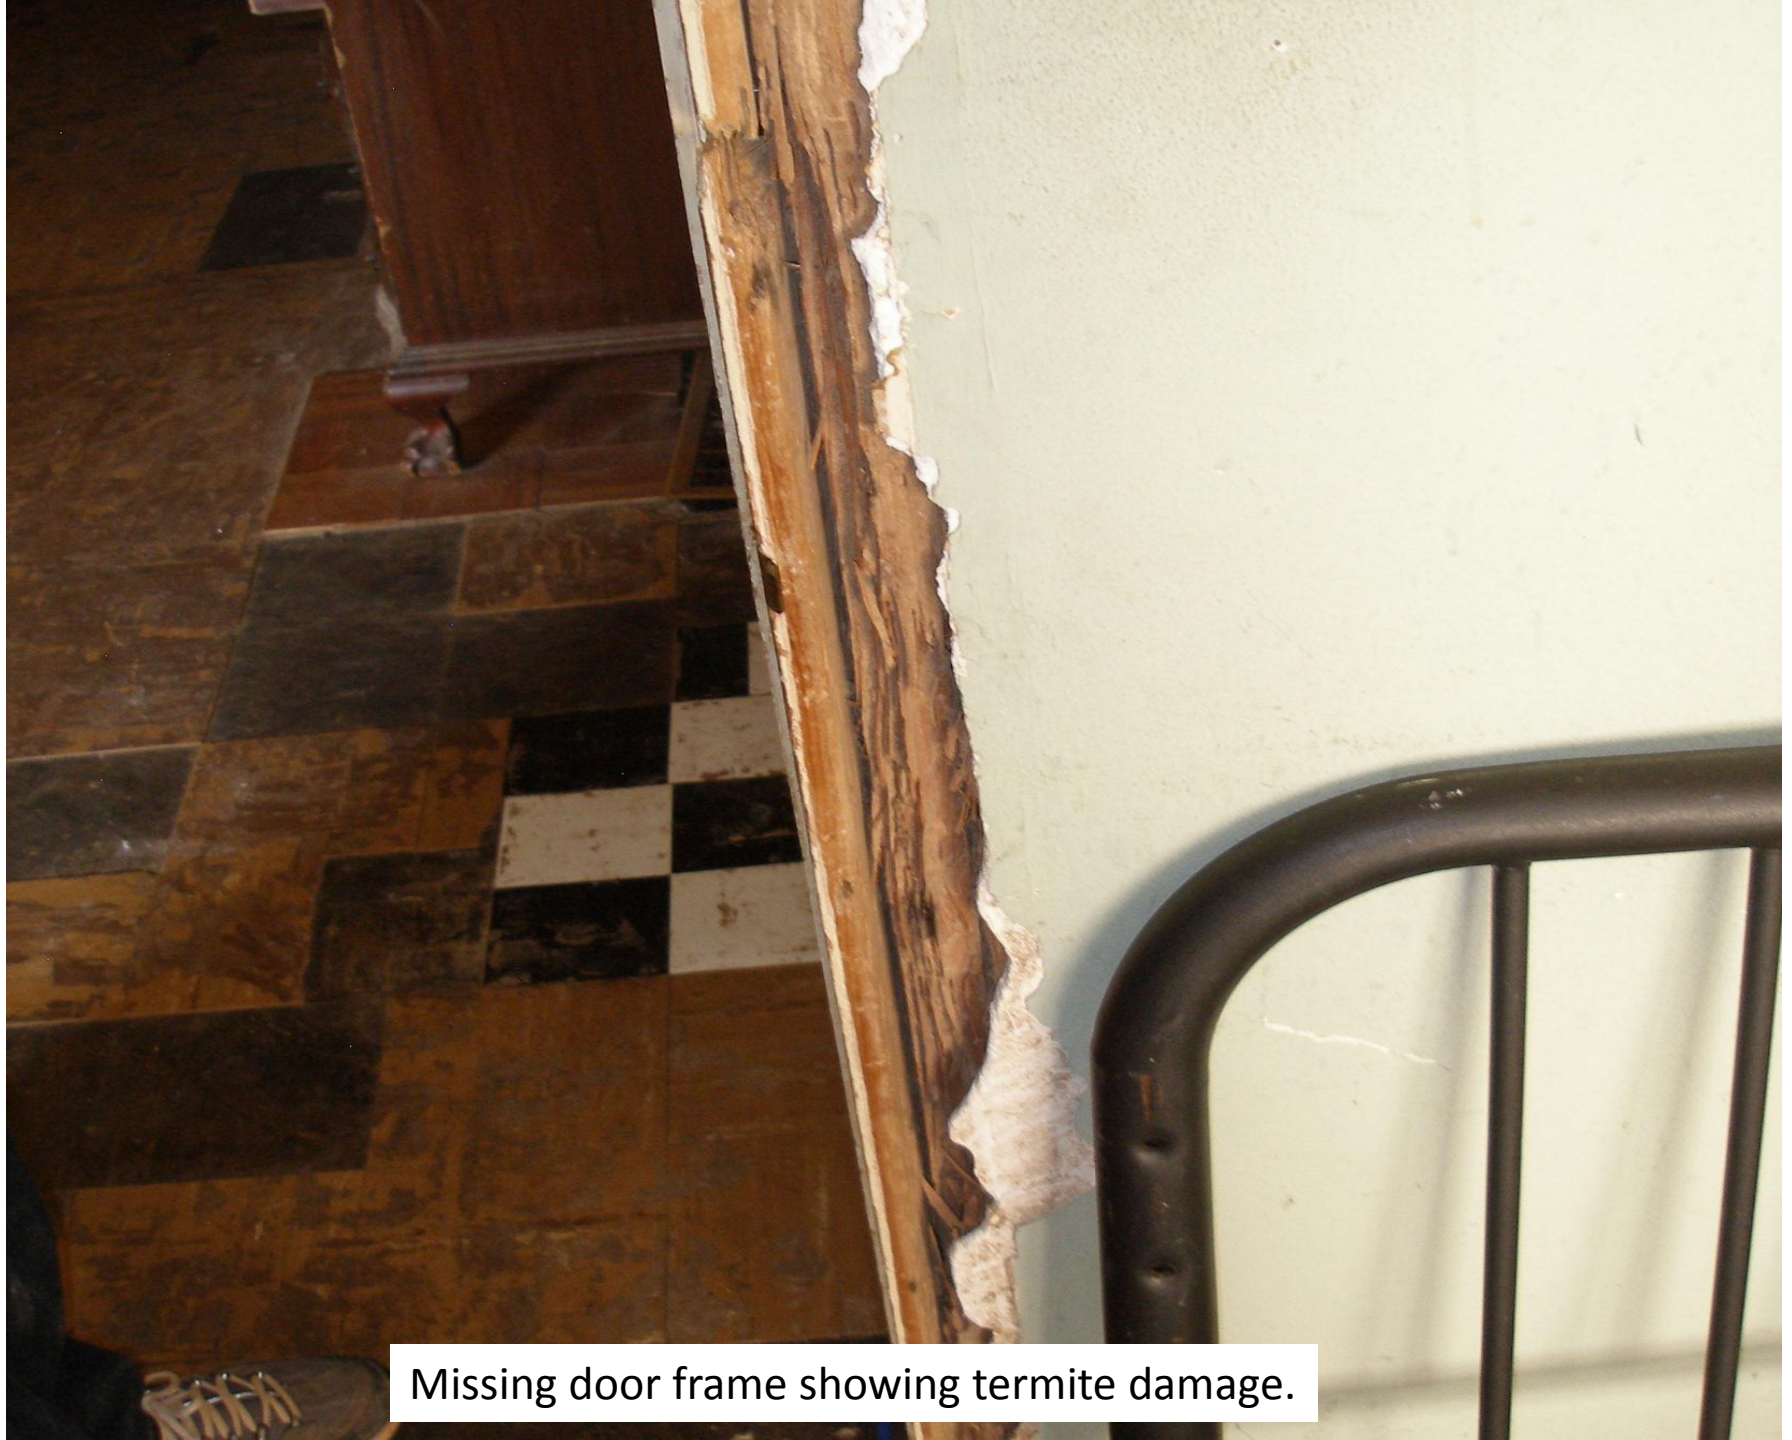
Missing door frame showing termite damage.

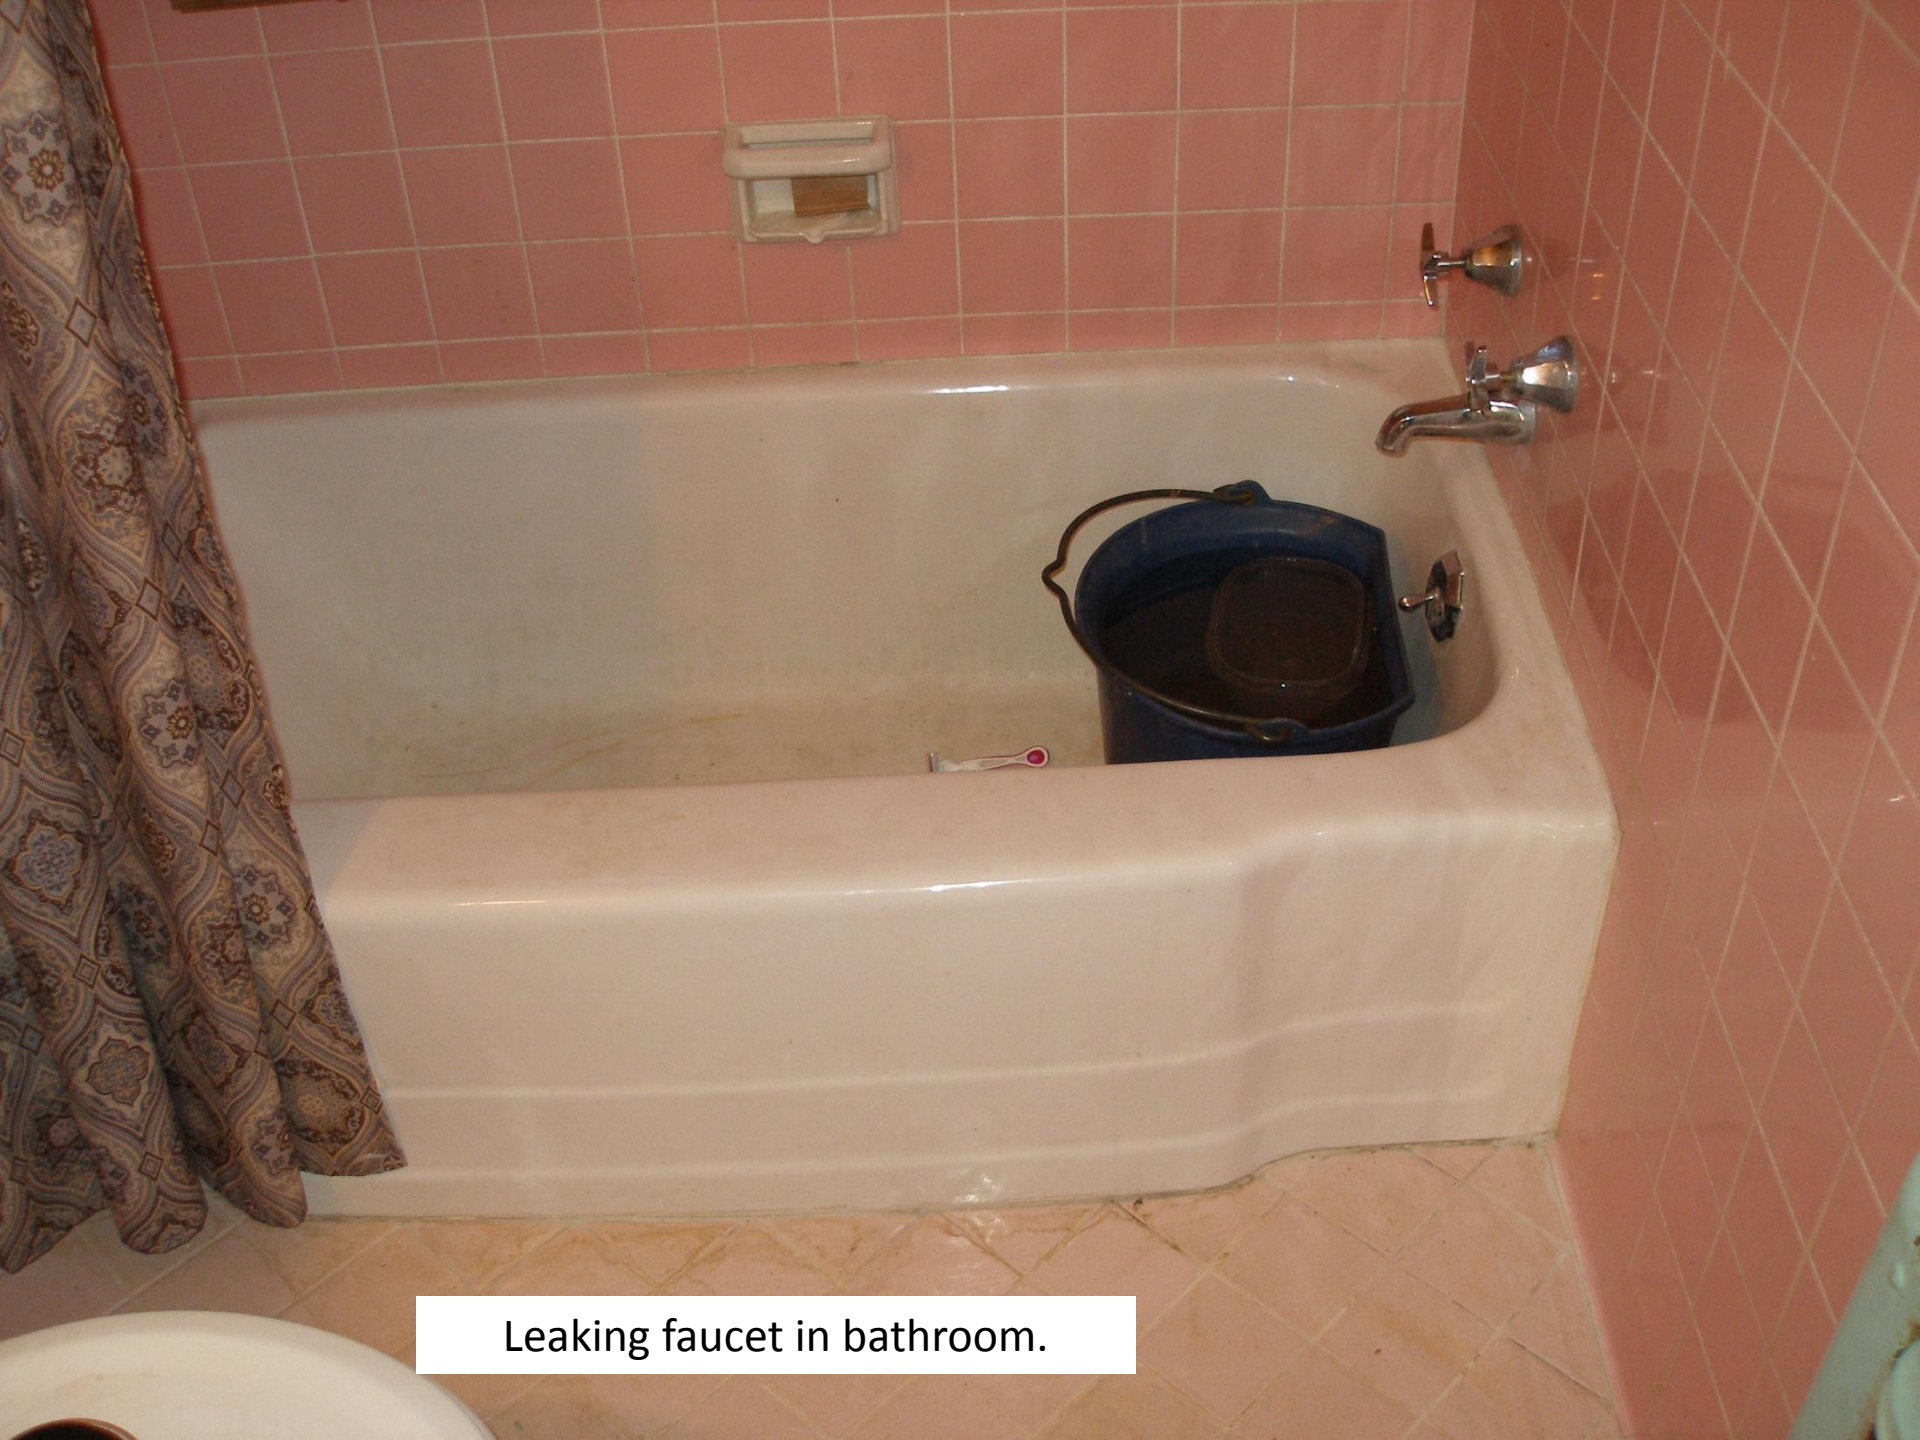
Leaking faucet in bathroom.

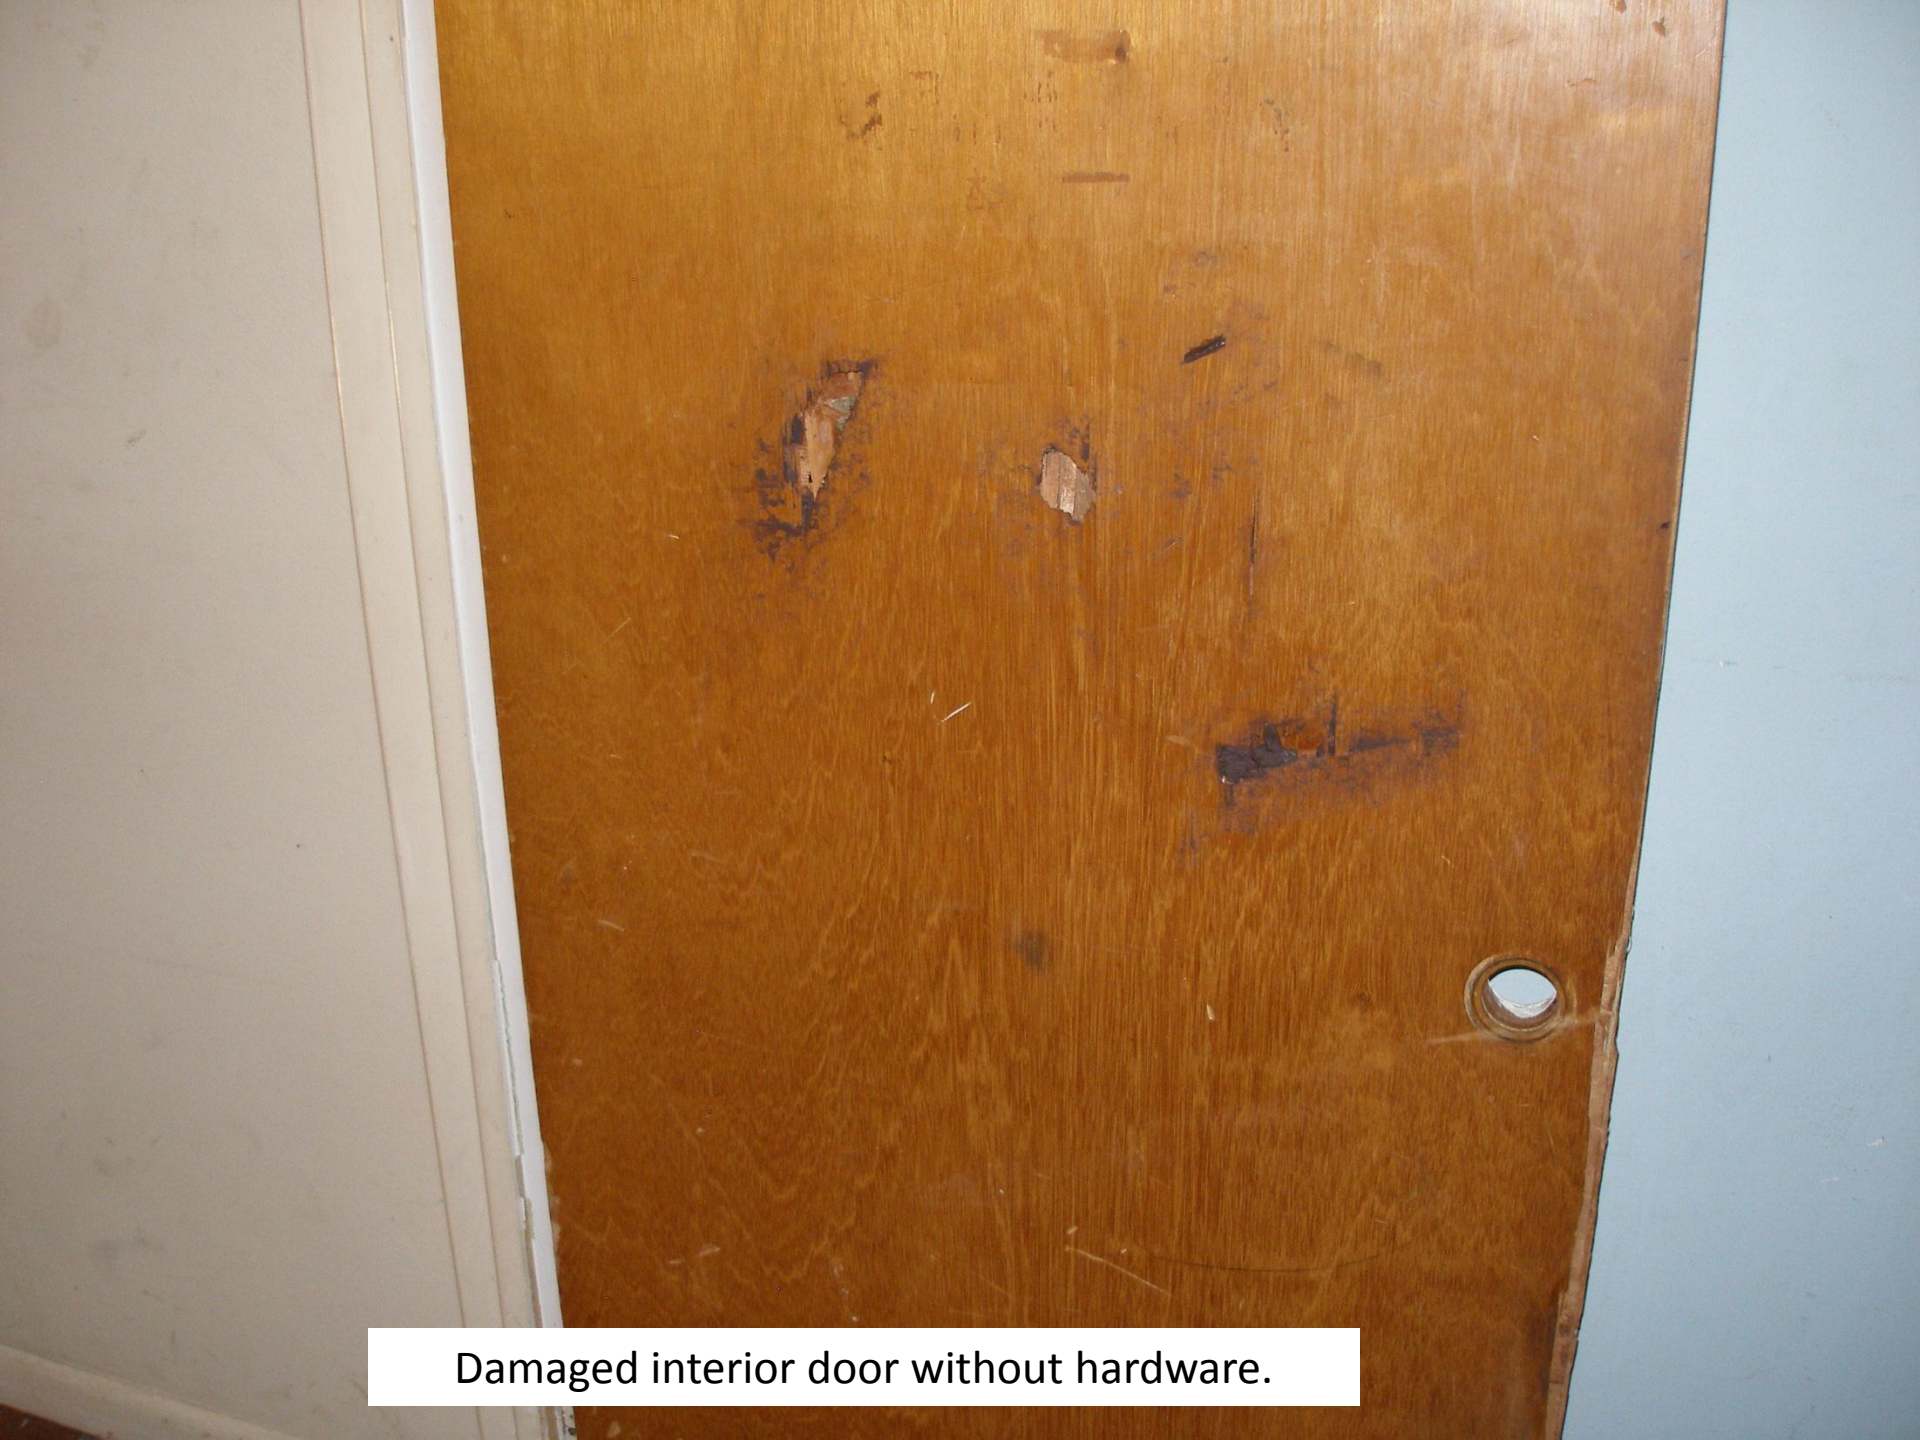
Damaged interior door without hardware.

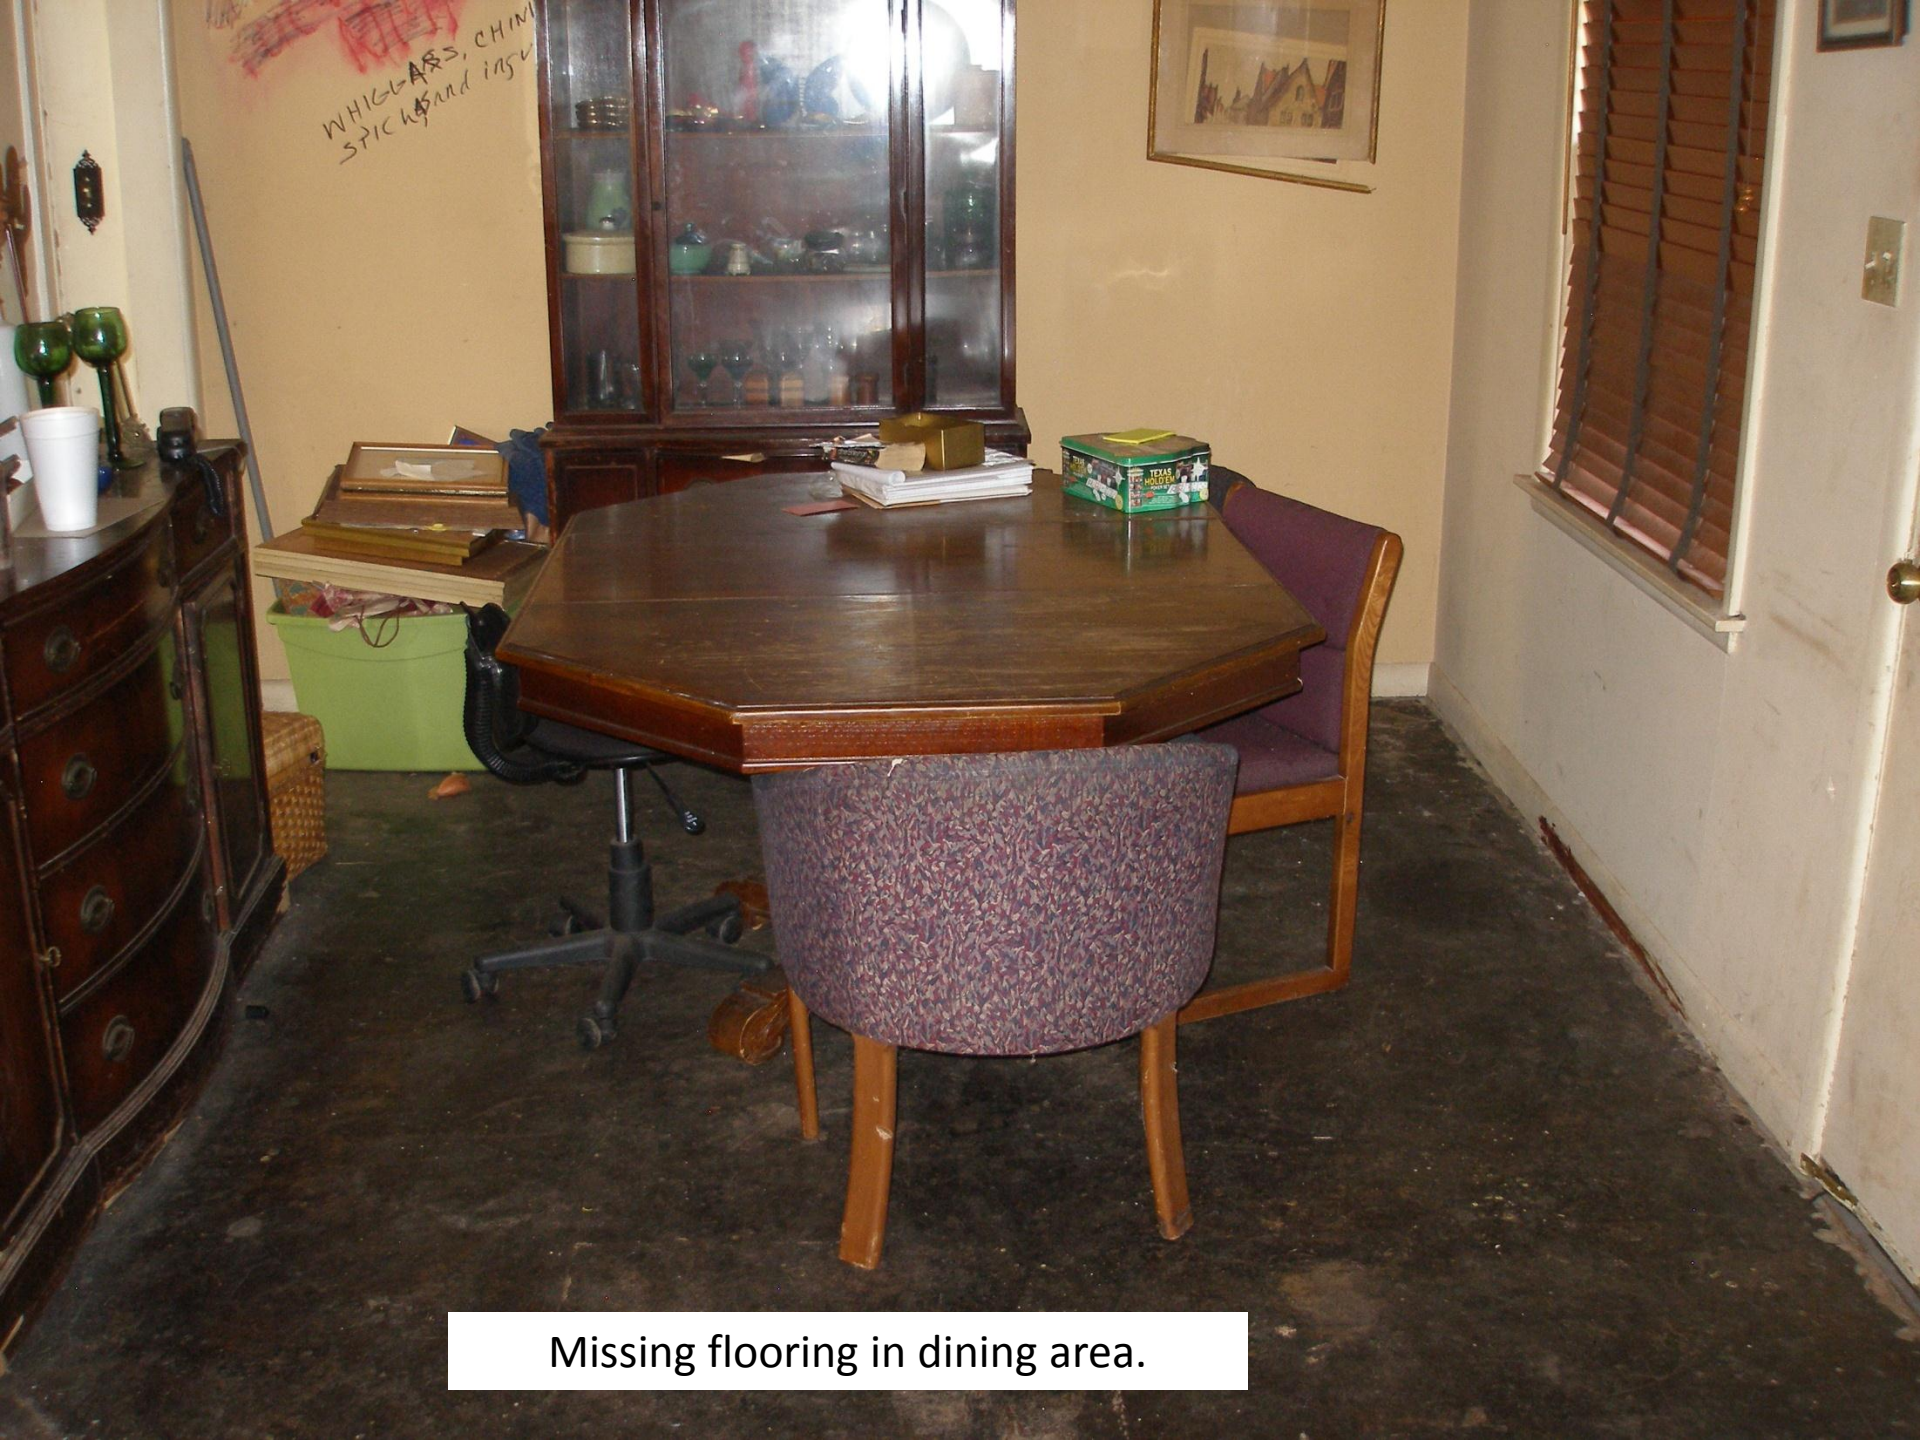
Missing flooring in dining area.

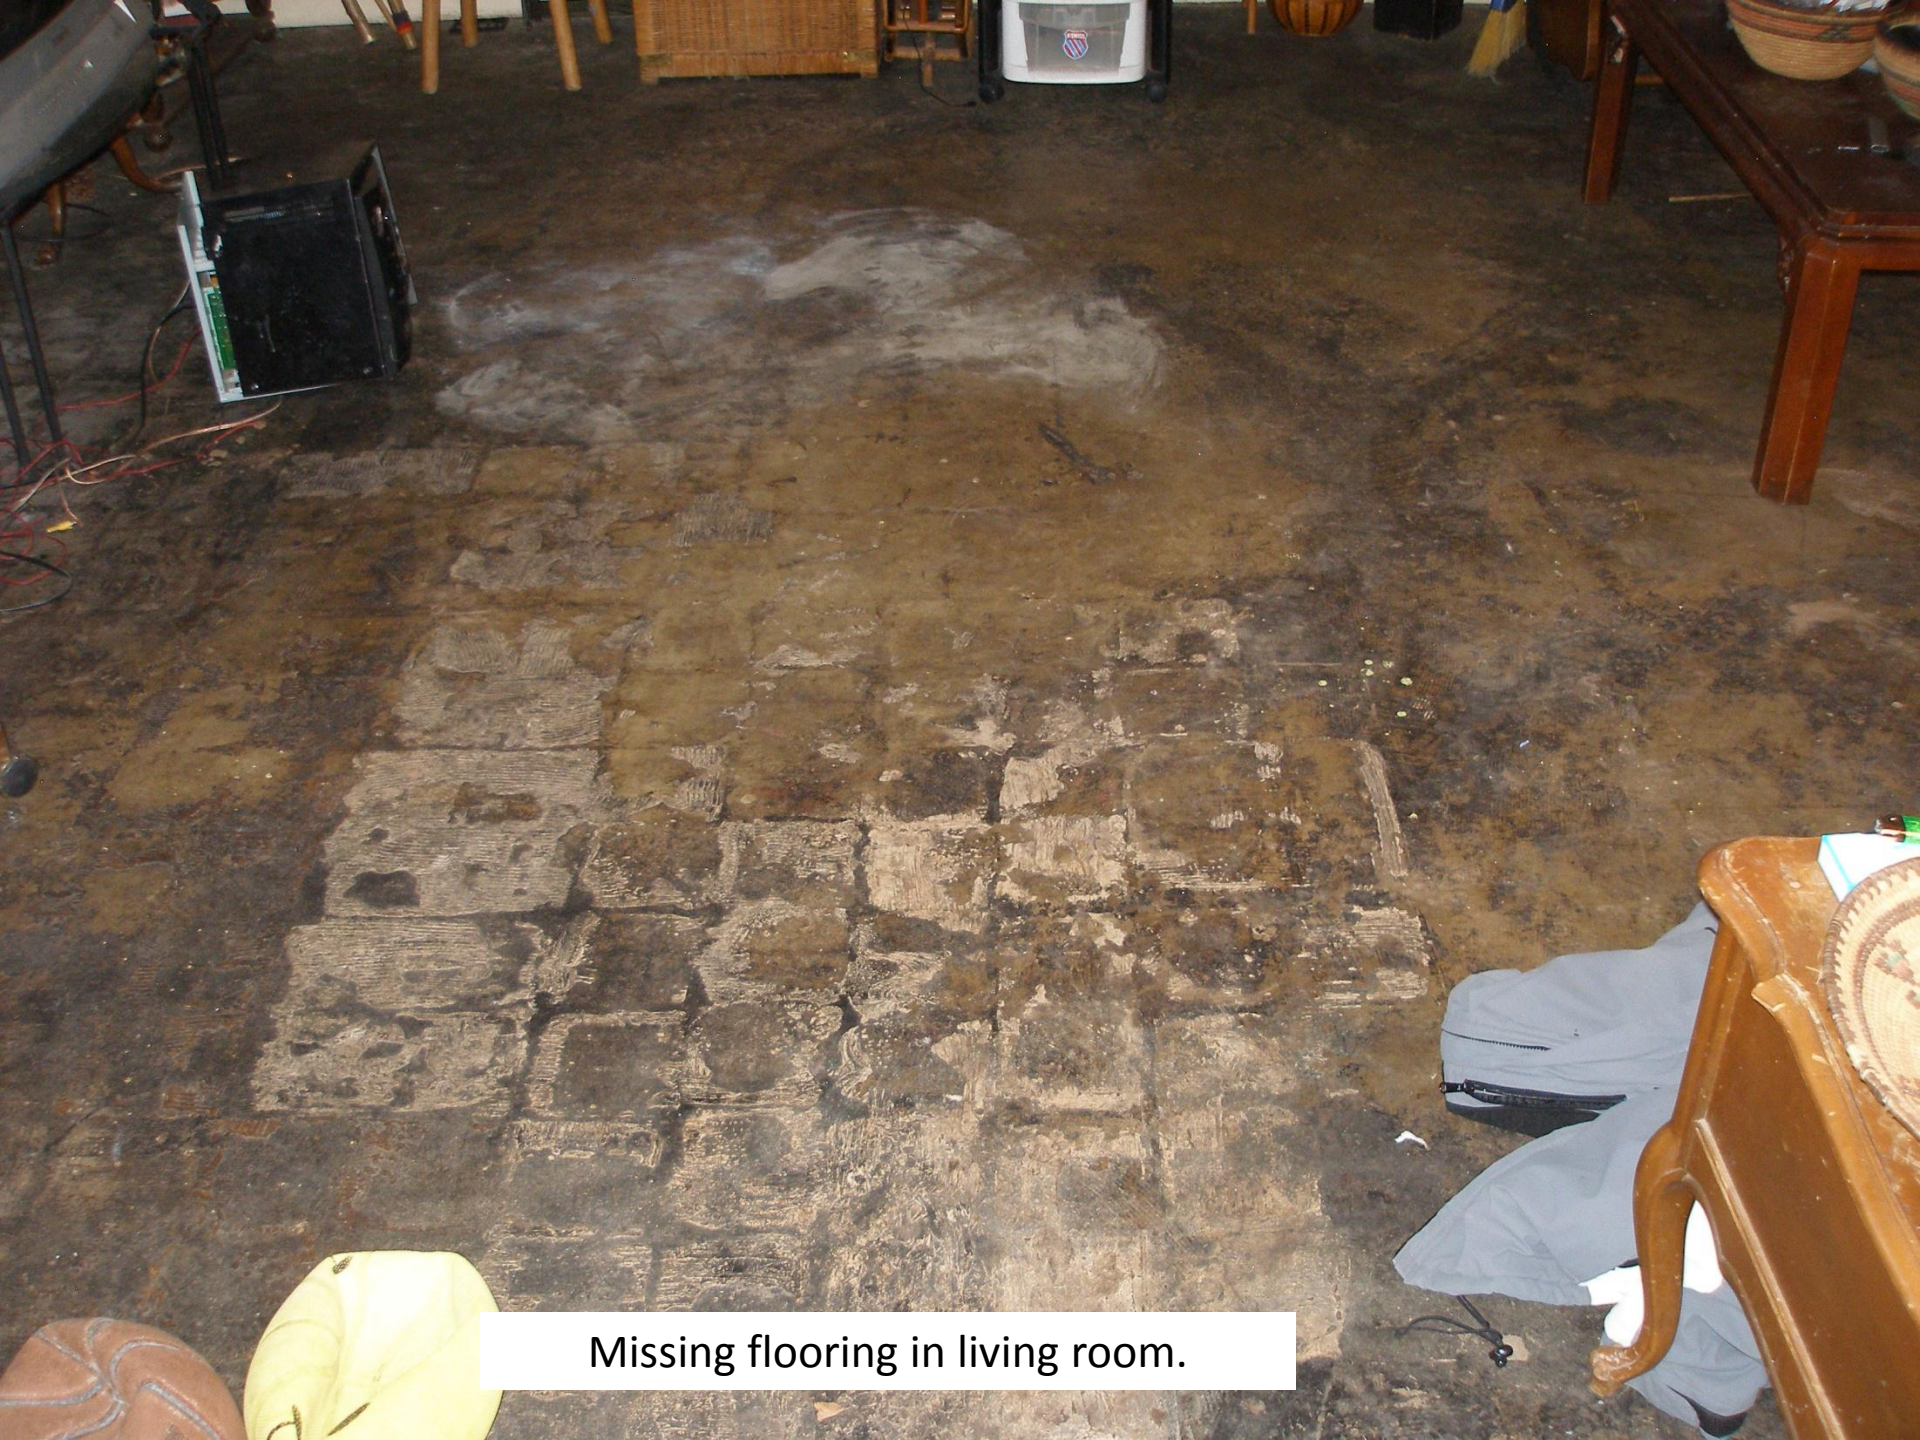
Missing flooring in living room.

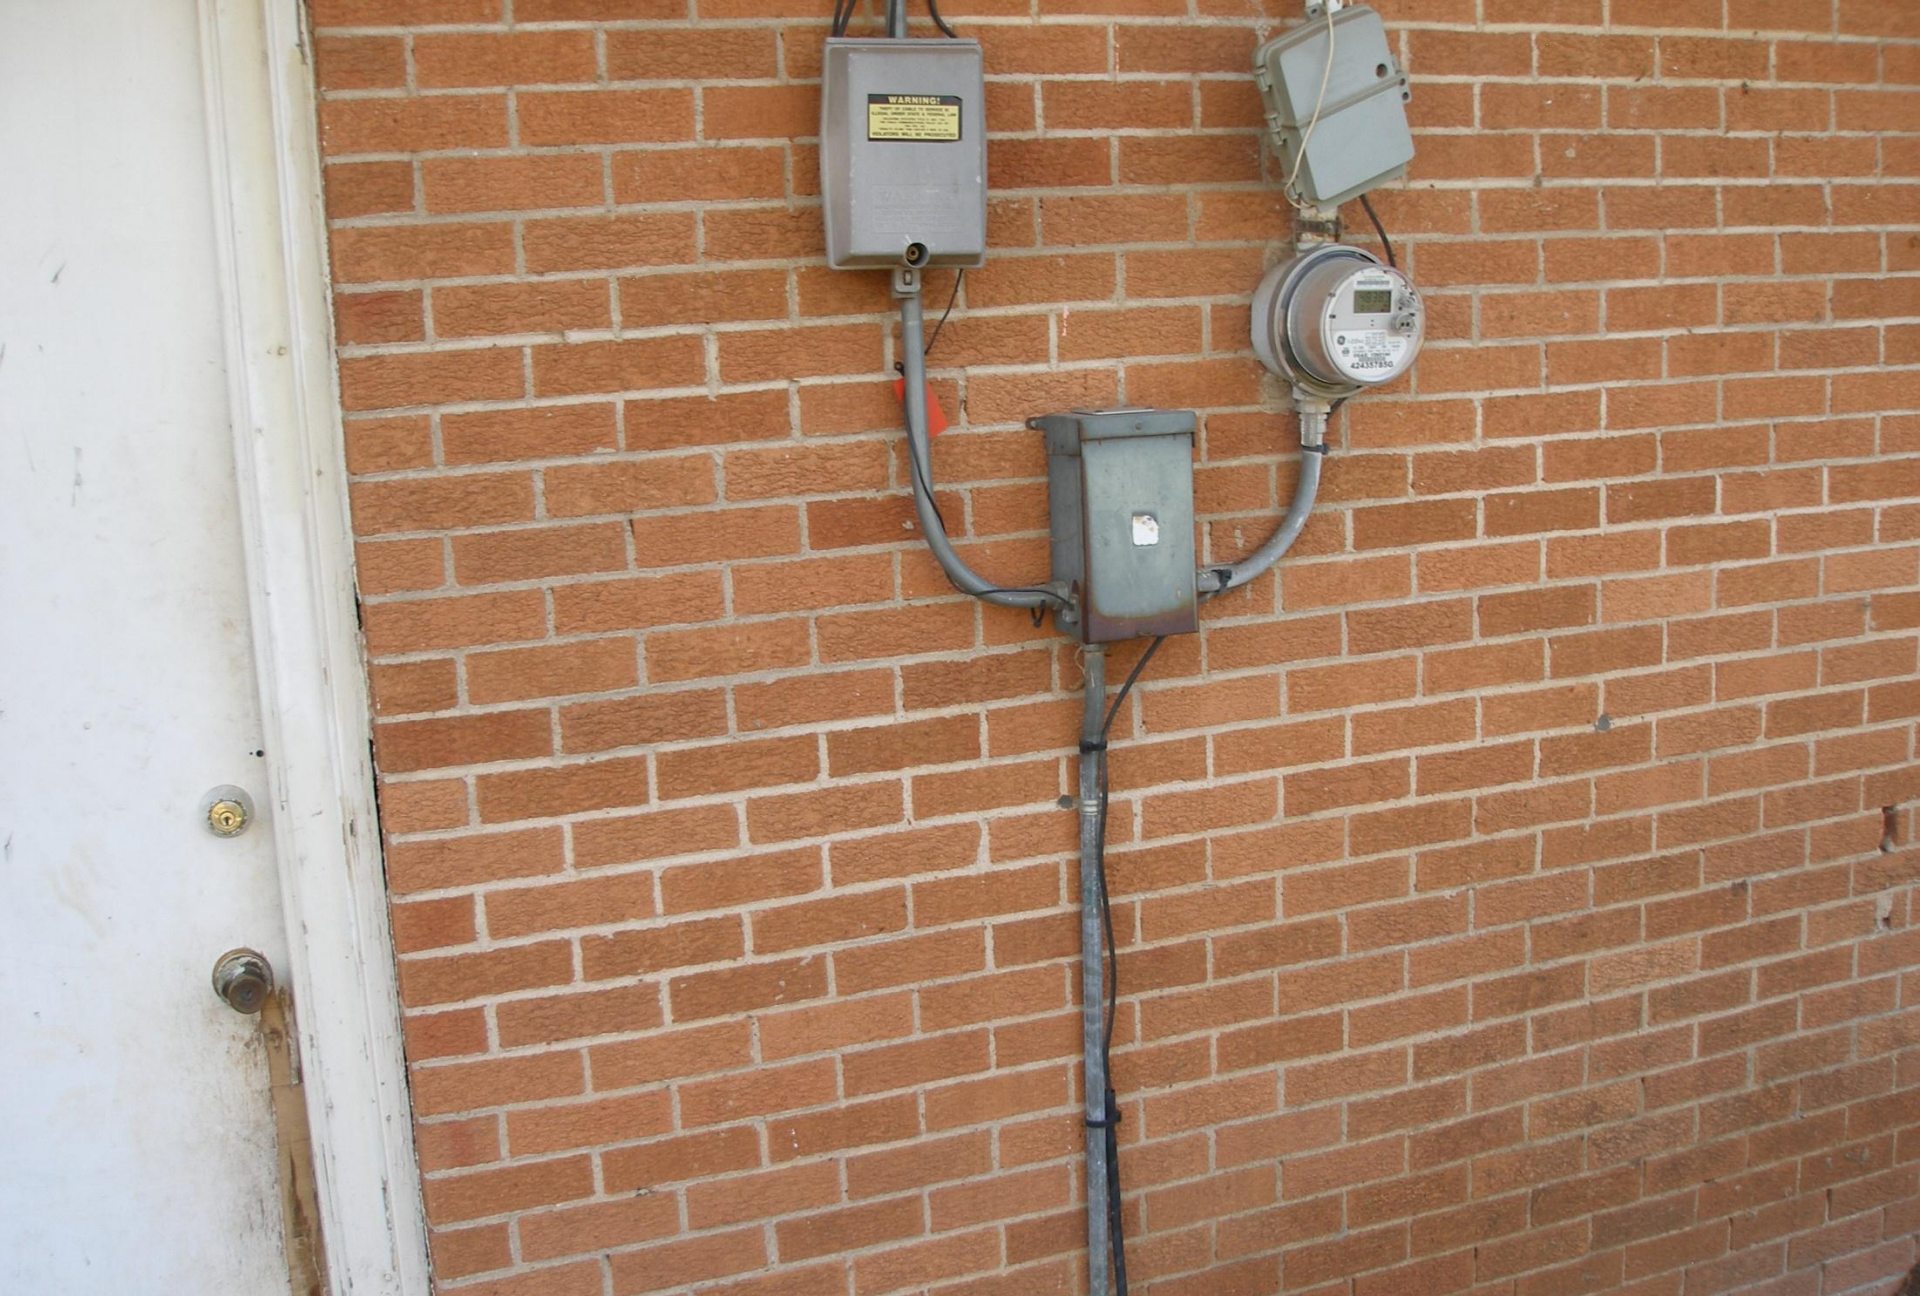
or electric service entrance to the home. The meter appears to have multiple taps on an older  
al Pacific Panel. The manufacturer has recommended replacement of that panel type.

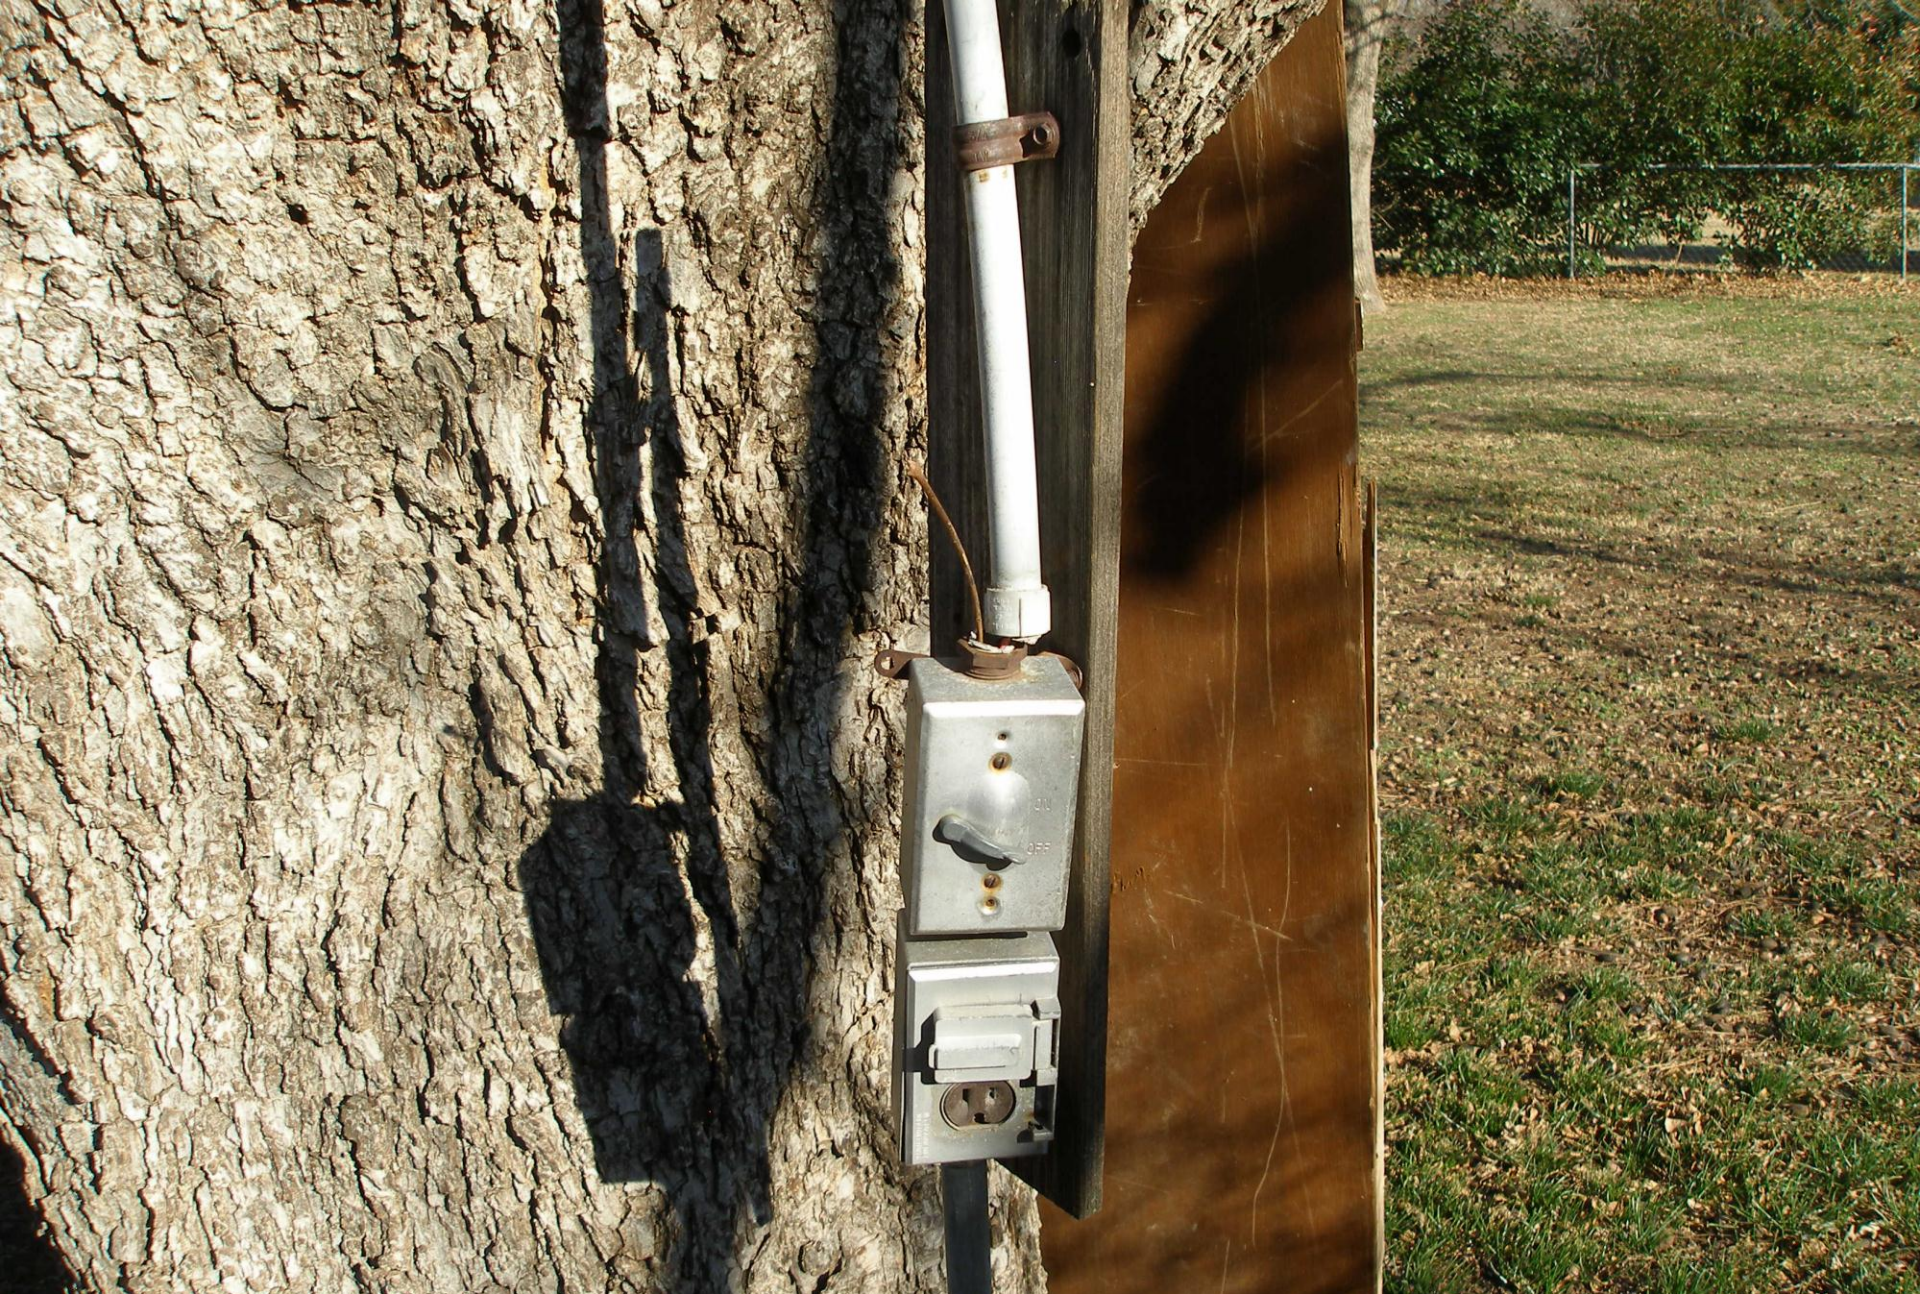
Broken conduit for exterior lighting with exposed wiring and open to allow water into box.
