December 6, 2016

Re: Norman Train Depot Reconstruction Project  
Explanation of Unforeseen Conditions  
Norman, Oklahoma

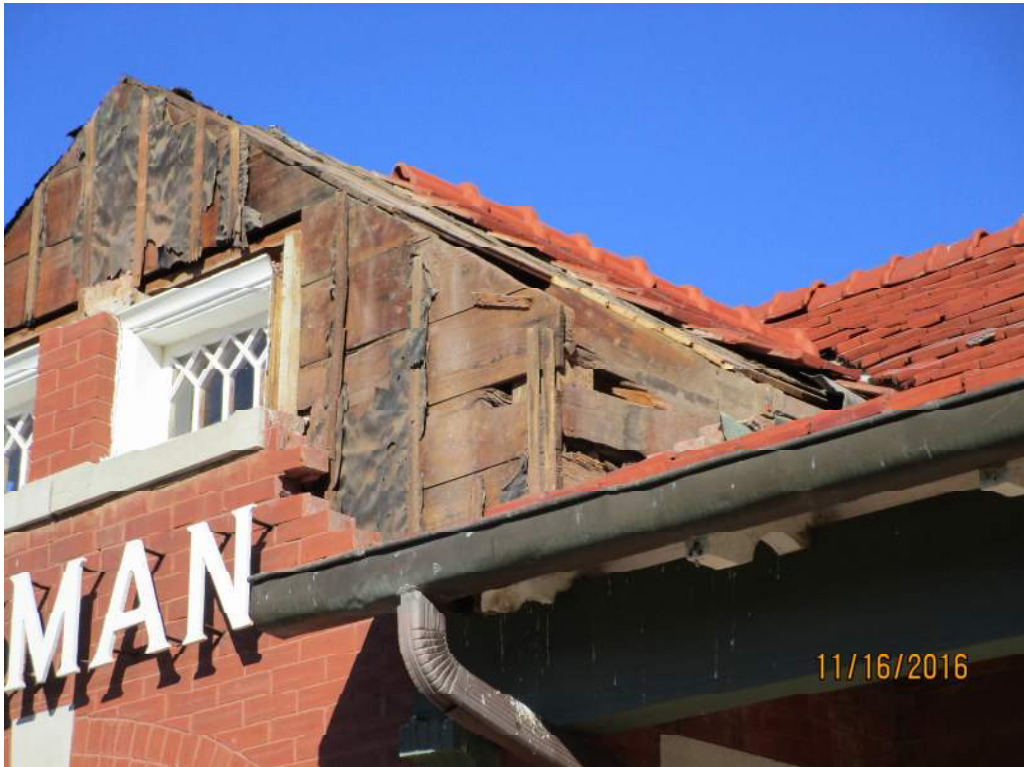
1. November 16, 2016: During demolition of the west gable, heavy water damage was uncovered at the wall studs and rafters (see Photo 1). Another view of this area was taken on November 17, 2016 (Refer to Photo 5). This area must be repaired to restore the structural integrity of the roof.

Photo 1 – November 16, 2016: West Gable Wood Damage Uncovered

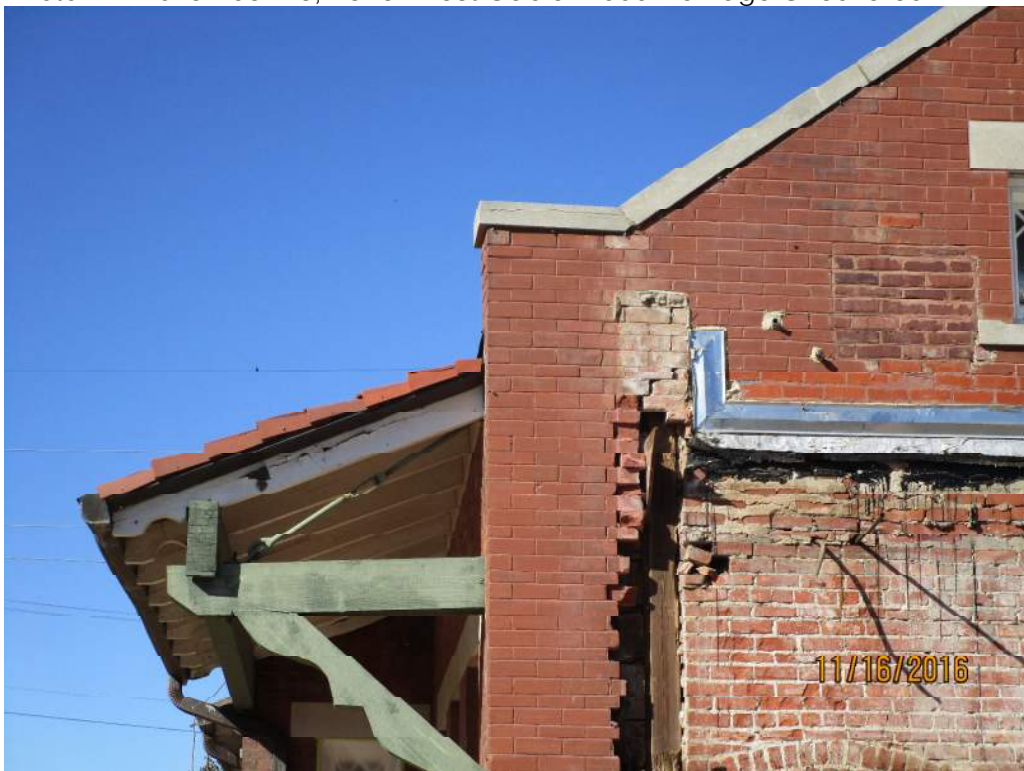
2. November 16, 2016: As the south demolition was completed, the southwest and southeast corners were open to view. Stud degradation was initially observed as shown in Photo 2. As this area was opened up further on November 17, 2016, additional water damage was found around the corner on the stud walls and at the rafters of the south gable. See Photos 3 and 4. Photo 6 taken on November 22, 2016 exposes more of the deteriorated rafter at the south gable. These deteriorated wood studs, rafters and sheathing must be replaced in order to restore the load carrying abilities of the roof and walls.

Photo 2 – November 16, 2016: Southwest Corner Water Damaged Stud Uncovered

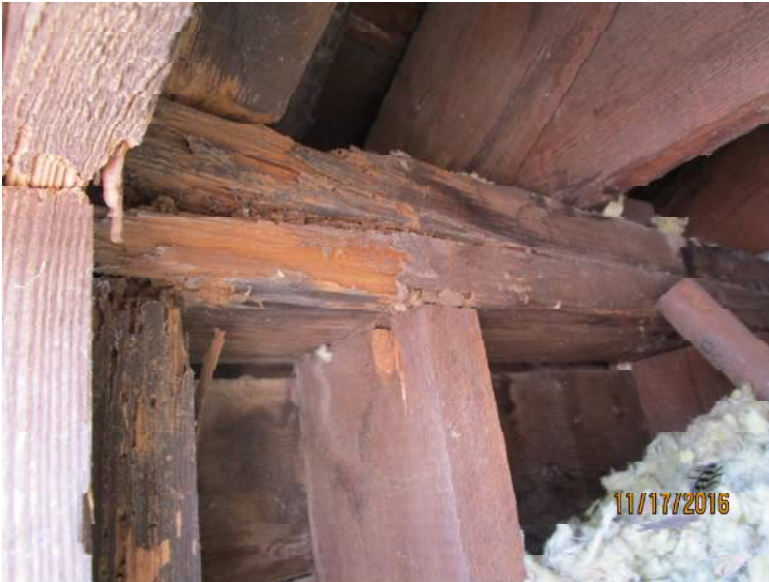
Photo 3 – November 17, 2016: More Water Damaged Studs Uncovered at SW Corner

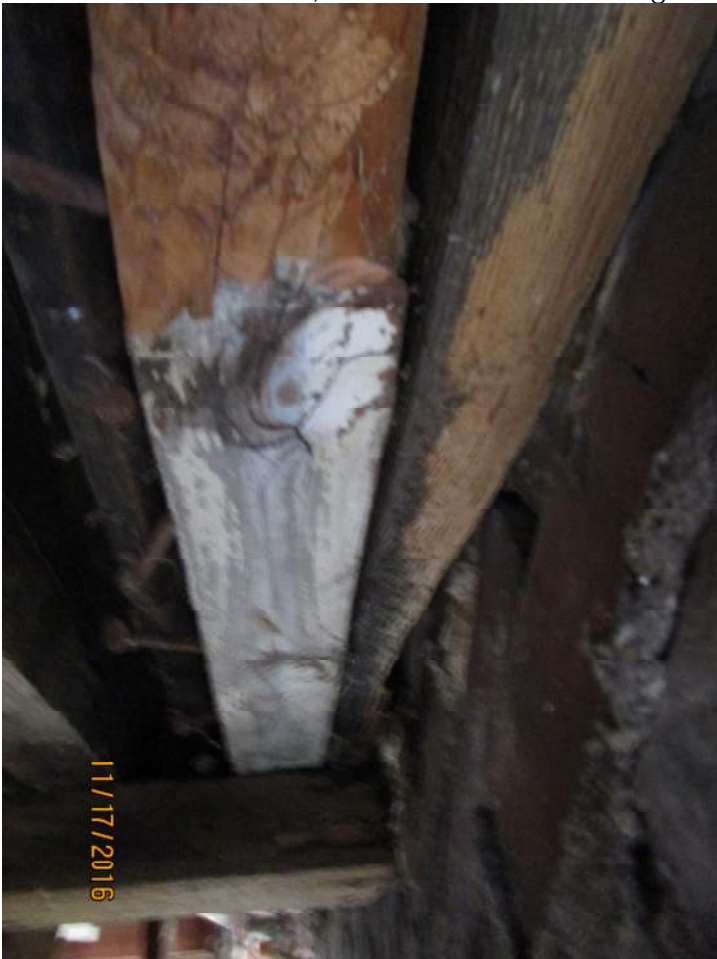
Photo 4 – November 17, 2016: Water Damaged Rafters at South Gable of Waiting Area

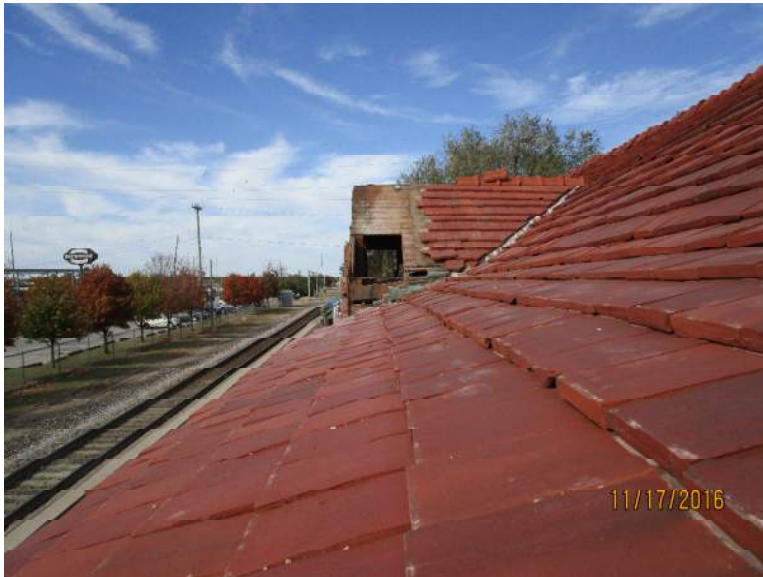
Photo 5 – November 17, 2016: Water Damage at West Gable

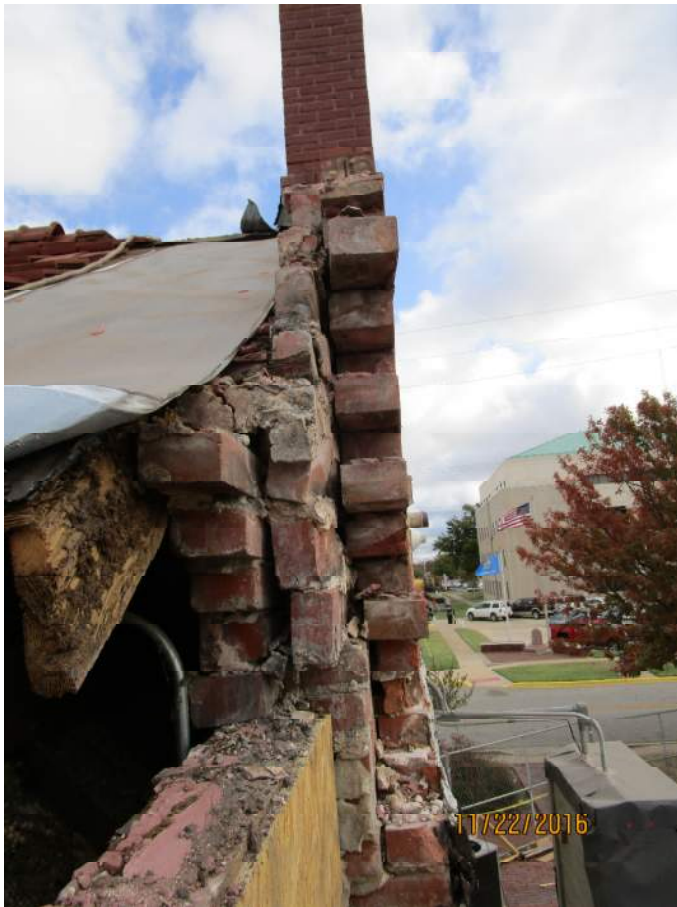
Photo 6 – November 22, 2016: Damaged Rafter at South Gable Exposed

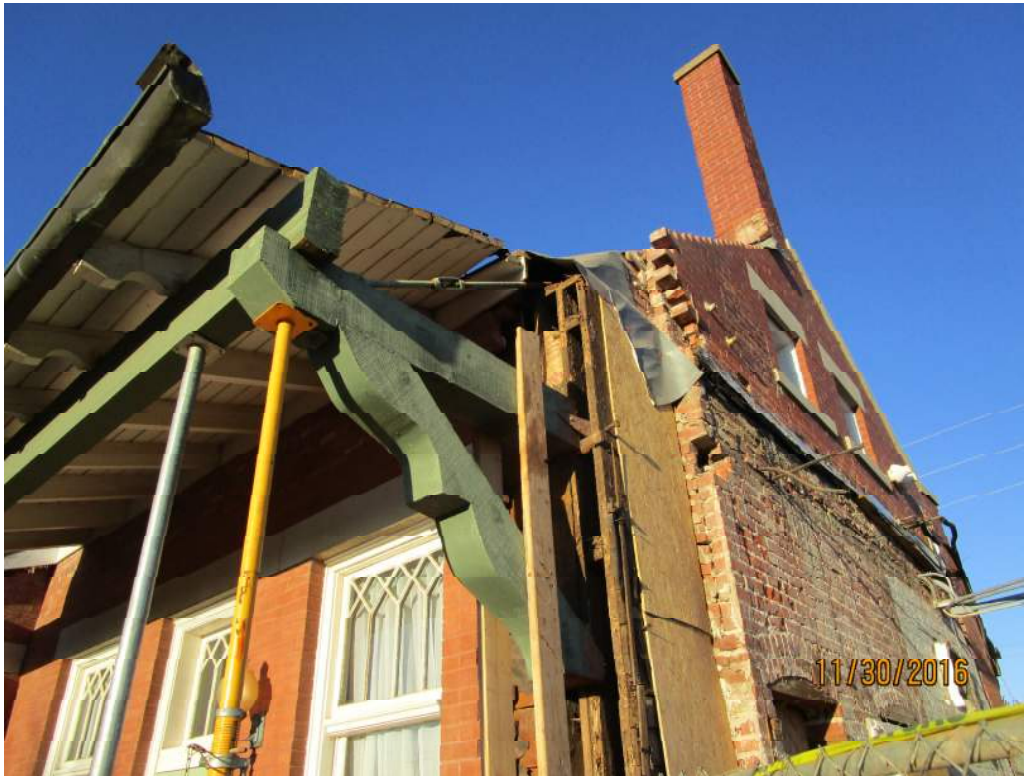
3. November 30, 2016: The southwest wall corner was further exposed. The cedar bracket that supports the roof overhang was really just set in the brick and no direct support to the wall was observed. After the studs are repaired, the cedar beams must be connected with built up joist hanger brackets. Gravity loads in the top beam are supporting on the order of 2,500 pounds at the wall connection. The bottom decorative cedar strut is supporting approximately 2,500 pounds of compression. The rod is anchored to the roof rafters (that are water damaged) via blocking. This connection must be restored. Note that when the contractor shored the point of the bracket, he easily raised the bracket assembly.

Photo 7 – November 30, 2016: SW Roof Overhang Bracket Not connected to Wall

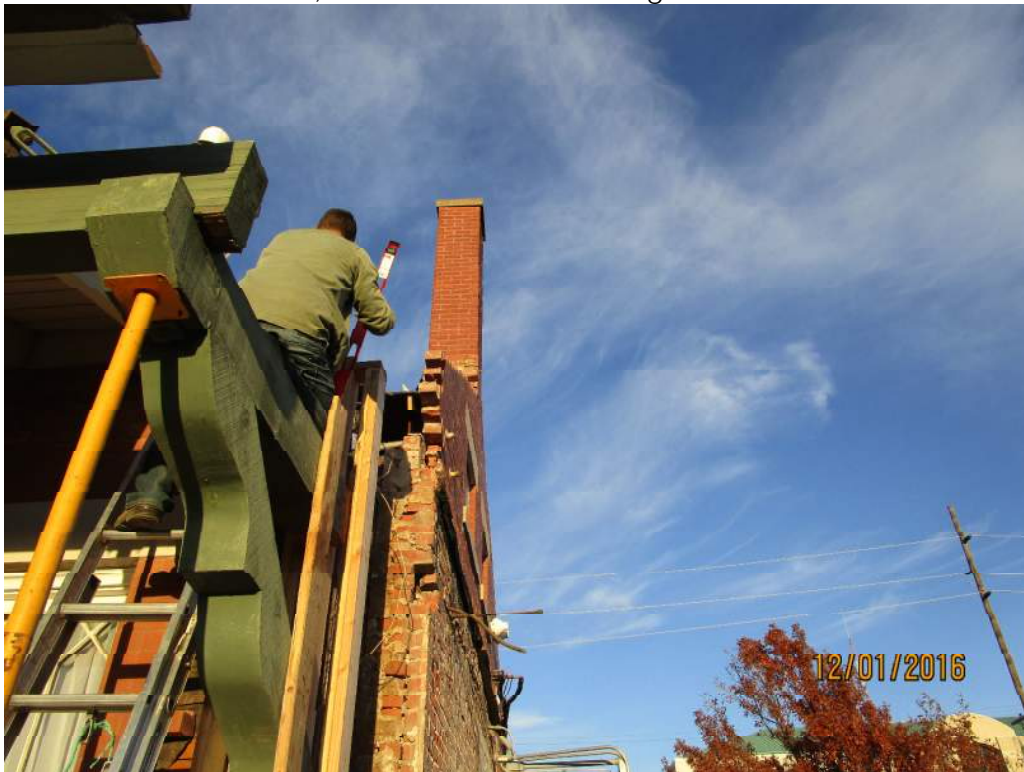
4. December 1, 2016: The south gable wall is very unstable, the rafters which needed to be repaired have been removed on the west half; however, the contractor noted that the chimney was leaning 1" to the south for every 4 feet. The multi-wythe brick wall was not well connected as the contractor noted that he did not have to break the mortar bonds with much of the brick, i.e., most of it was already loose. The contractor has temporarily braced the chimney back to the gable. In order to properly repair this wall, the chimney and brick must be torn down below the windows to the low roof flashing point; a concrete beam installed to support a new wood wall, brick veneer and rebuilt chimney. KFC has recommended the contractor take down the chimney as a safety precaution.

Photo 8 – December 1, 2016: Chimney at South Wall Leaning to South

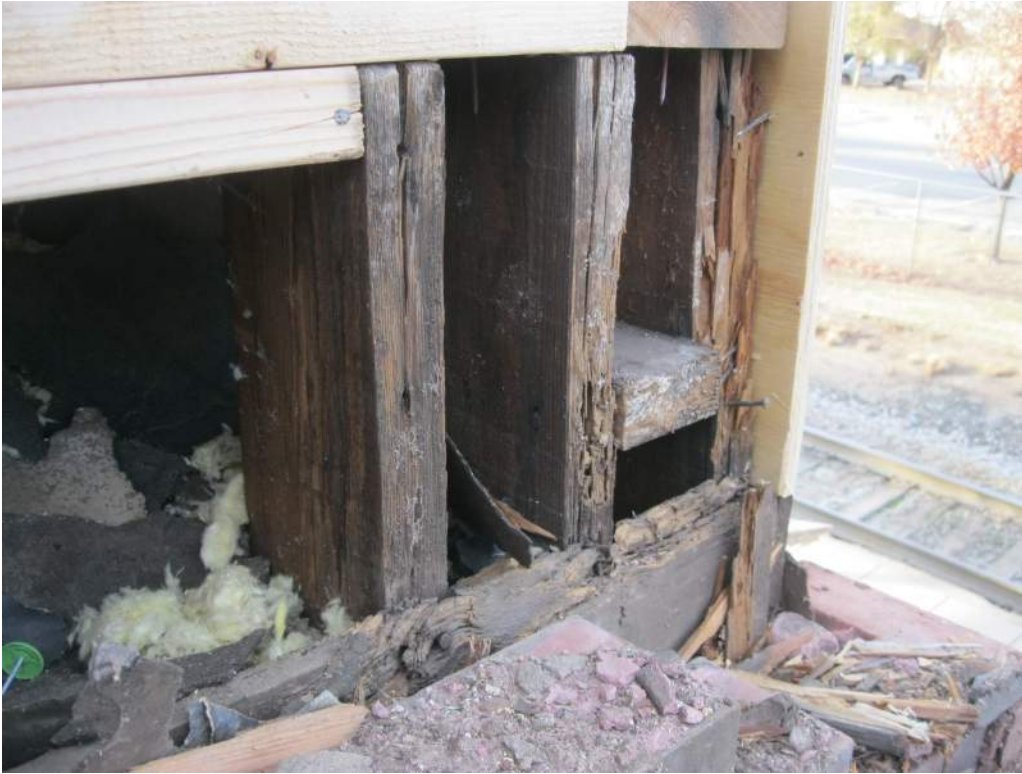
5. December 2, 2016: The NW wall corner beneath the gable repairs was observed to have significant water damage as shown in Photo 9. Additionally, the west overhang support beams bear on the brick and are not connected directly into the stud wall. The cracked brick face and mortar cracks show these stress concerns (see Photos 10 and 11). These conditions must be repaired to restore the load carrying abilities of these systems. KFC has recommended that Phoenix provide shores under these roof overhang beams until permanent repairs can be made.

Photo 9 – December 2, 2016: Water Damaged Studs at NW Corner below West Gable

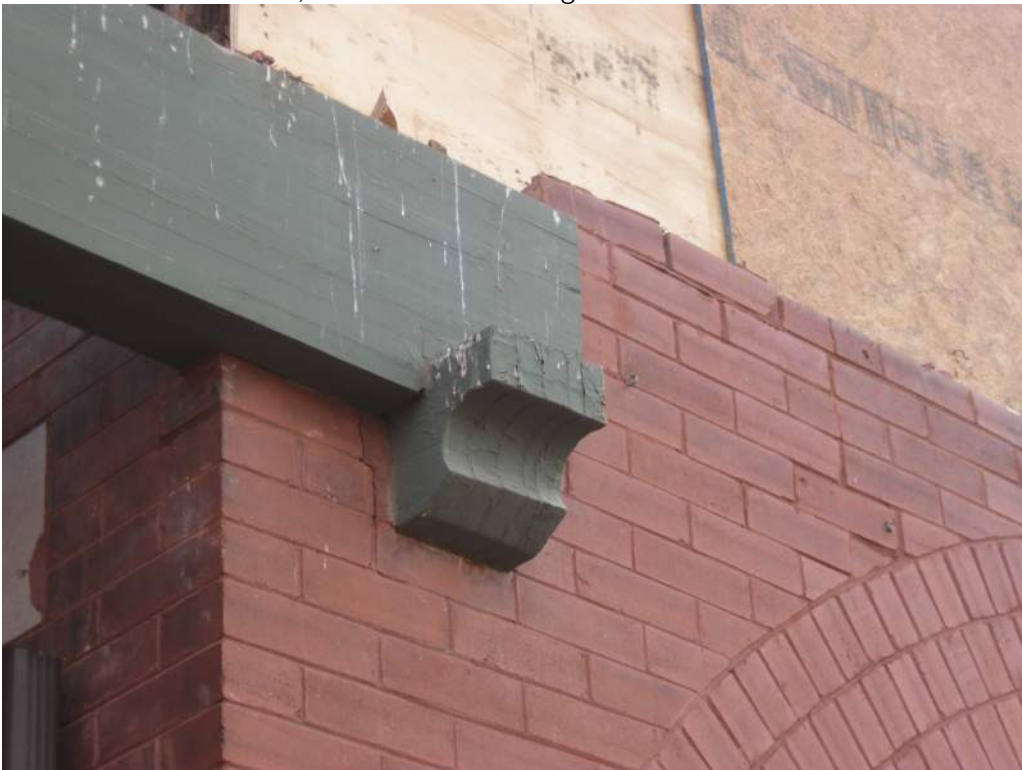
Photo 10 – December 2, 2016 – Roof Beam Support NW Corner below West Gable

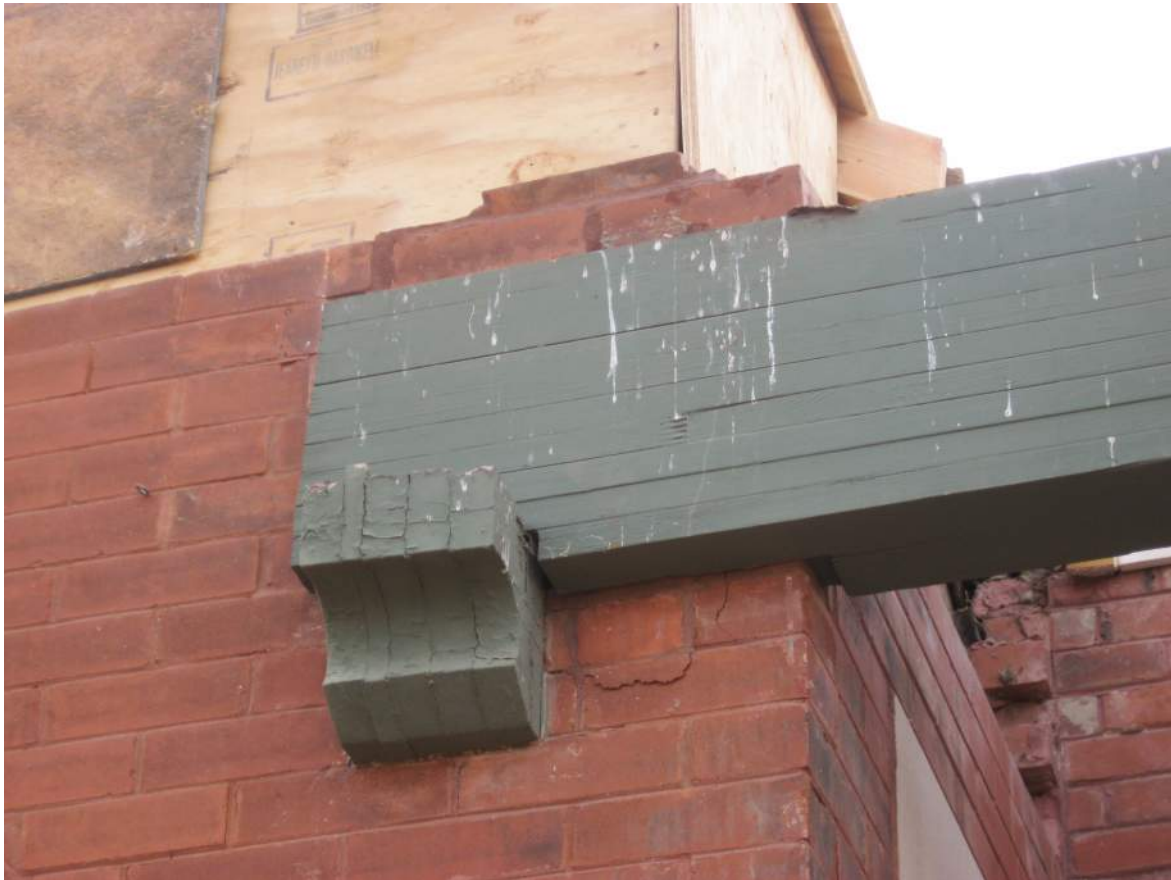
Photo 11 – December 2, 2016 – Roof Beam Support SW Corner below West Gable
