Subject: City of Norman, OK.
Fairbanks Morse Pump
16" VTSH
S/N K4H2-062735
Rehab Quote
PSG J/N 507136

Pump Services Group

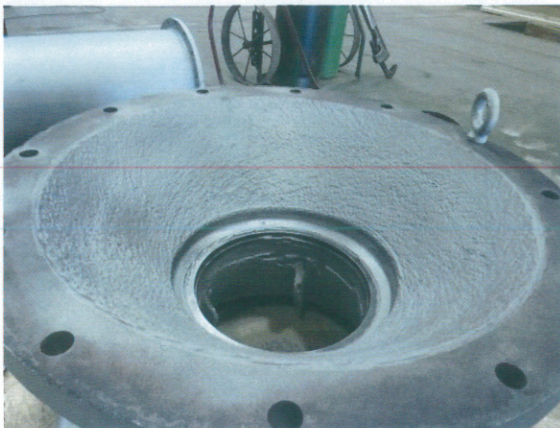
- 1) Receive pump from Customer.
- 2) Disassemble, clean and inspect per prints.
- 3) Beadblast all reusable components.
- 4) Suction Bell – It is in poor condition but reusable. Reestablish register fit and wear ring fit. Fill erosion with Ceramic "R" metal and top coat with Belzona Supermetal glide.

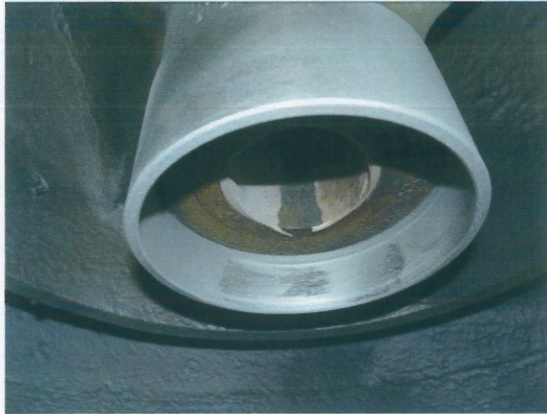
- 5) Discharge Bowl – From the picture you can see that the lower bearing fit has been sleeved before and the pump shaft has worn thru the bearing

into the sleeved portion. We suggest to machine the sleeve to a nominal size and machine a new bearing with the proper OD. The sleeved bore is approximately .004 under low limit of our standard print dimension.

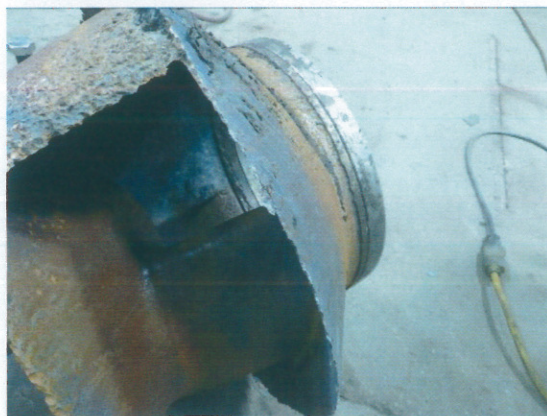
- 6) Impeller – Impeller is worn extremely thin. Pitted and eroded, suggest replacing.

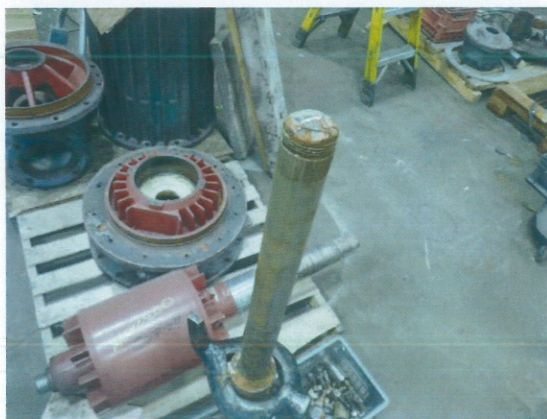
- 7) Pump Shaft – broke at the threaded portion of the shaft. Replace.

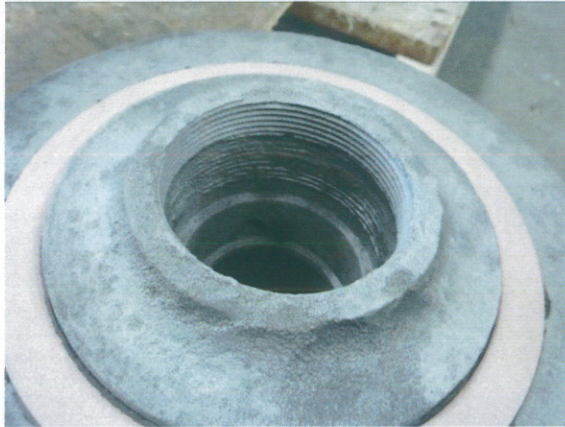
- 8) Lineshafting – Due to the wear at the bearing journals we suggest replacing.
- 9) Enclosing Tube – Clean and reuse.
- 10) Column Pipe – Clean and reuse.
- 11) Tube Tension Bearing Housing – Due to the eroded threads we suggest replacing.

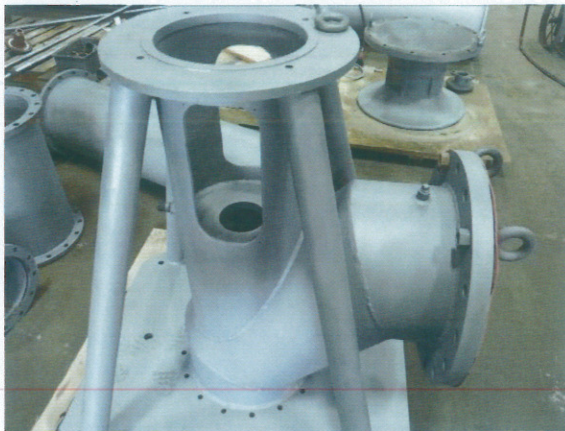
- 12) Discharge Head – Weld repair the register fits on this piece, motor register, tension housing bore and column fit. Weld and finish machine to print dimension.
