LOWER IMHOFF CREEK HYDRAULIC & HYDROLOGIC STUDY PROJECT

Norman, Oklahoma

Prepared For: City of Norman, Oklahoma

REPORT UPDATE - June 30, 2017

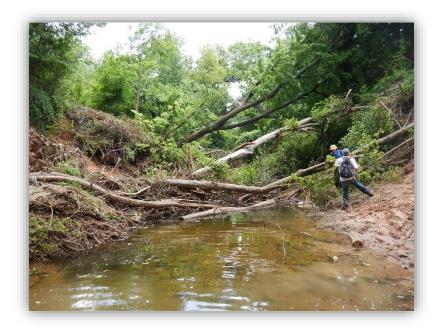
Approximately 100 feet downstream of the pedestrian bridge crossing, there is a tree across the channel causing significant erosion. There are others upstream of this area as shown in the Figure 1 and Figure 2 on the next page. Bank erosion on the right descending bank is threatening the pedestrian bridge abutment. Upstream of the bridge the channel slope increased and additional accumulation of both gravel and large non-native stone was observed. Filter fabric and remnants of riprap on the channel banks from this area upstream to the articulated block section were observed. At this time, it is unknown whether the material was carried downstream after a failure at the end of the articulated block section or was part of a separate riprap channel improvement. In some areas, the channel is significantly clogged with this material which is causing erosion along the toe of the banks. There are additional downed trees through this segment which is contributing to additional bank erosion and instability. Lastly, there is a significant erosion problem at the end of the articulated block section as shown in the second picture below.

Figure 1: Stream Blockage - Vegetation

- 4. Several downed trees appear to be accelerating bank erosion and in some cases they are blocking the channel. Trees should be trimmed and debris removed as needed. This can be accomplished by City staff or a private contractor. It is important that the crew performing this work understands basic stream dynamics. It is recommended that City maintenance staff attend a Stream Management Workshop to learn and hone their skills in effective stream debris cleaning activities.

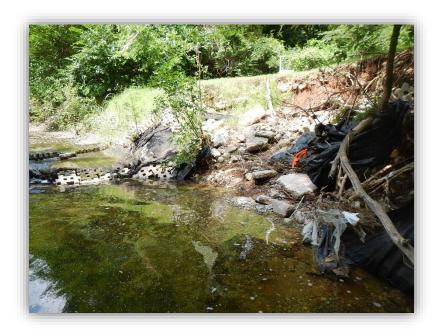
The team progressed upstream and observed 2 locations of unstable articulated block sections. One location has dislocated one of the concrete step crossings (near 1123 Whispering Pines Dr). These sections are not located within the extents of this study. These sections are currently being addressed as part of a design project from another engineering consultant.

Figure 2: Articulated Block Channel Failure

- 1. Inspect the articulated block section after significant rainfall events and make repairs as necessary. Through discussions with City staff it was agreed that the articulated block section was not part of this project's scope of work and would be addressed as part of a separate design project being performed by another engineering consultant.

- 2. There are several sections of articulated block failure that need immediate attention as the cost to repair will increase with additional damage. This is especially true where there is a failure at a section of stairs. Based on conversations with City staff it was agreed that this was not part of this project's scope of work and would be addressed as part of a separate design project being performed by another engineering consultant.

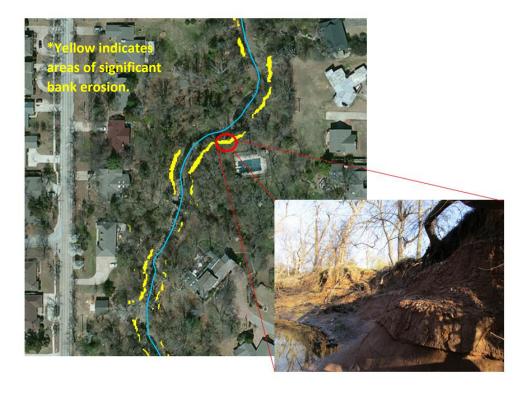
In addition to the field investigation Amec Foster Wheeler also performed a review of the topographic information to highlight potential problem areas. These areas were identified by developing slope grids of the available topography using GIS processes. Areas identified during the field investigation were used as reference points during the analysis. Multiple areas were flagged in which unstable vertical streambanks were present. The conceptual solutions developed as part of this project were then selected to address these locations. Figure 3 below depicts in yellow an example of some of the locations that were identified as problem areas in the analyses. The areas highlighted in yellow indicate locations in which excessive bank erosion and instability exist.

Figure 3: Example of Site Problem Area

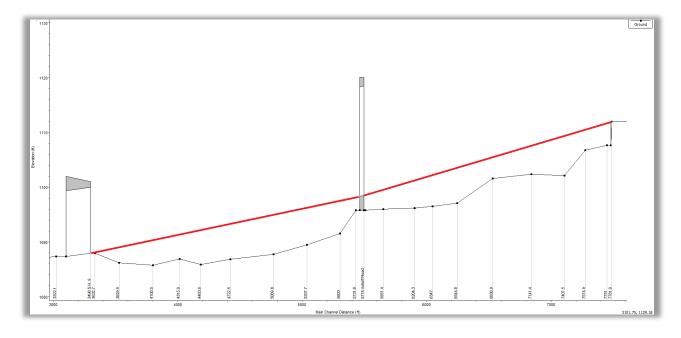
Finally during the field investigation it was noted that Imhoff Creek has likely down cut over time. As part of this study in channel field survey was collected and coupled with detailed LiDAR data of the channel surface. This combination of data was used to evaluate the channel profile. Figure 4 below illustrates the stream bed profile from SH-9 through Imhoff Road to the end of the improved articulated block wall using sample points of the channel survey and LiDAR data.

Figure 4: Stream Profile Summary

The red line shown in Figure 4 indicates the likely original stream profile. Using this profile a hydraulic model was used to estimate the possible 100-year water surface elevations prior to any stream down cutting and erosion.

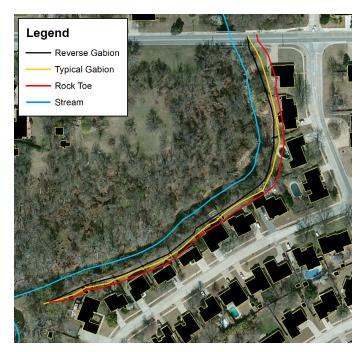
Figure 12: Estimated Impact Limits Downstream Imhoff Road

As indicated in Figure 12 above the potential impacts to existing infrastructure downstream of Imhoff Road is quite extensive. As indicated in Figure 13 there are isolated areas in which some improvement options may impact existing infrastructure. The primary impact of Option 4 would the removal of existing vegetation and some excavation of lawn area.

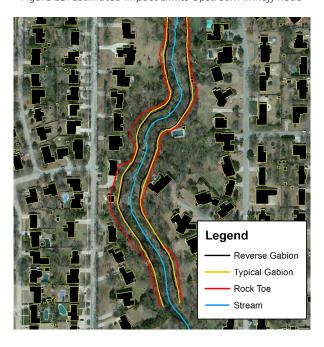
Figure 13: Estimated Impact Limits Upstream Imhoff Road

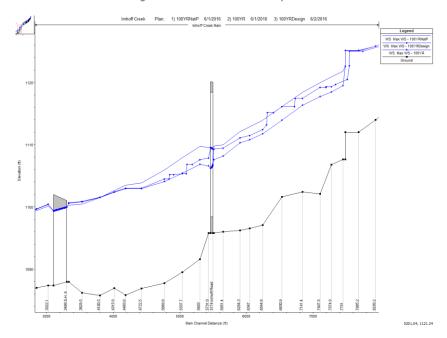
Figure 14: 100-Year WSEL Comparison

As indicated in Figure 14 above the proposed improvements are generally below those water surface elevations with the previous streambed slope. In addition the resulting change in water surface elevation also remains contained in the channel and therefore does not adversely impact any new properties or infrastructure. Figure 15 and Figure 16 below depict a comparison of the existing conditions 100-year floodplain with the 100-year floodplain as a result of the proposed improvements. As indicated the extent of the 100-year floodplain changes very little as a result of the proposed improvements.
