# LOWER IMHOFF CREEK HYDRAULIC & HYDROLOGIC STUDY PROJECT Norman, Oklahoma

**Prepared For:**  
City of Norman, Oklahoma

**Prepared By:**  
Meshek & Associates, LLC  
1437 S Boulder Ave, Suite 1550  
Tulsa, OK 74119  
&  
Amec Foster Wheeler  
245 N Waco Ave, Suite 110  
Wichita, KS 67202

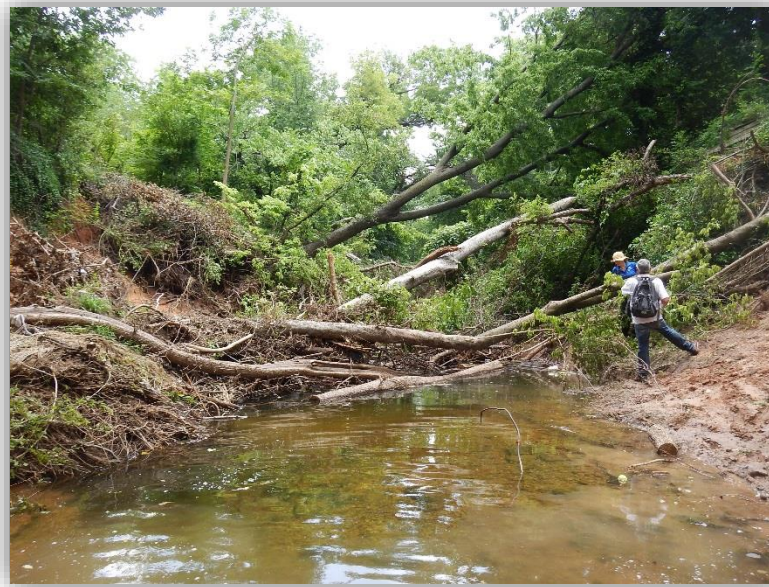
*Figure 1: Stream Blockage - Vegetation*

Approximately 100 feet downstream of the pedestrian bridge crossing, there is a tree across the channel causing significant erosion. There are others upstream of this area as shown in the Figure 1 and Figure 2 on the next page. Bank erosion on the right descending bank is threatening the pedestrian bridge abutment. Upstream of the bridge the channel slope increased and additional accumulation of both gravel and large non-native stone was observed. Filter fabric and remnants of riprap on the channel banks from this area upstream to the articulated block section were observed. At this time, it is unknown whether the material was carried downstream after a failure at the end of the articulated block section or was part of a separate riprap channel improvement. In some areas, the channel is significantly clogged with this material which is causing erosion along the toe of the banks. There are additional downed trees through this segment which is contributing to additional bank erosion and instability. Lastly, there is a significant erosion problem at the end of the articulated block section as shown in the second picture below.

4. Several downed trees appear to be accelerating bank erosion and in some cases they are blocking the channel. Trees should be trimmed and debris removed as needed. This can be accomplished by City staff or a private contractor. It is important that the crew performing this work understands basic stream dynamics. It is recommended that City maintenance staff attend a Stream Management Workshop to learn and hone their skills in effective stream debris cleaning activities.

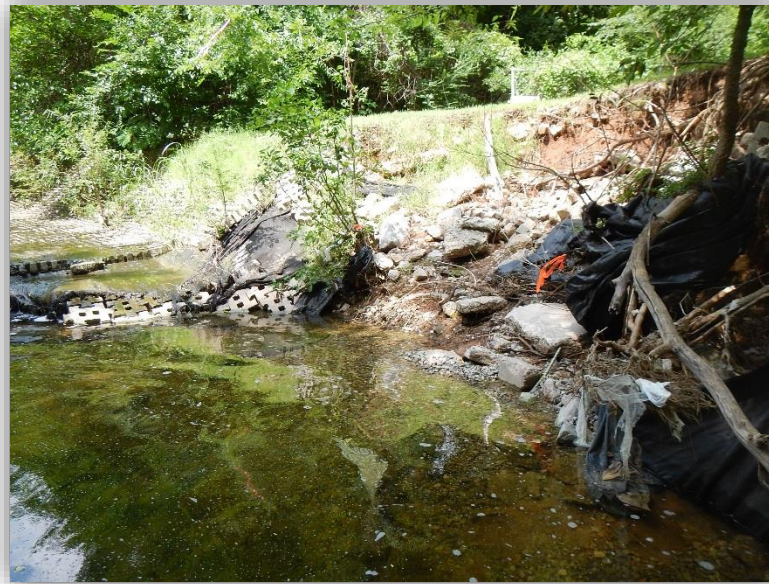
Figure 2: Articulated Block Channel Failure

The team progressed upstream and observed 2 locations of unstable articulated block sections. One location has dislocated one of the concrete step crossings (near 1123 Whispering Pines Dr). These sections are not located within the extents of this study. These sections are currently being addressed as part of a design project from another engineering consultant.

1. Inspect the articulated block section after significant rainfall events and make repairs as necessary. Through discussions with City staff it was agreed that the articulated block section was not part of this project’s scope of work and would be addressed as part of a separate design project being performed by another engineering consultant.

2. There are several sections of articulated block failure that need immediate attention as the cost to repair will increase with additional damage. This is especially true where there is a failure at a section of stairs. Based on conversations with City staff it was agreed that this was not part of this project’s scope of work and would be addressed as part of a separate design project being performed by another engineering consultant.

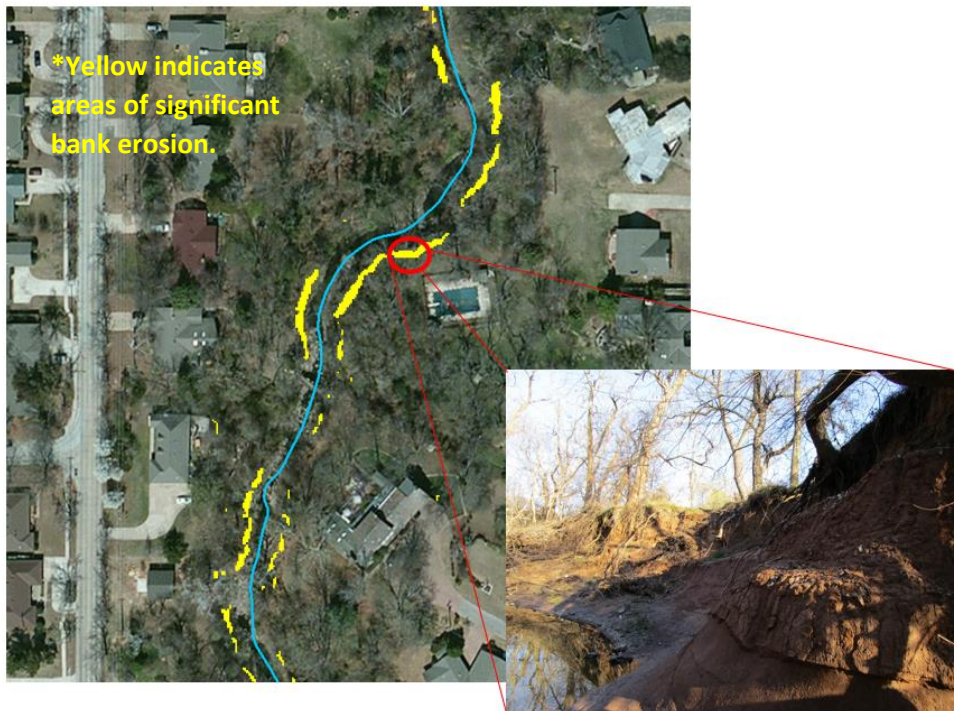
*Figure 3: Example of Site Problem Area*

In addition to the field investigation Amec Foster Wheeler also performed a review of the topographic information to highlight potential problem areas. These areas were identified by developing slope grids of the available topography using GIS processes. Areas identified during the field investigation were used as reference points during the analysis. Multiple areas were flagged in which unstable vertical streambanks were present. The conceptual solutions developed as part of this project were then selected to address these locations. Figure 3 below depicts in yellow an example of some of the locations that were identified as problem areas in the analyses. The areas highlighted in yellow indicate locations in which excessive bank erosion and instability exist.

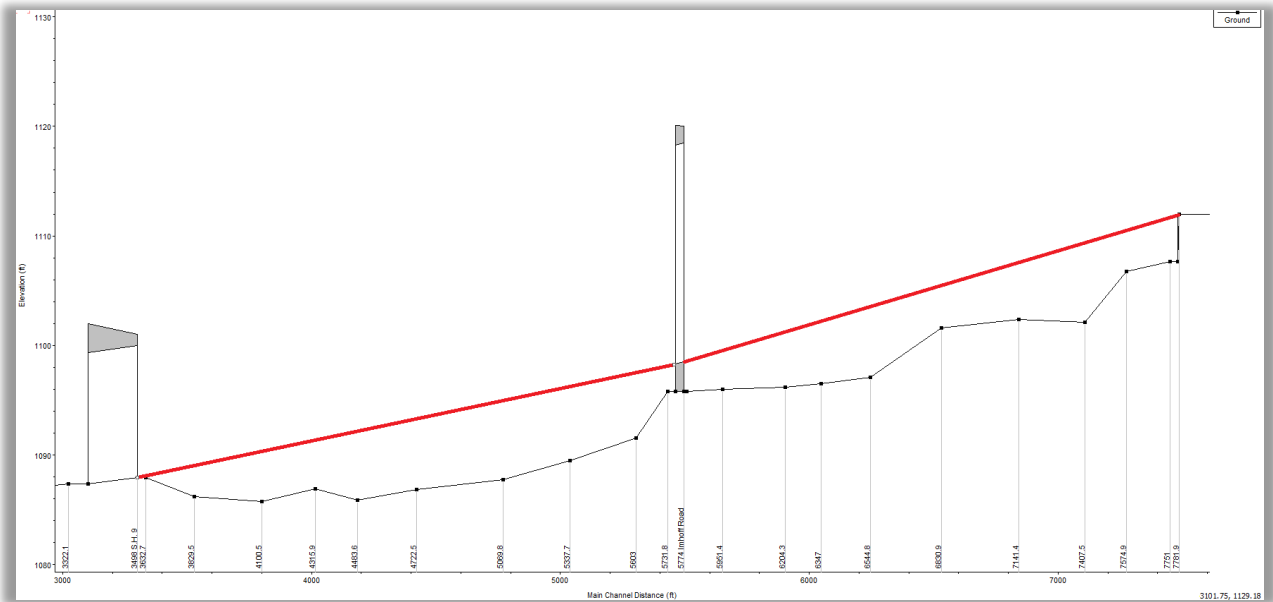
Figure 4: Stream Profile Summary

Finally during the field investigation it was noted that Imhoff Creek has likely down cut over time. As part of this study in channel field survey was collected and coupled with detailed LiDAR data of the channel surface. This combination of data was used to evaluate the channel profile. Figure 4 below illustrates the stream bed profile from SH-9 through Imhoff Road to the end of the improved articulated block wall using sample points of the channel survey and LiDAR data.

The red line shown in Figure 4 indicates the likely original stream profile. Using this profile a hydraulic model was used to estimate the possible 100-year water surface elevations prior to any stream down cutting and erosion.

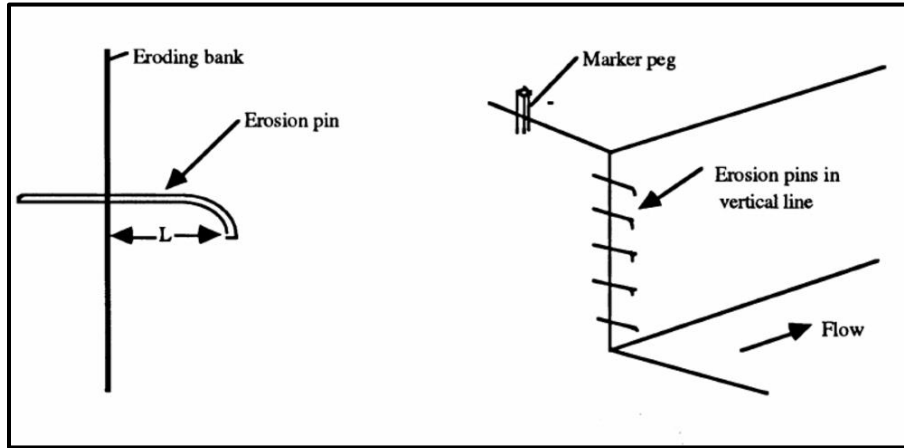
Figure 9: Horizontal Monitoring Method

Among the many monitoring methods two distinct methods are relatively cost effective and would require minimal effort. The first method would be to monitor the horizontal movement of the stream bank by driving rebar horizontally into the stream bank at varying depths. Personnel would document the exposed amount of rebar to quantify the movement of the soil erosion and determine a rate of loss. Figure 9 below provides a visual representation of this method.

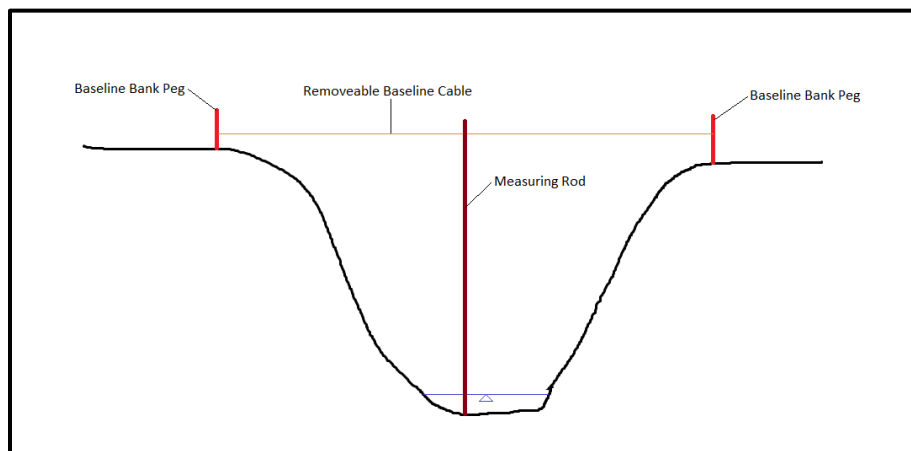
Figure 10: Vertical Monitoring Method

The second method would be to monitor the vertical movement of the streambed by establishing a baseline benchmark by extending a horizontal line across the top of bank from established points. Then personnel would use a rod to measure the depth from the baseline benchmark to the bottom of the stream bed. As erosion occurs overtime the depth would increase from the baseline thus providing the means to establish a rate of vertical loss. Figure 10 provides a visual representation of this method.

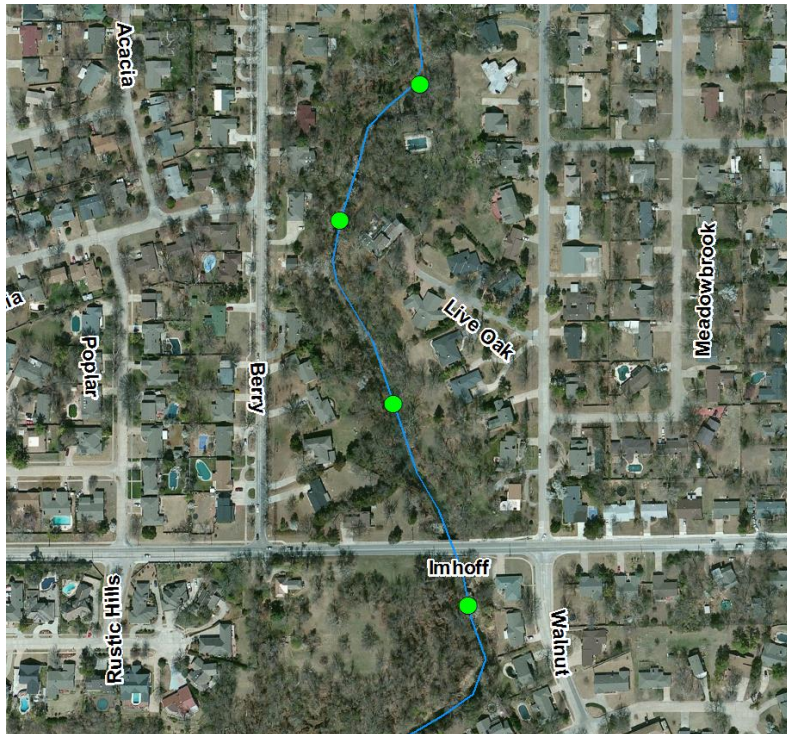
*Figure 11: Potential Monitoring Locations*

Based on field investigations the design team recommends that a minimum of four (4) monitoring locations be established to quantify the rate of loss and evaluate the performance of potential mitigation actions. The locations shown as green points in Figure 11 below have historically been subject to adverse erosive impacts. These locations provide a suitable opportunity for monitoring actions. These areas are located adjacent to or are on private property therefore monitoring activities will require some communication with the property land owners.

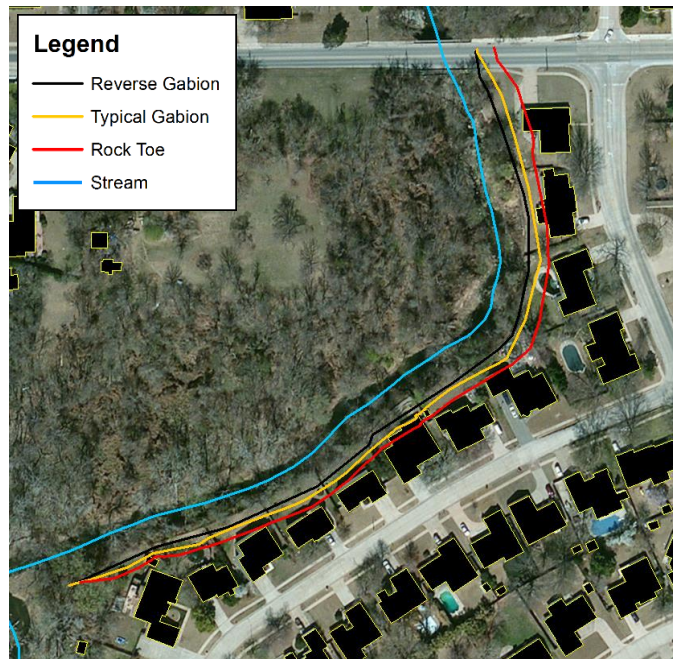
*Figure 12: Estimated Impact Limits Downstream Imhoff Road*

As part of this study, initial recommendations have been made regarding the placement of particular improvement options. These recommendations were determined by using engineering judgement of the constructability of the proposed improvements in combination with the proximity of existing infrastructure to the improvement location. To proceed, it is recommended that public meetings be held to further refine the location and placement of proposed improvements. Where possible it is desired to use Option 4 (the rock toe design) as it provides the most natural improvement and would greatly reduce the cost of the improvements. The challenge with Option 4 is that in locations with vertical banks the toe would be maintained and protected with rock but the slope would be laid back, ideally at a 2H:1V slope. This excavation would remove existing vegetation and impact existing property quite significantly. As an alternative vertical structures can be used thus removing a smaller extent of the vegetation and existing property; however, these vertical structures are more costly. The design team developed initial estimates of the extent of construction impacts using Option 1 (Reverse Gabion), Option 2 (Reverse Gabion Partial Height), Option 3 (Typical Gabion Partial Height), and Option 4 (Rock Toe). The actual area of impact would vary based on the design at the time of construction but these estimates provide the means to understand what would likely be impacted based on the improvements and highlighted the most appropriate recommendation for each area. To visualize these improvements, limits have been developed to aid in alternative selection. Figure 12 depicts estimated impact limits downstream of Imhoff Road. Figure 13 shows the estimated impact limits upstream of Imhoff Road.

As indicated in Figure 12 above the potential impacts to existing infrastructure downstream of Imhoff Road is quite extensive. As indicated in Figure 13 there are isolated areas in which some improvement options may impact existing infrastructure. The primary impact of Option 4 would be the removal of existing vegetation and some excavation of lawn area.

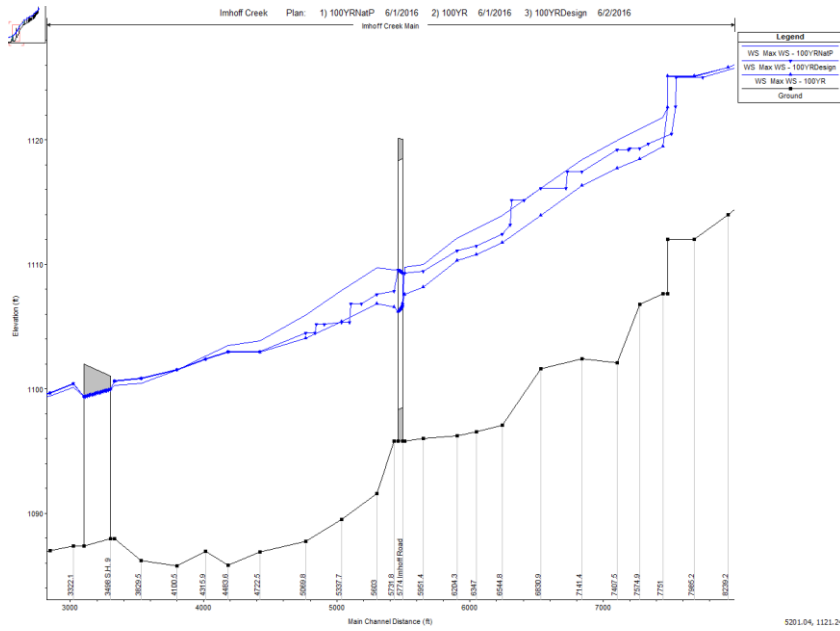
Figure 14: 100-Year WSEL Comparison

The existing conditions HEC-RAS model was modified to develop an upper limit scenario. A copy of the existing conditions geometry was modified by increasing the level of the streambed to those that would have likely been present prior to channel bed movement. The resulting water surface elevations were

then plotted. Figure 14 below illustrates comparison of the existing conditions, proposed improvement, and probably natural bed resulting 100-year water surface elevations.

As indicated in Figure 14 above the proposed improvements are generally below those water surface elevations with the previous streambed slope. In addition the resulting change in water surface elevation also remains contained in the channel and therefore does not adversely impact any new properties or infrastructure. Figure 15 and Figure 16 below depict a comparison of the existing conditions 100-year floodplain with the 100-year floodplain as a result of the proposed improvements. As indicated the extent of the 100-year floodplain changes very little as a result of the proposed improvements.

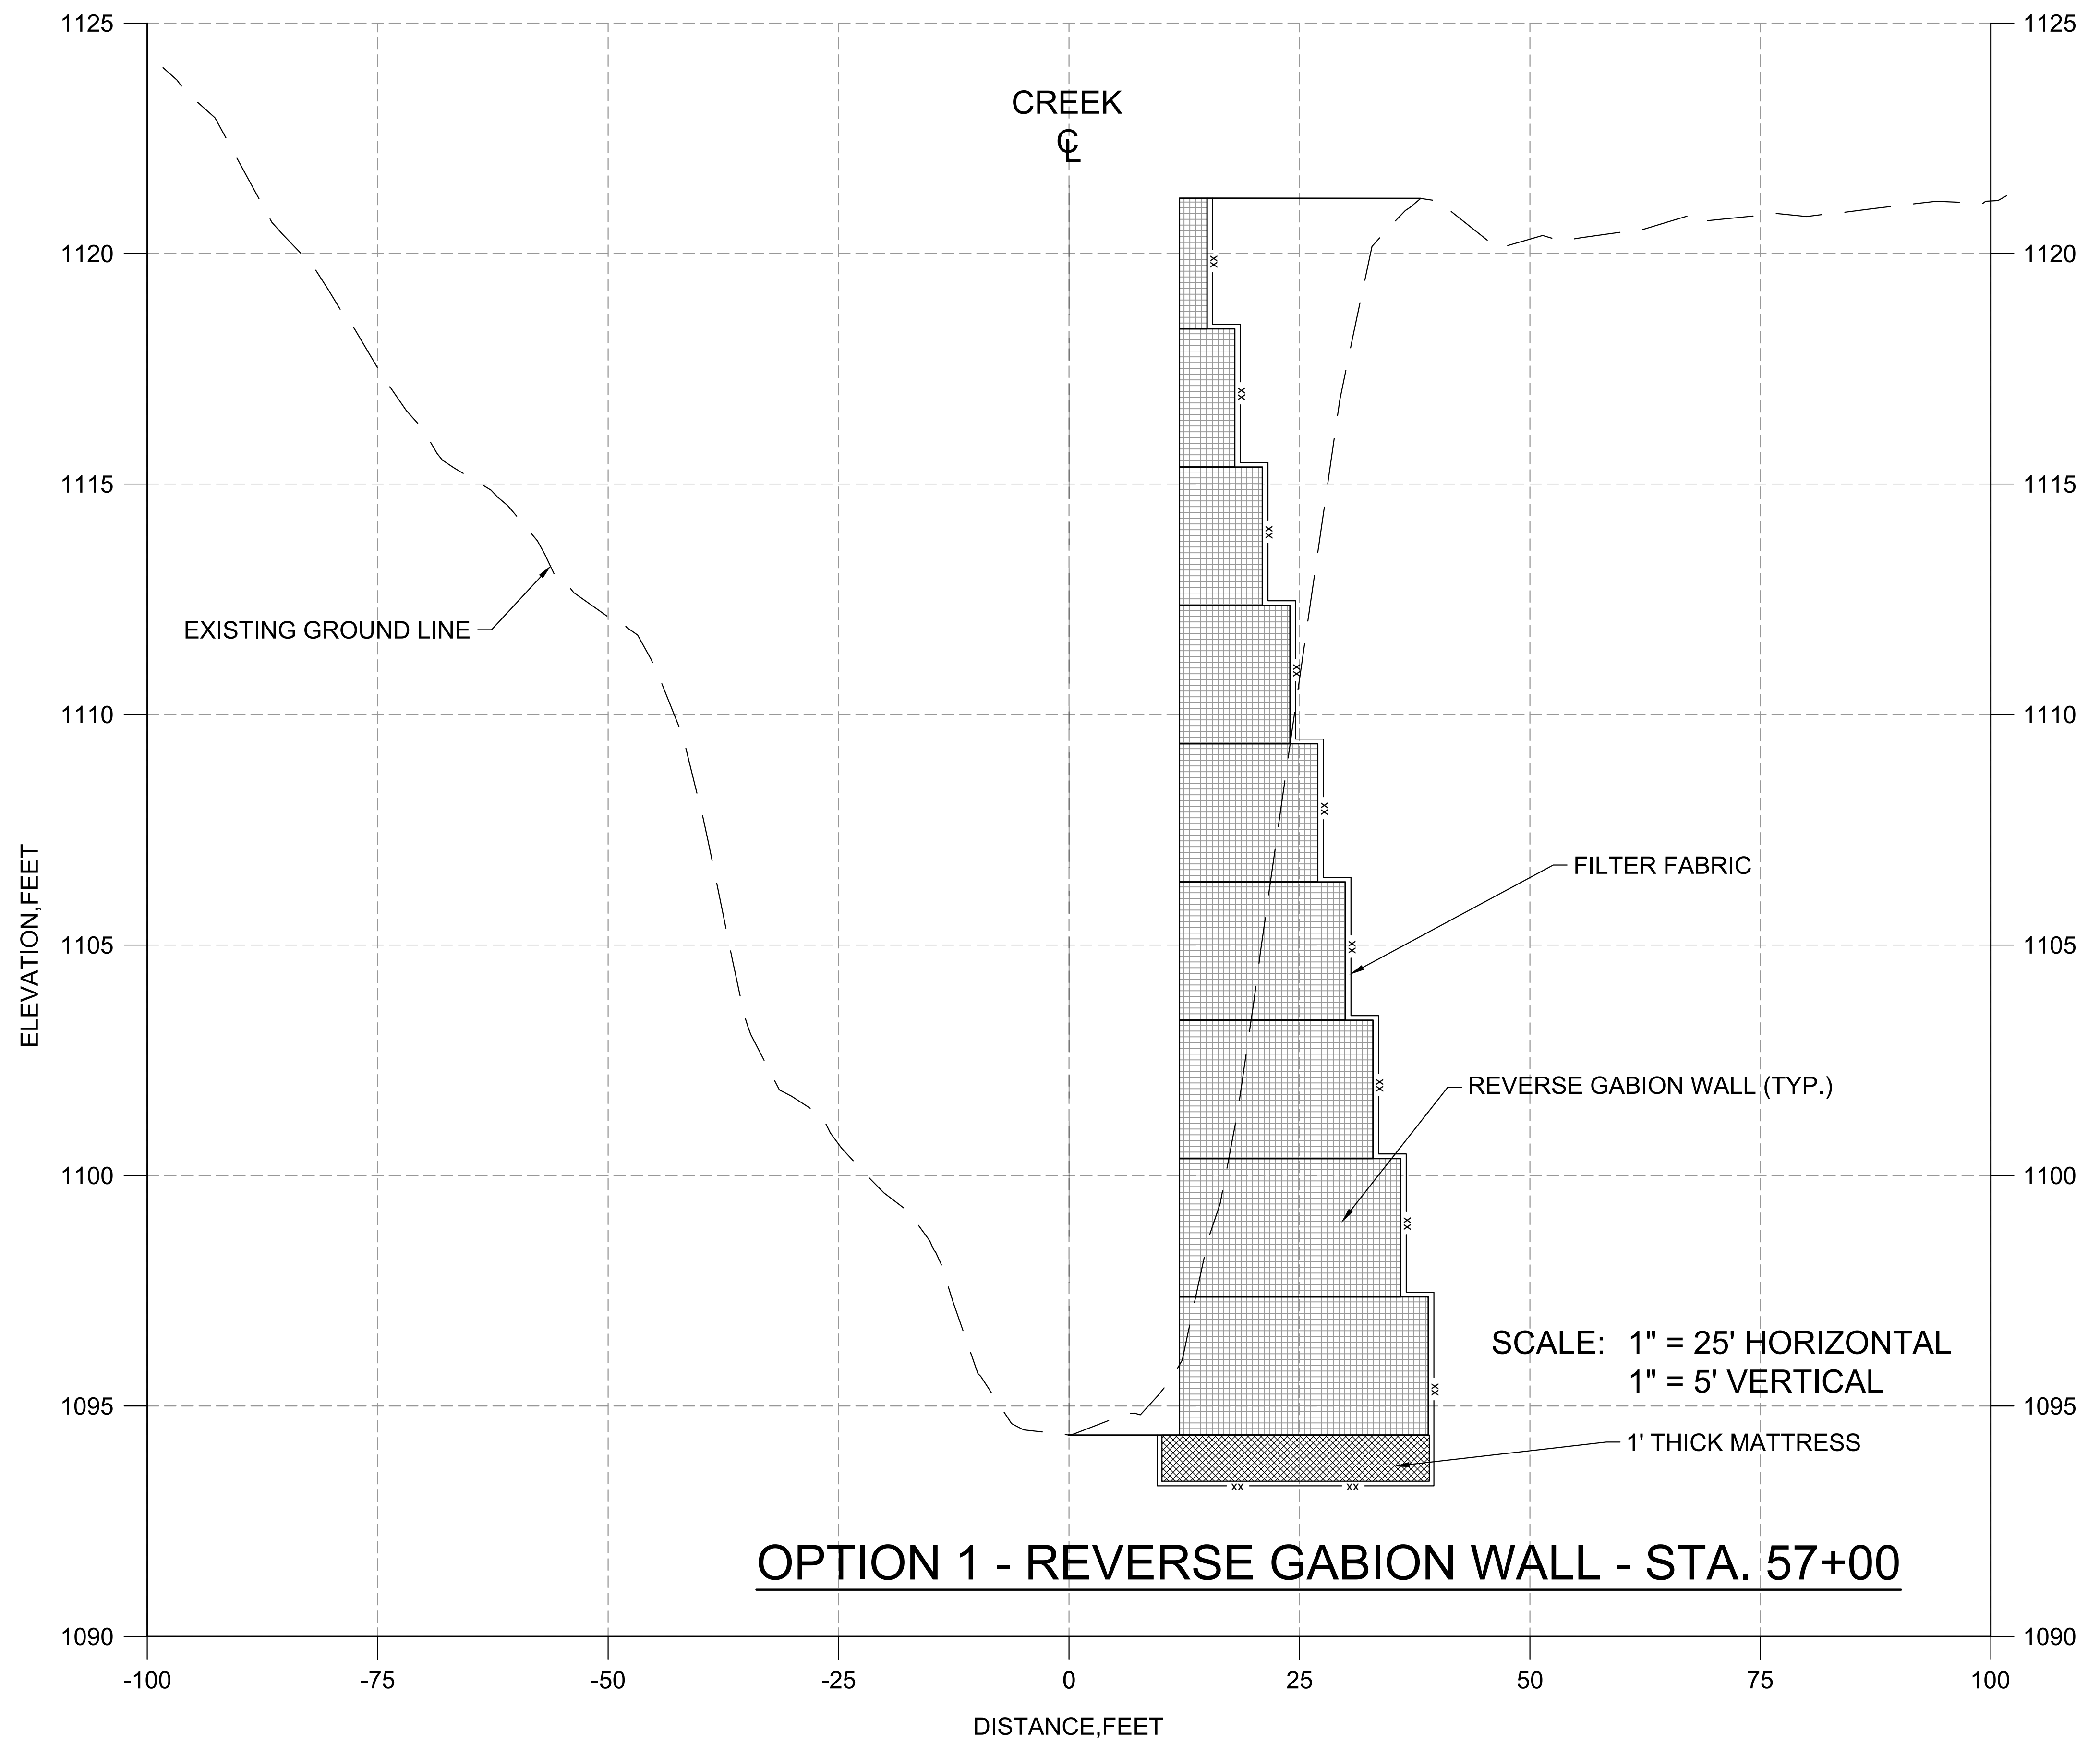
IMHOFF CREEK  
OPTION 1 - TYPICAL SECTION

**OPTION 1 - REVERSE GABION WALL - STA. 57+00**

Options 1 – 3 represent various versions of a gabion wall. The design team utilized gabion wall design documentation published by Environmesh Volume 3 Designing with Gabions & Mattresses, 2007 and Modular Gabion Systems, Division of C.E. Shepherd Company, Gabion Walls Design, 2004. These documents provide recommended design calculations and specifications which was used as the basis of these conceptual improvements and develop cost estimates. In locations in which the proximity of existing infrastructure dictates smaller construction limits it may be necessary to utilize a vertical structure. One of the benefits of gabion rock structures is that they can maintain stability while molding to limited material movement. In addition, gabion structures tend to collect material within the rock structure which can often lead to establishment of some vegetative growth over time, further strengthening the structure and providing a natural look in situations that require vertical stability.

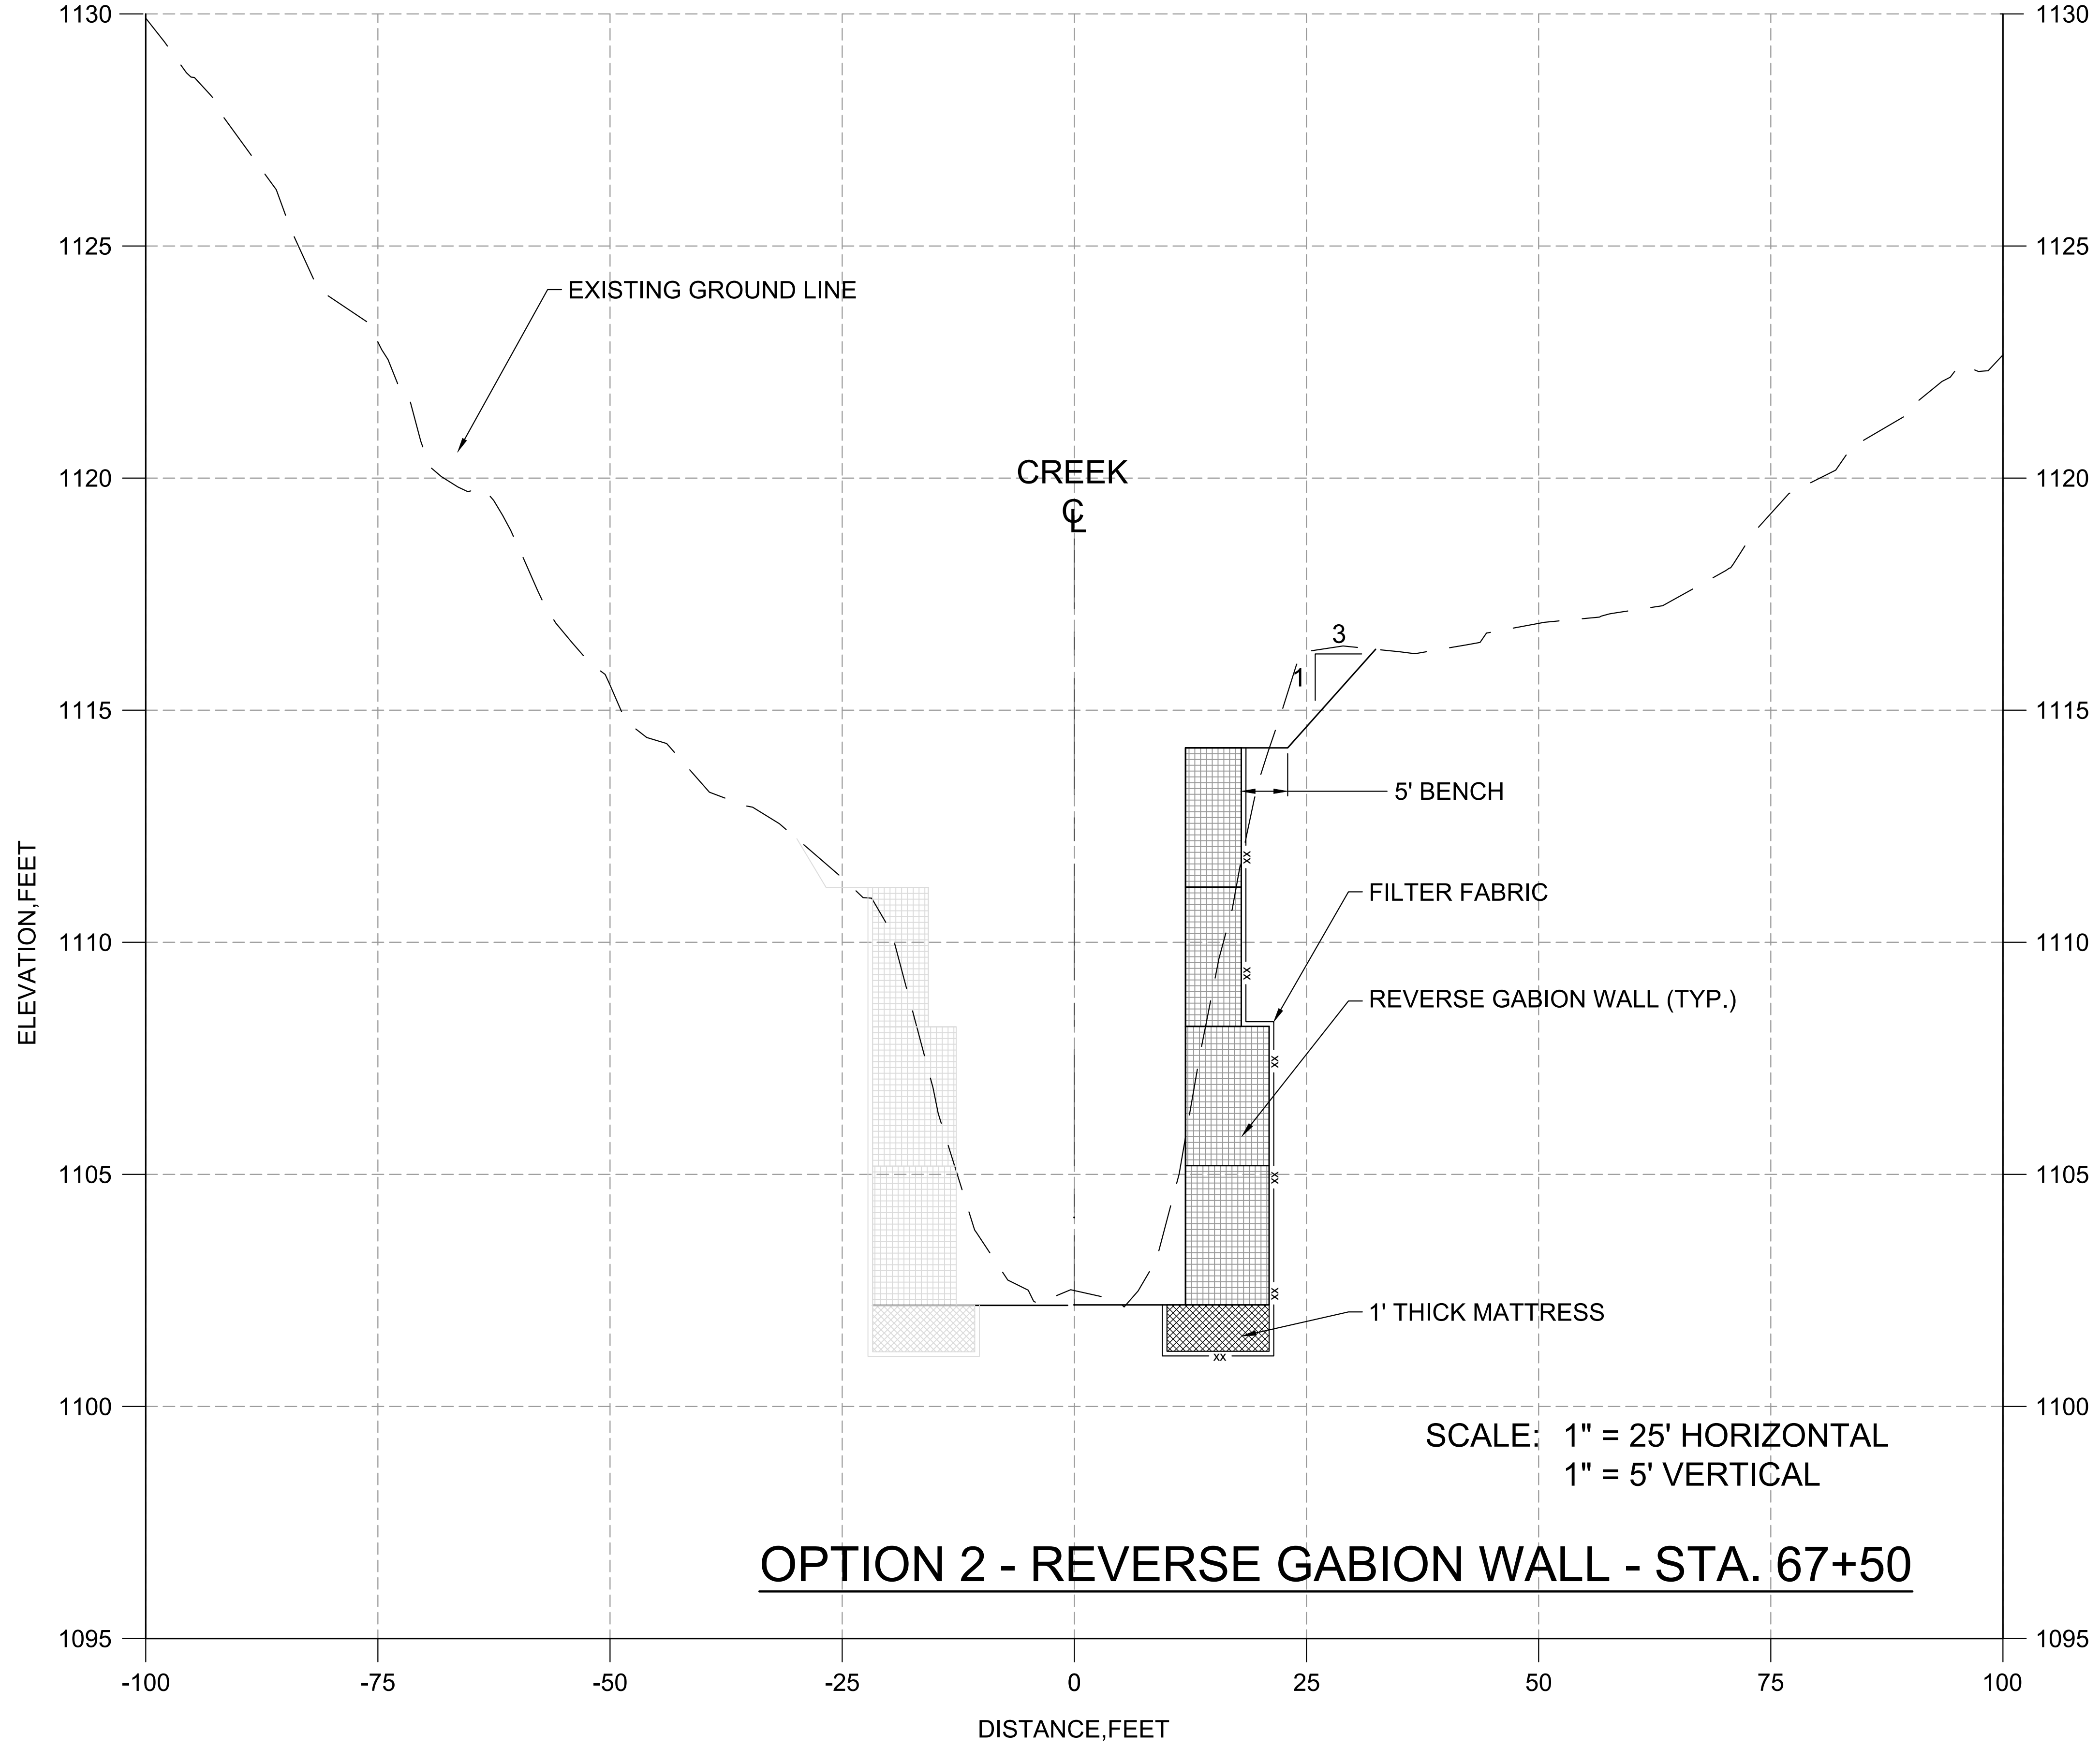
IMHOFF CREEK  
 OPTION 2 - TYPICAL SECTION

**OPTION 2 - REVERSE GABION WALL - STA. 67+50**

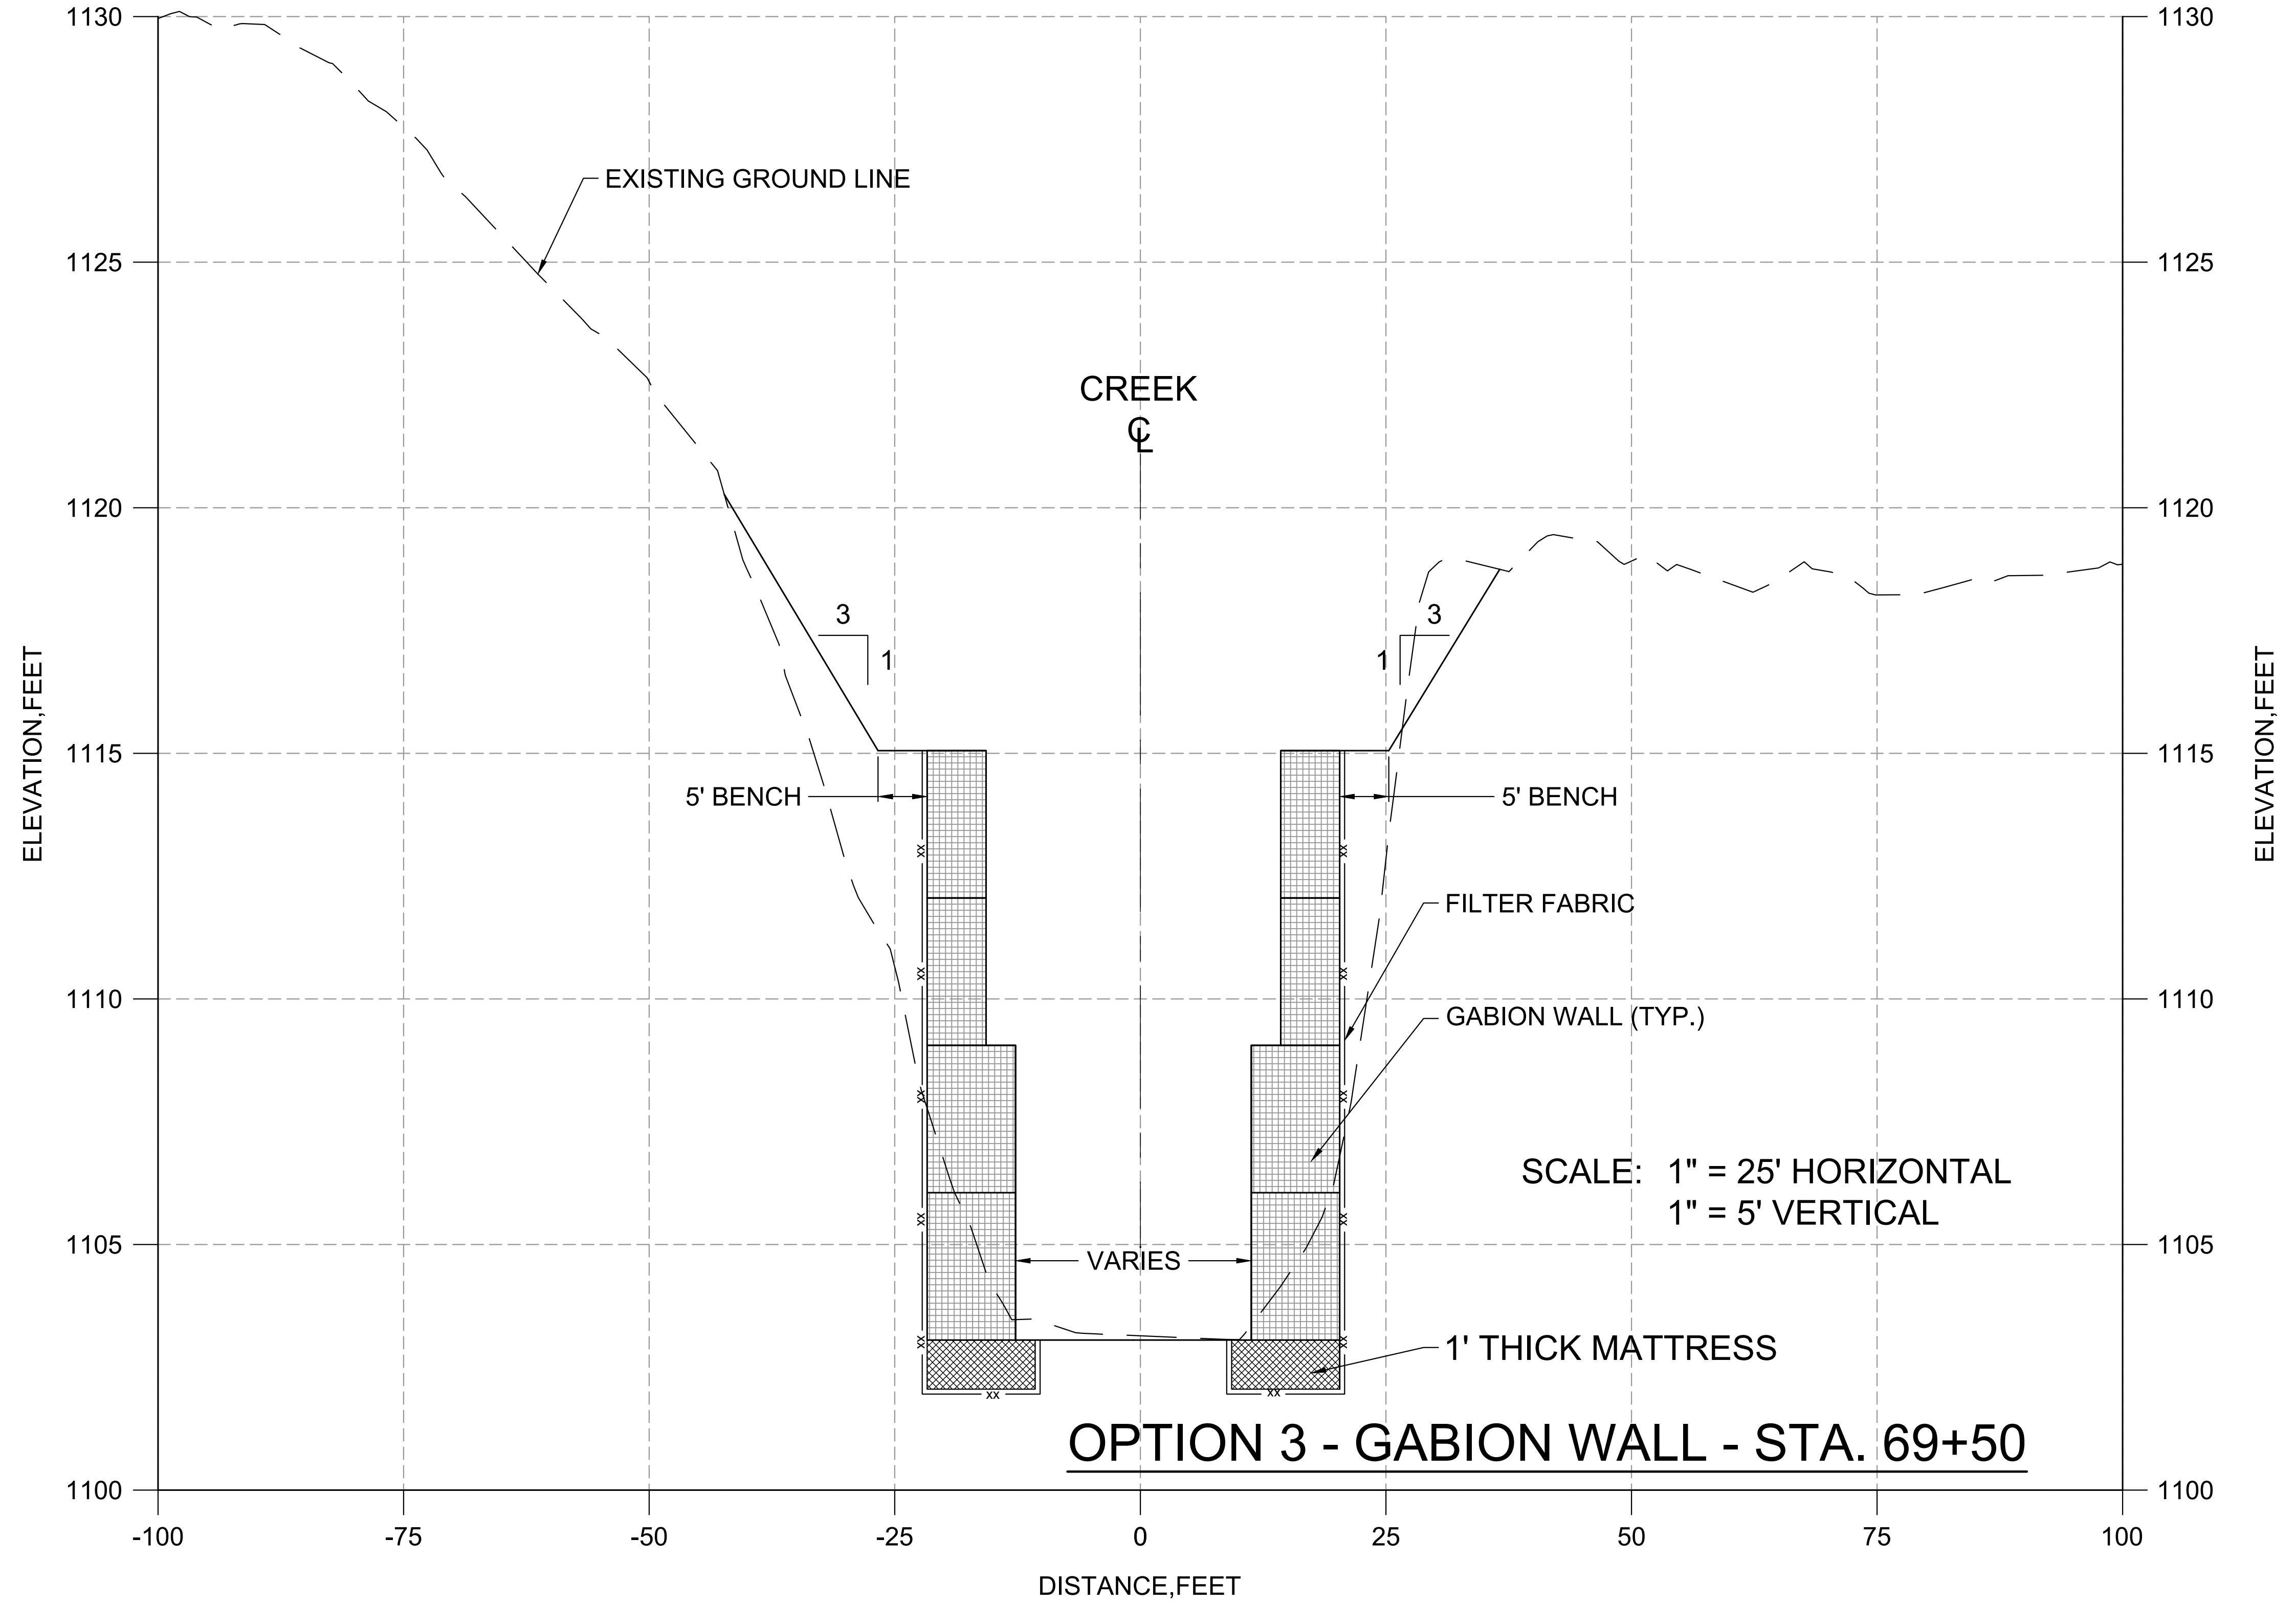
IMHOFF CREEK  
OPTION 3 - TYPICAL SECTION

**OPTION 3 - GABION WALL - STA. 69+50**
