# LOWER IMHOFF CREEK HYDRAULIC & HYDROLOGIC STUDY PROJECT Norman, Oklahoma

**Prepared For:**  
City of Norman, Oklahoma

**Prepared By:**  
Meshek & Associates, LLC  
1437 S Boulder Ave, Suite 1550  
Tulsa, OK 74119  
&  
Amec Foster Wheeler  
245 N Waco Ave, Suite 110  
Wichita, KS 67202

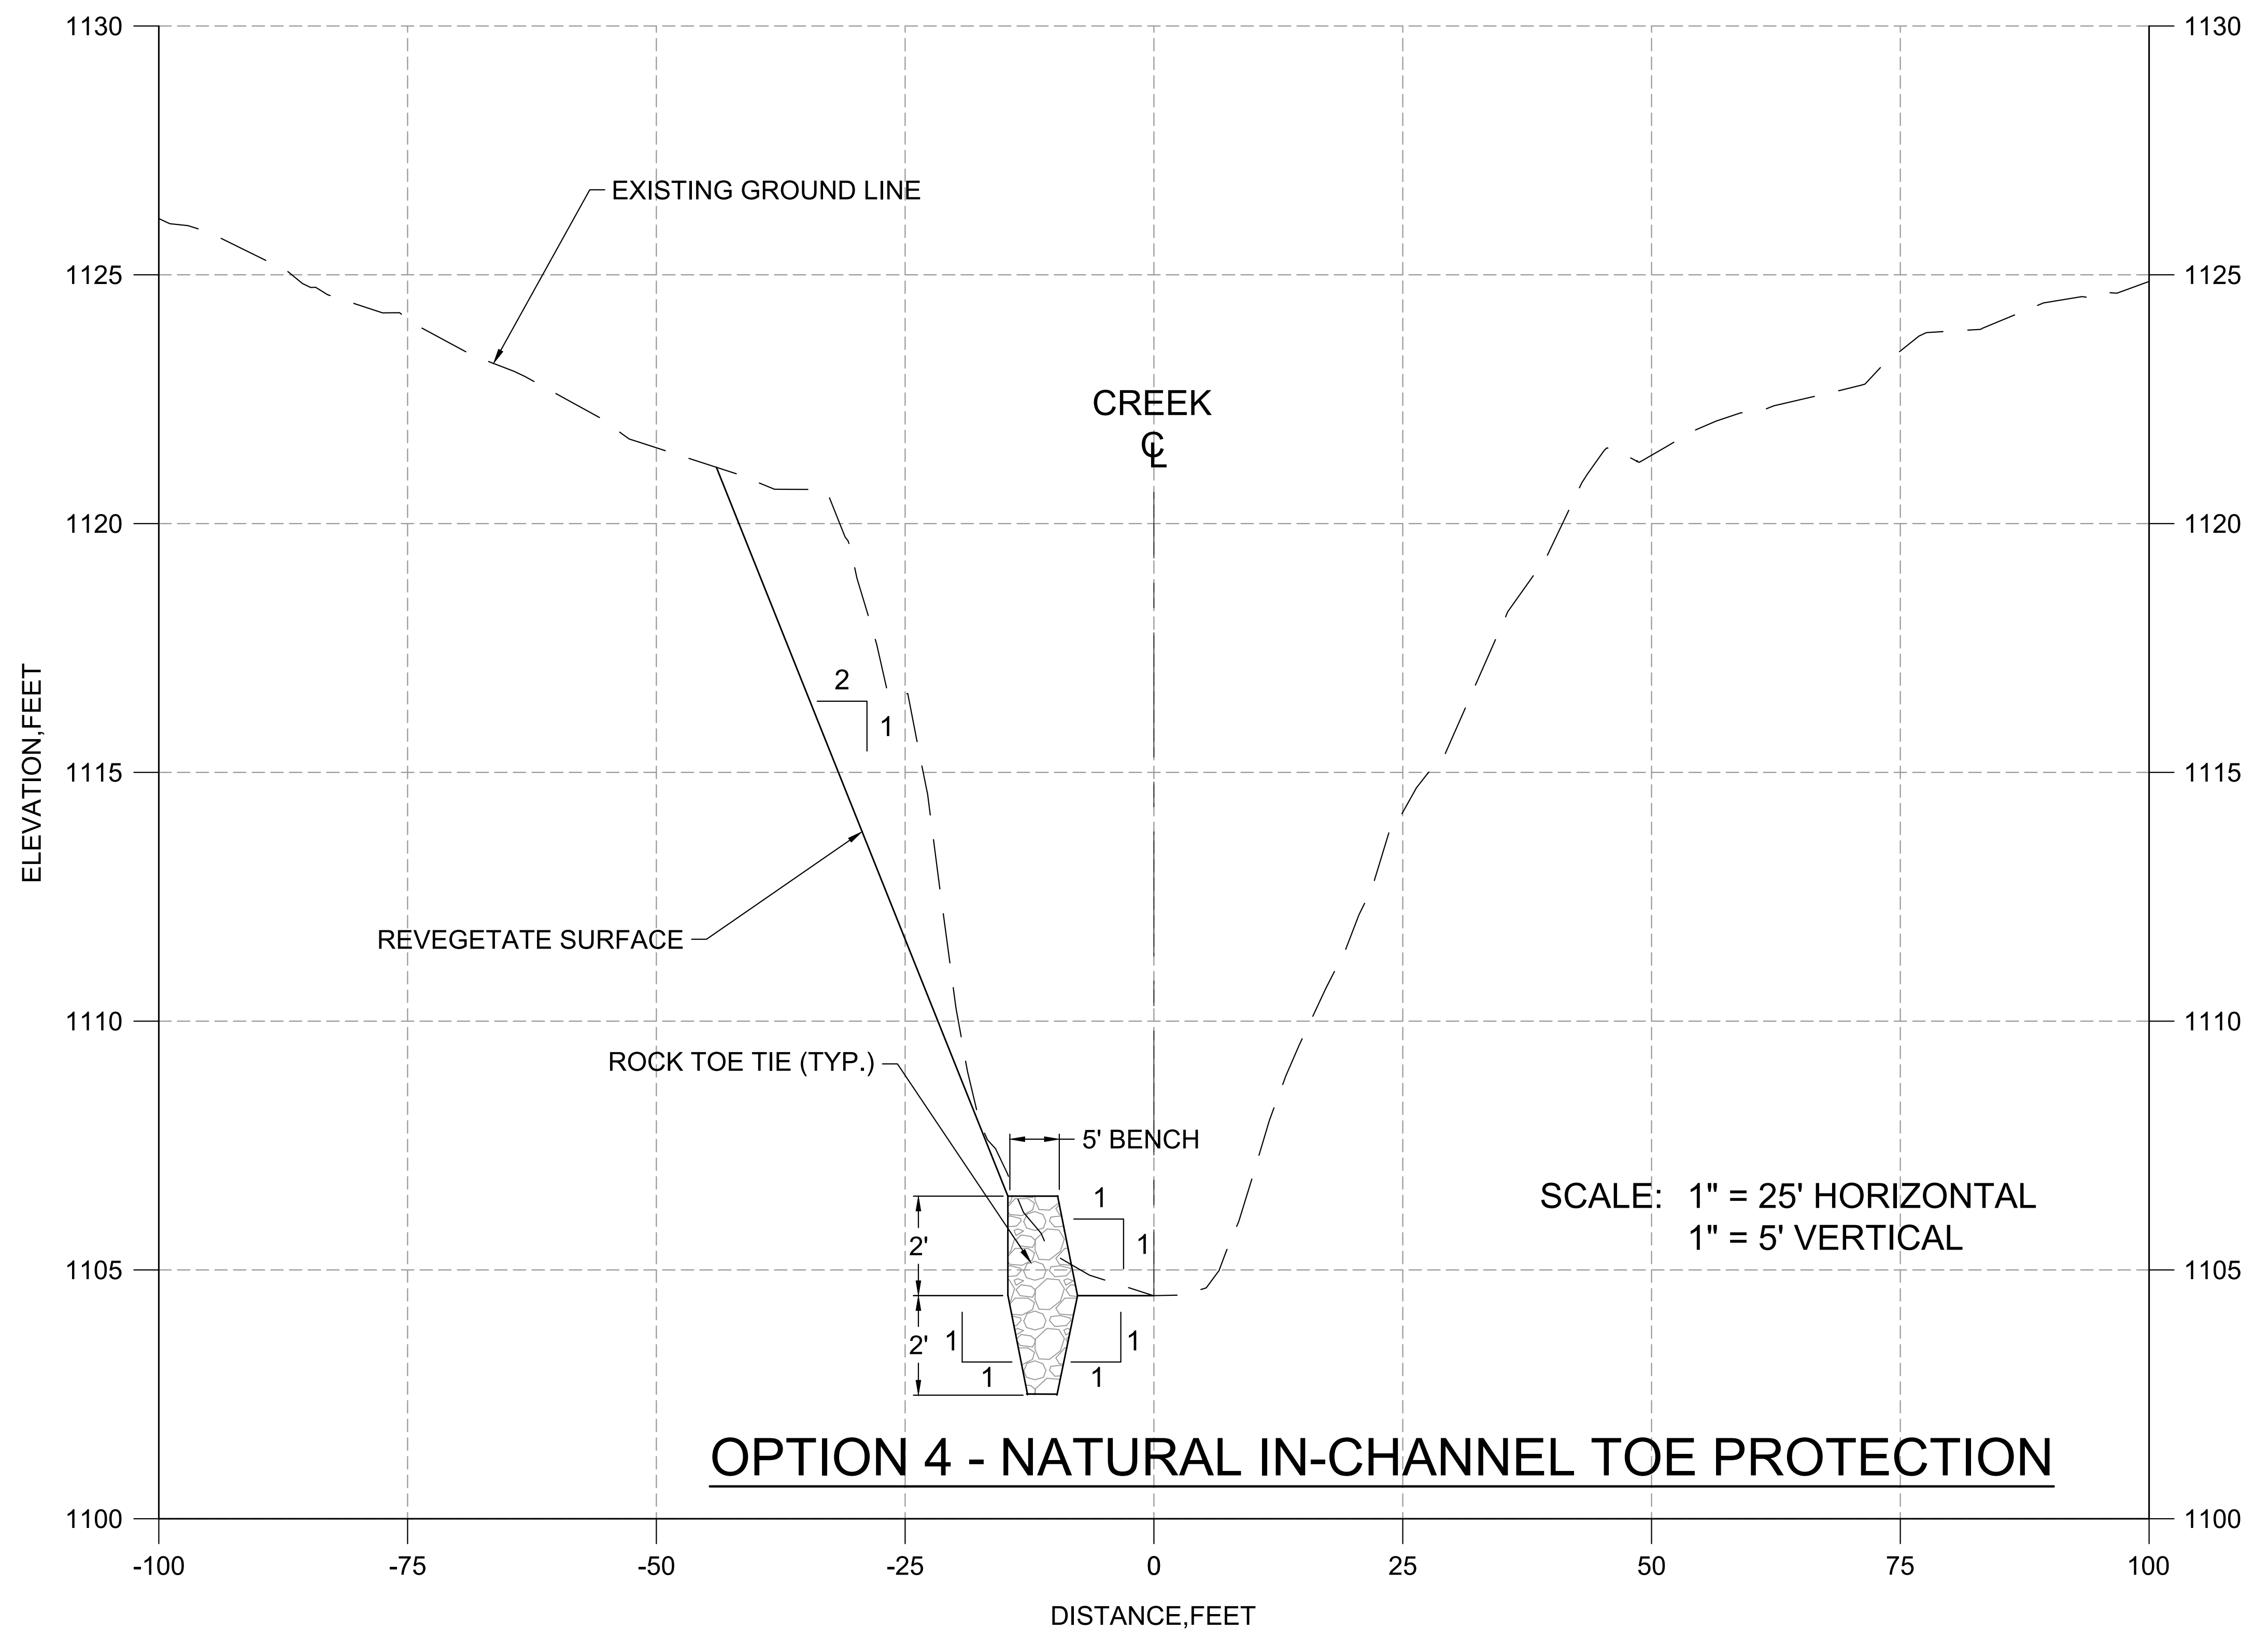
SHEET IDENTIFICATION  
**6**  
SHEET 6 OF 8

**OPTION 4 - NATURAL IN-CHANNEL TOE PROTECTION**

Option 4, the simplest and most natural solution, is to protect the toe and then tie a moderate slope back to natural grade. Rock would be placed at the existing toe and if necessary the bank would be tied back at around a 2:1 slope or to a point in which a stable vegetative foundation can be established. Based on the hydraulic analyses channel velocities exceed 10 feet per second and approach 15 feet per second in some reaches. Using the FHWA Hydraulic Engineering Circular No. 15 permissible shear stress calculations indicate the need of riprap with a mean size of 1.0 to 1.5 feet using a Safety Factor of 2.0. The rock toe would prevent undermining of the material above during low flows while the vegetative sloped surface would provide protection from moderate flows. The downside to Option 4 is that it can tend to require greater construction easements for excavating the slope back which may be prohibitive in certain locations given the proximity of existing structures to the vertical bank particularly in the left stream bank (looking downstream) downstream of Imhoff Road. The vertical left bank downstream of Imhoff Road in some locations is within 20 feet of existing infrastructure. If slope excavation is required, the other downside to Option 4 would be the loss of property “lawns” and existing vegetation. It provides the most natural look but if maintaining lawn area is the priority then alternative options may be considered.

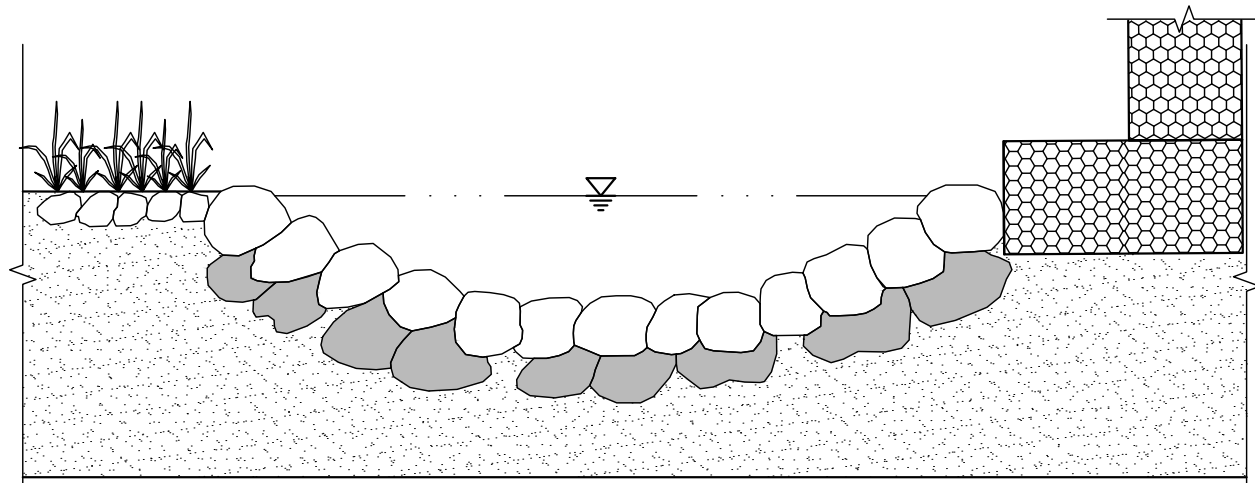
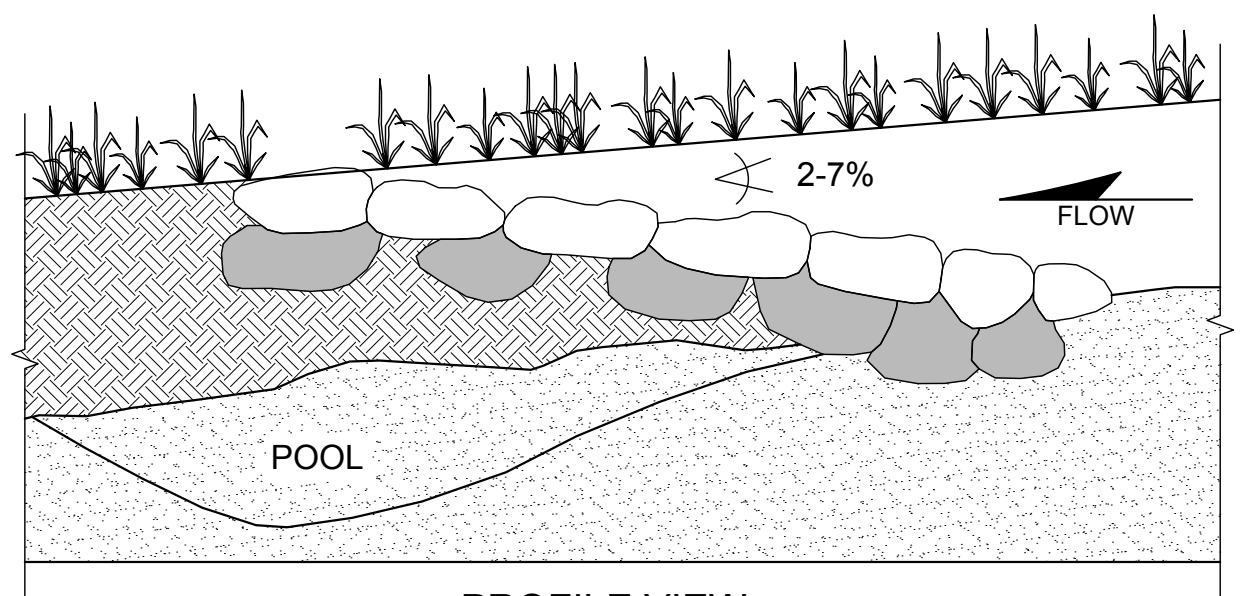
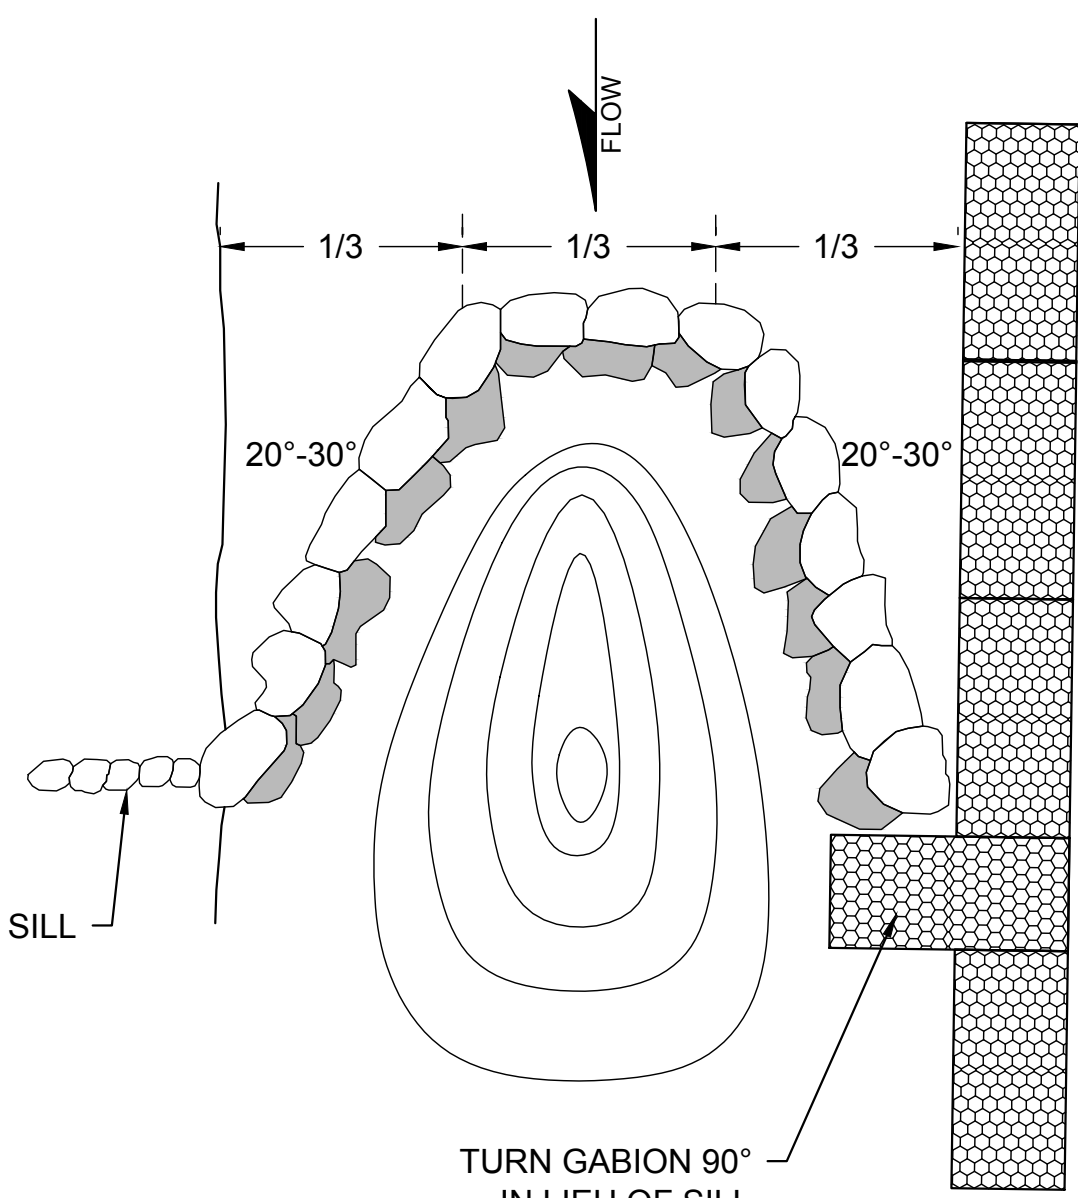
1 CROSS-VANE DETAIL NOT TO SCALE

CROSS SECTION VIEW

PROFILE VIEW

TURN GABION 90° IN LIEU OF SILL

PLAN VIEW
