CITY OF NORMAN

Lower Imhoff Creek Study

Presented By: Carrie Evenson, City Stormwater Program Manager
Brandon Claborn, Principal Engineer, Meshek & Associates

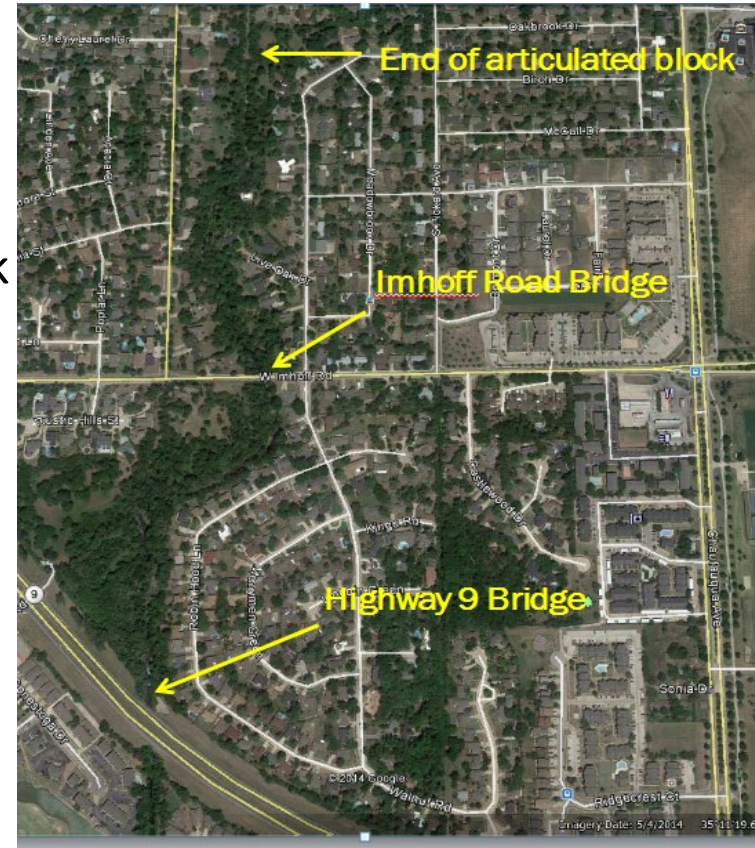
Exhibit 6-7a

- SWMP identified problem in 2009 as:
 - 4,200 LF of severe bank erosion along both banks
 - Led to trees and fences falling into creek
- Listed as IC-2
 - Watershed priority ranking: 2
 - Overall City priority ranking: 5
 - SWMP Cost: \$6,563,091
- Solution: Prevent further erosion and loss of property by stabilizing streambanks upstream of Hwy 9

Baseline Floodplain and Recommended Solutions Overview Imhoff Creek

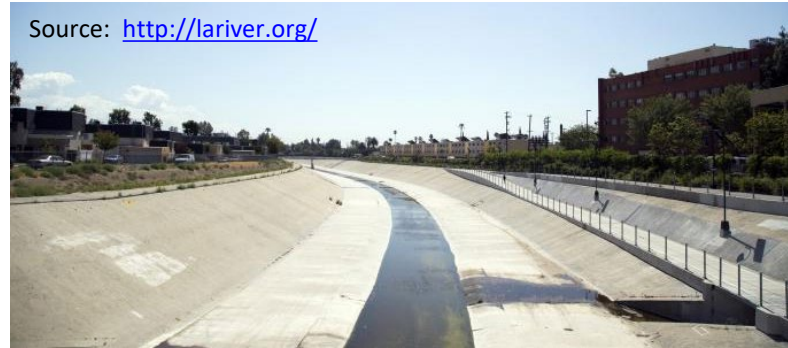
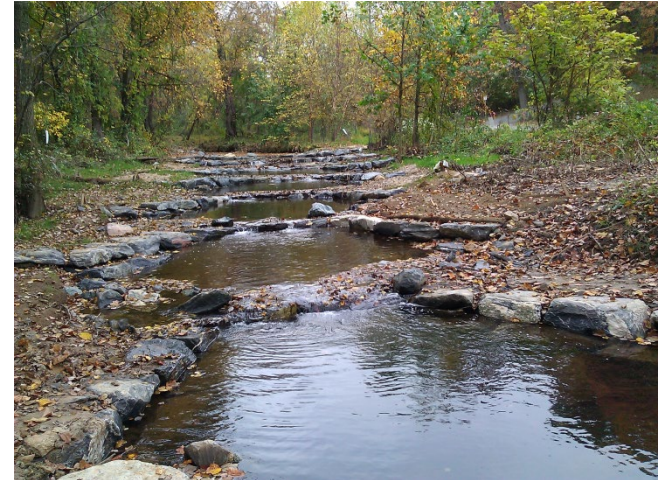
- How do we stabilize streambanks?
 - Traditional approach: Hard armoring of channel
 - Pros: Protects property, Addresses immediate erosion problem
 - Cons: Increases velocity, Makes downstream erosion worse, Reduces natural stream functions
 - Alternative approach: Natural stream restoration techniques
 - Pros: Protects property, Restores or maintains natural stream functions
 - Cons: Can't be used in all stream conditions

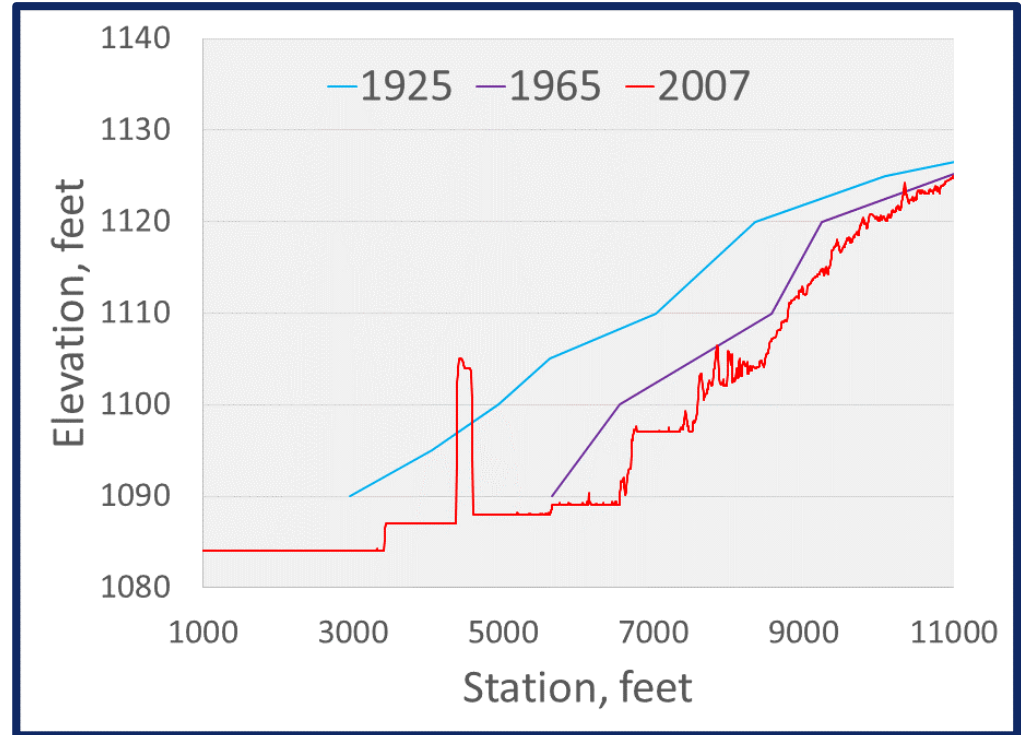
Imhoff Creek Historical Flow Line

- Channel flow line has dropped over time

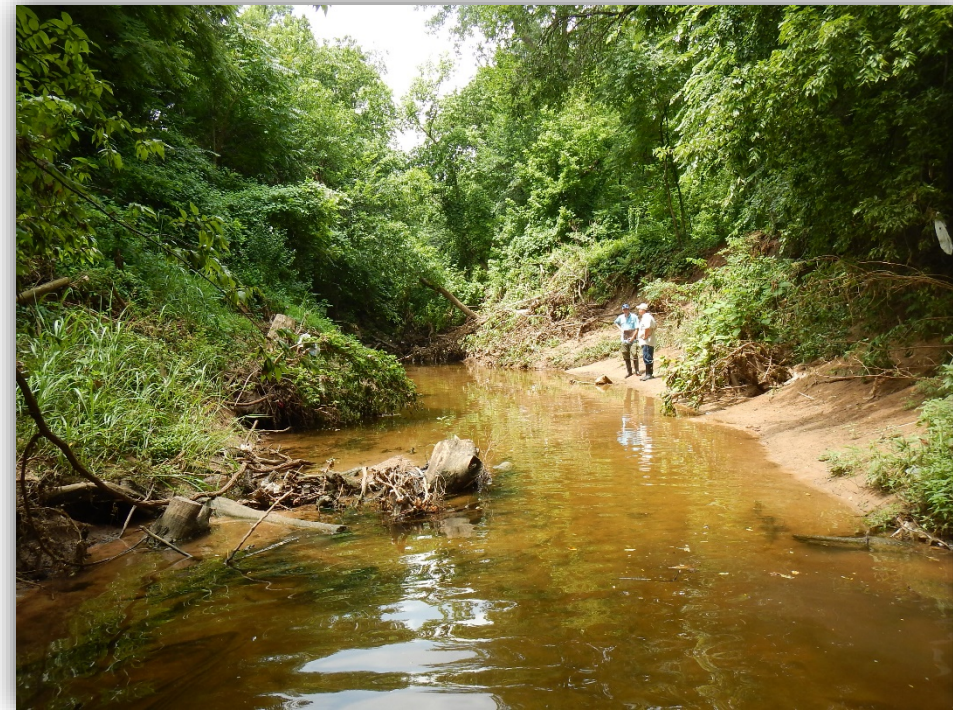
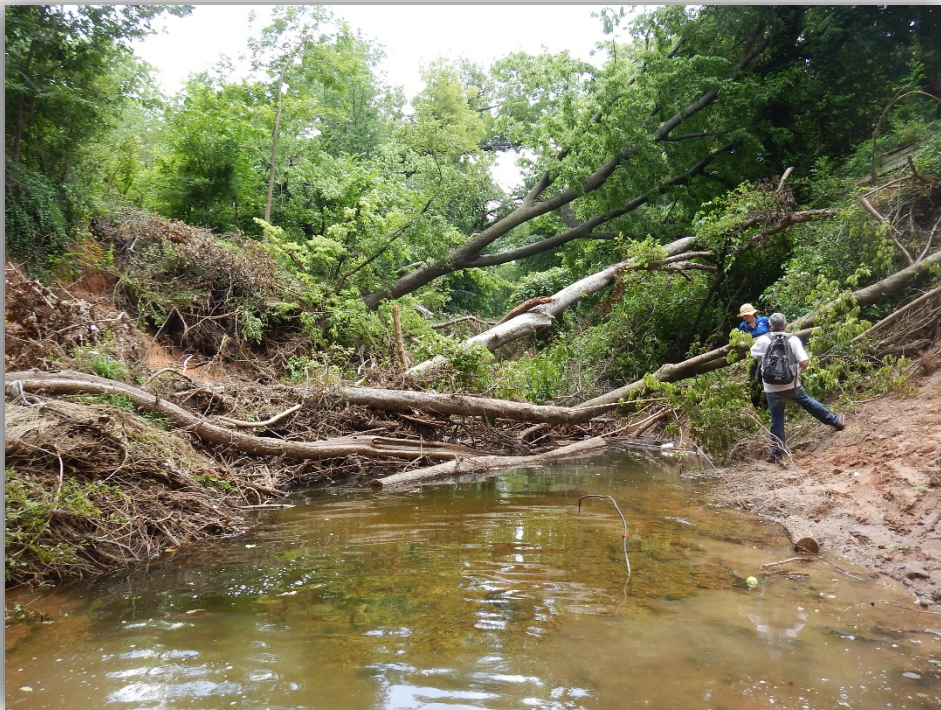
Imhoff Creek

- Channel Evolution Model
- Stage II (disturbance)
- Future damage of the bridge structure if not properly addressed
- Downstream channel is transitioning through Stage III (incision) to Stage IV (widening)
 - Becomes “U” shaped
 - Down cutting
 - Bank erosion

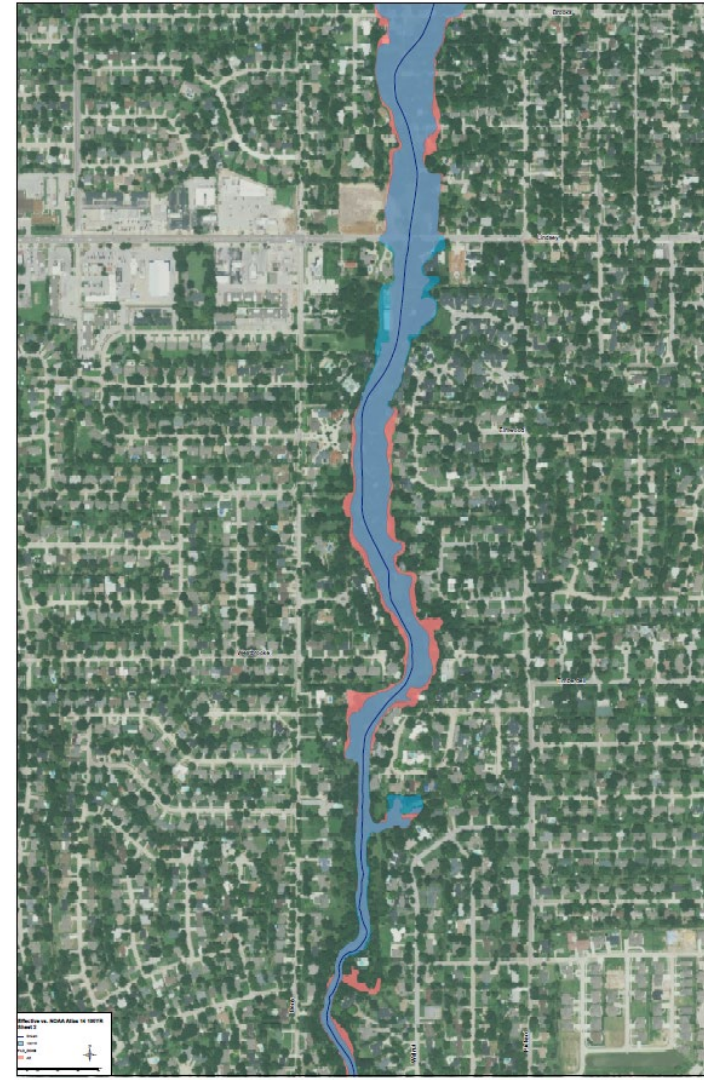
- Updated Hydraulic Model
 - Detailed Channel Survey
 - Analyzed 2014 & 2015 Storms
 - Updated Floodplain Mostly Smaller

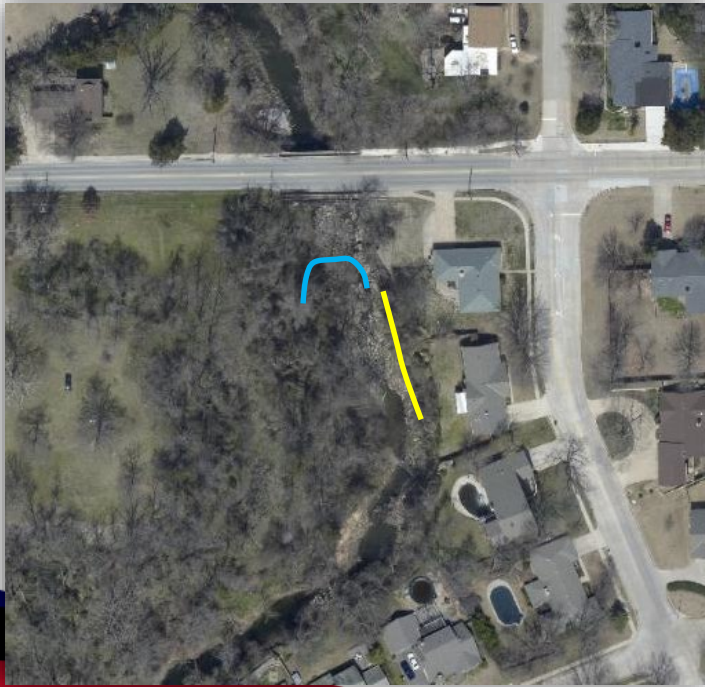
Recommendations Lower Segment

- Monitoring Plan
 - Document Rate of Change
 - Use to Prioritize Improvements
 - Stream Maintenance
 - Train City Staff in Stream Restoration and Bank Stabilization Techniques
-

- Current Study – Analysis and Conceptual Design
 - Next Step – Final Design and Construction (funding needed)
 - Phase I
 - From Imhoff Road south approximately 1,200'
 - Greatest risk to existing infrastructure
 - Cost estimate: \$3,150,300
 - Phase 2
 - Upstream of Imhoff Road to end of Channel Liner Repair project
 - Cost estimate: \$4,347,950
-

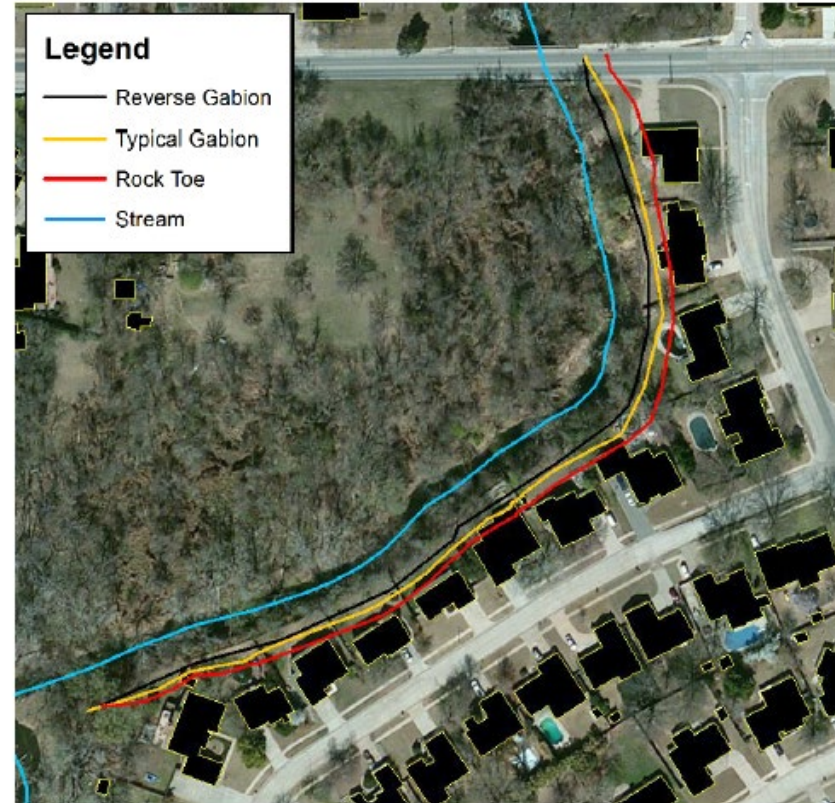
Figure 12: Estimated Impact Limits Downstream Imhoff Road

- Bank stabilization options
- Limited availability
- Additional detailed analysis required

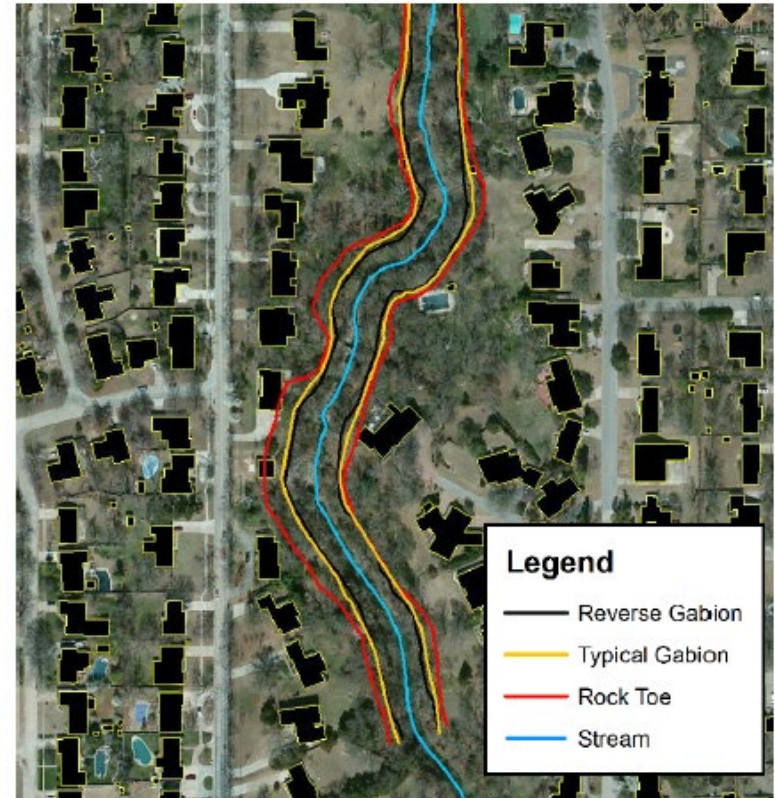
Figure 13: Estimated Impact Limits Upstream Imhoff Road

- Bank stabilization options
- Limited availability
- Additional detailed analysis required
