LOWER IMHOFF CREEK HYDRAULIC & HYDROLOGIC STUDY PROJECT

Norman, Oklahoma

Prepared For: City of Norman, Oklahoma

REPORT UPDATE - June 30, 2017

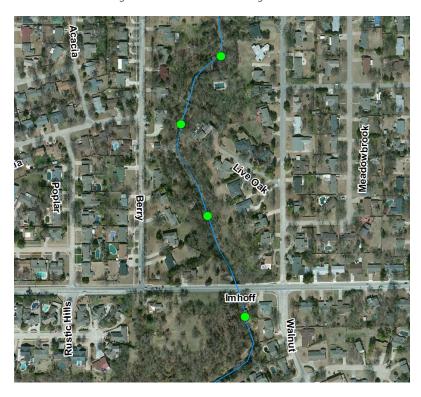
Figure 11: Potential Monitoring Locations

Based on field investigations the design team recommends that a minimum of four (4) monitoring locations be established to quantify the rate of loss and evaluate the performance of potential mitigation actions. The locations shown as green points in Figure 11 below have historically been subject to adverse erosive impacts. These locations provide a suitable opportunity for monitoring actions. These areas are located adjacent to or are on private property therefore monitoring activities will require some communication with the property land owners.
