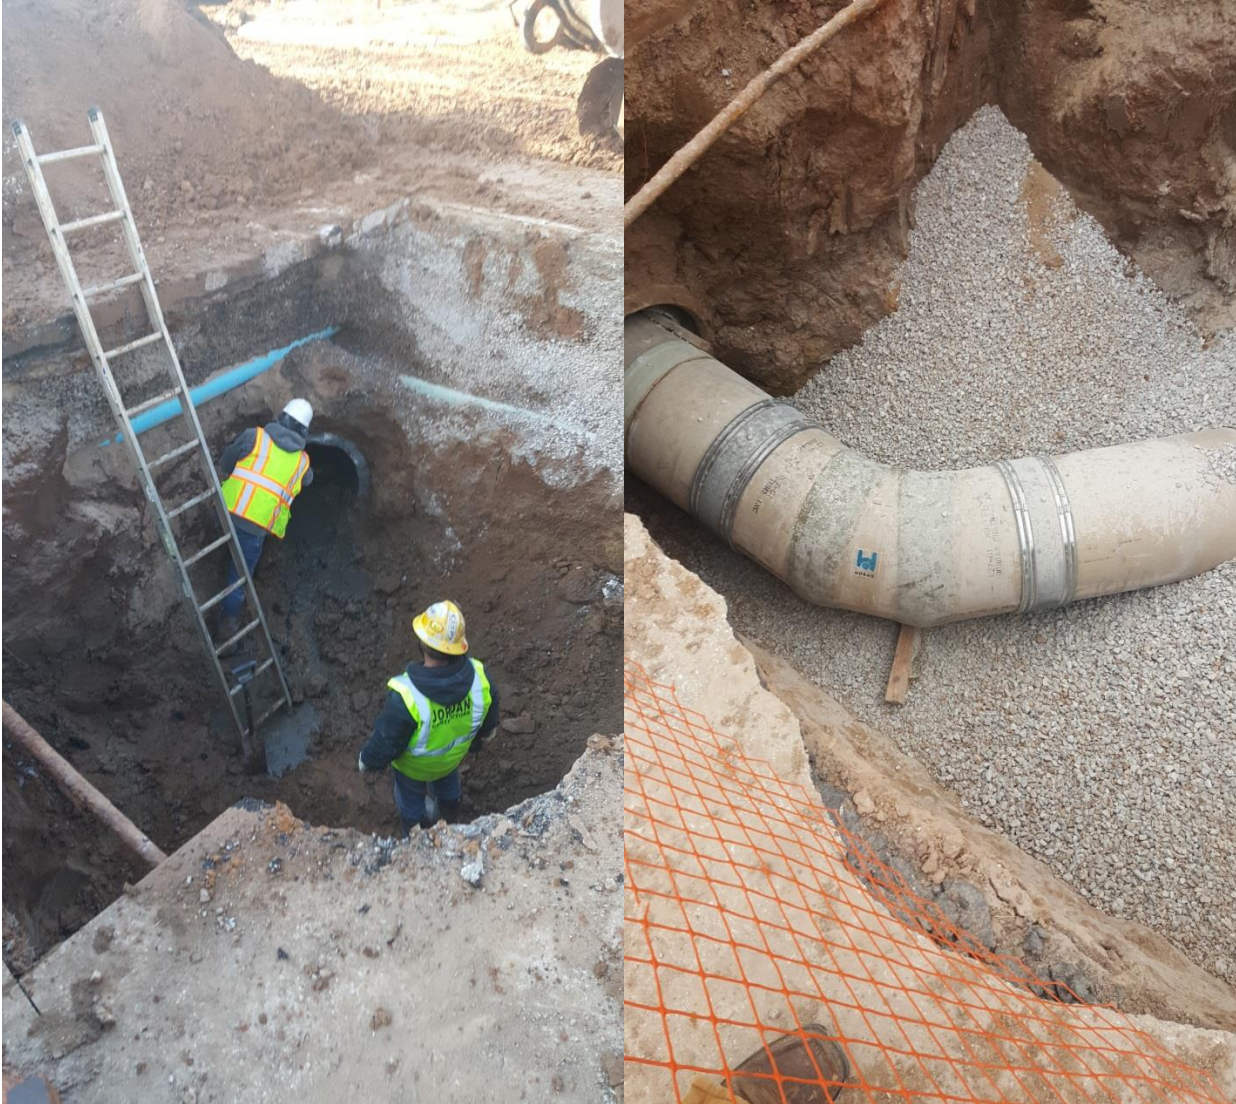
Before and after photos of new 27-inch FRP piping, fittings and Fernco couplings in roadway NE of Environmental Services Building on Influent Line to Primary Clarifiers 3 and 4.

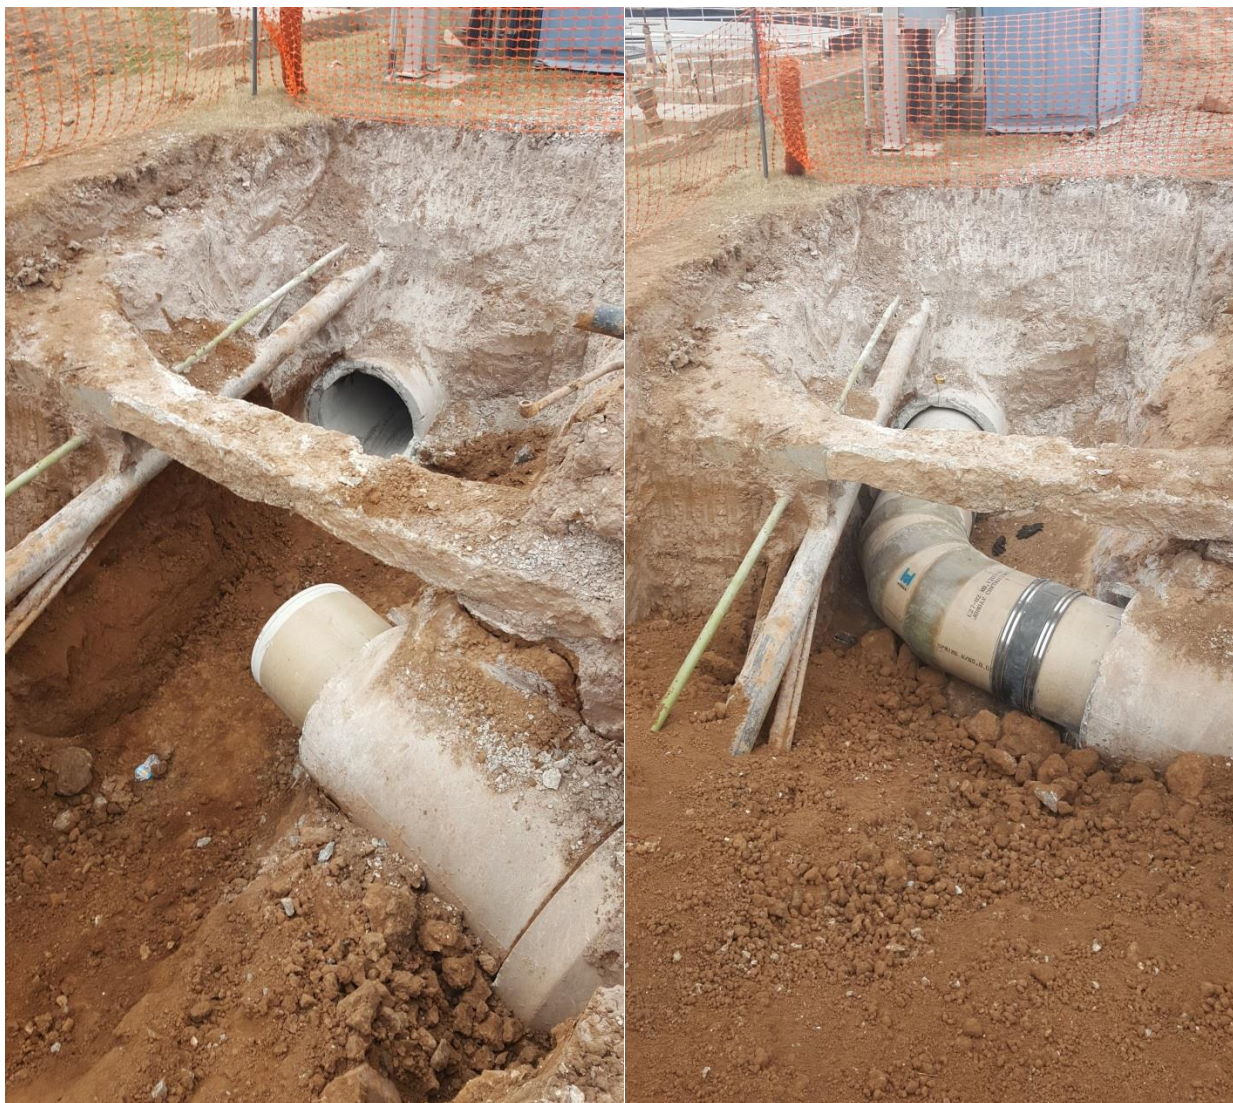
Before and after photos of new 27-inch FRP piping inserted in 30-inch RCP and fittings and Fernco couplings south of Motor Control Center on Influent Line to Primary Clarifiers 3 and 4
